PROPERTY CONDITION ASSESSMENT REPORT

Fresco's Waterfront Bistro
300 2nd Avenue NE
Saint Petersburg, Florida 33701

NOVA Project Number: 10106-0518002

April 19, 2018

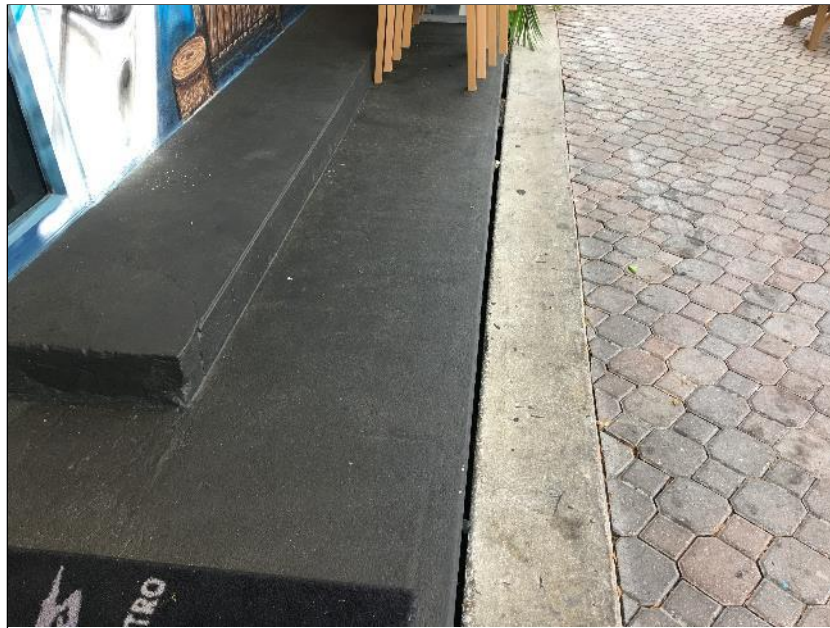
The sidewalks, entrance flatwork and visible concrete pad sections generally appeared to be in good condition. Minor stress/shrinkage cracks were observed in the sidewalks and pad. Considering the 20-year term in our evaluation, it can be reasonably expected that refurbishing of the concrete and sidewalk areas will be required during the term.

Photo 7: Building slab along main entrance on north side. The sidewalk is lined with pavers.

- Refurbish and repair expected damage in areas of flatwork in year 10.
- Routine maintenance, miscellaneous minor repairs and normal operating maintenance will be required.

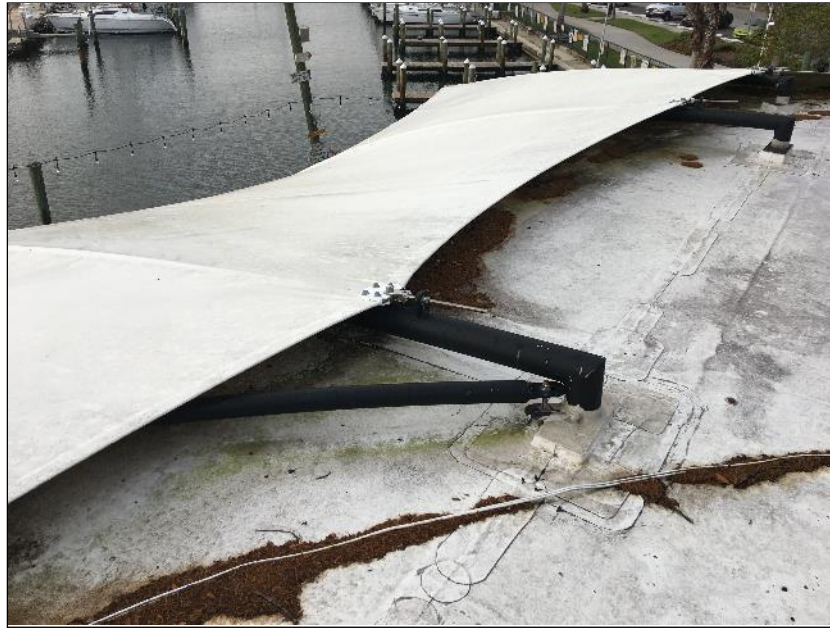
Landscaping and appurtenances at the subject property appear to be in good overall condition. NOVA did not observe issues or concerns regarding the landscaping or appurtenances. The installed tarpaulin will likely require replacement during the term due to exposure to the natural elements.

Photo 11: Canopy installation over outdoor seating.

- Replace tarpaulin covering in Year 10.
- Routine maintenance, miscellaneous minor repairs and normal operating maintenance will be required.

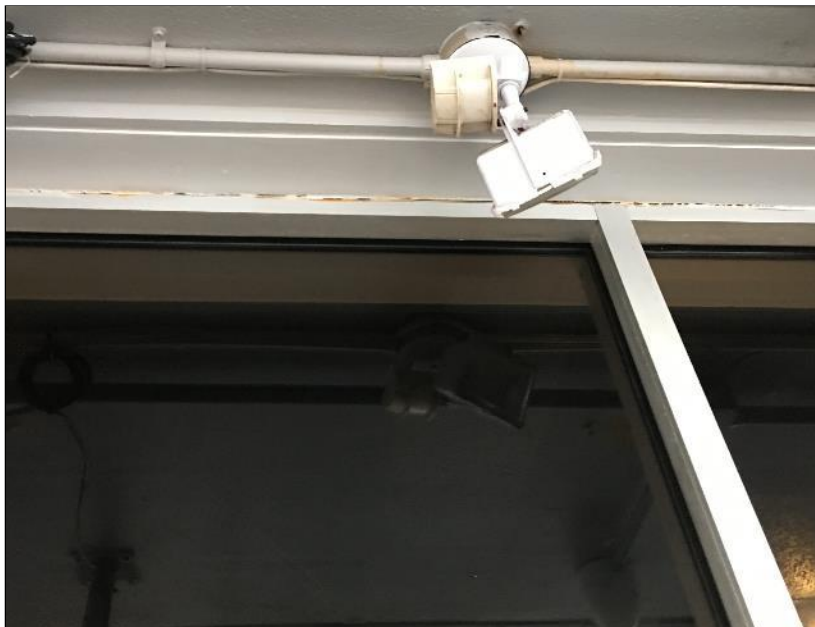
Photo 24: Detached sealant along header of storefronts.

- Exterior metal doors on north and east sides should be replaced in year 10.
- Aluminum storefronts should be replaced in year 10.
- Replace existing perimeter window sealants at all locations in years 10 and 20.
- Routine maintenance, miscellaneous minor repairs, and normal operating maintenance will be required.

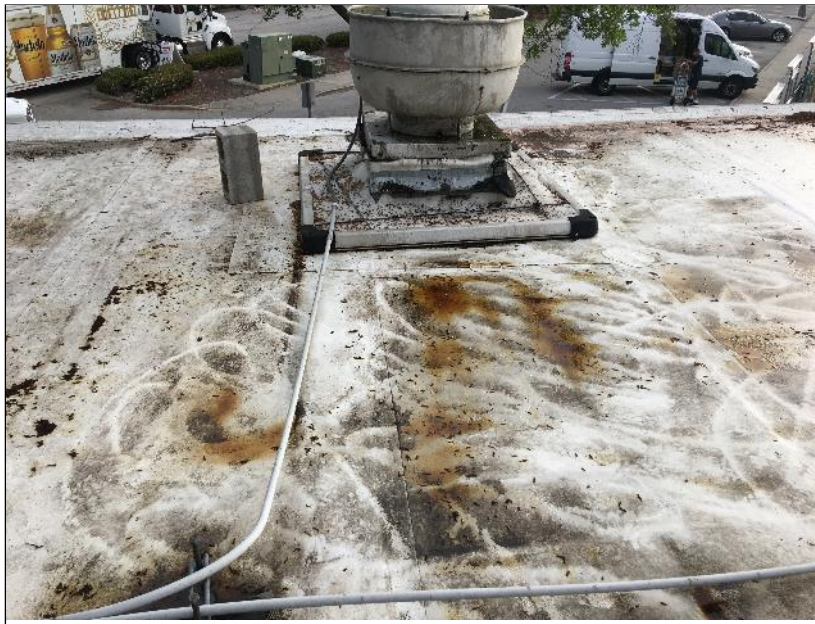
Photo 26: Observed grease residue near kitchen exhaust.

- Remove grease from roof area and replace grease trap under exhaust vent. Install mesh between canopy and PVC membrane to prevent accumulation of debris at gutters.
- Replace kitchen exhaust in Year 3.
- Replace roof system in Year 11.

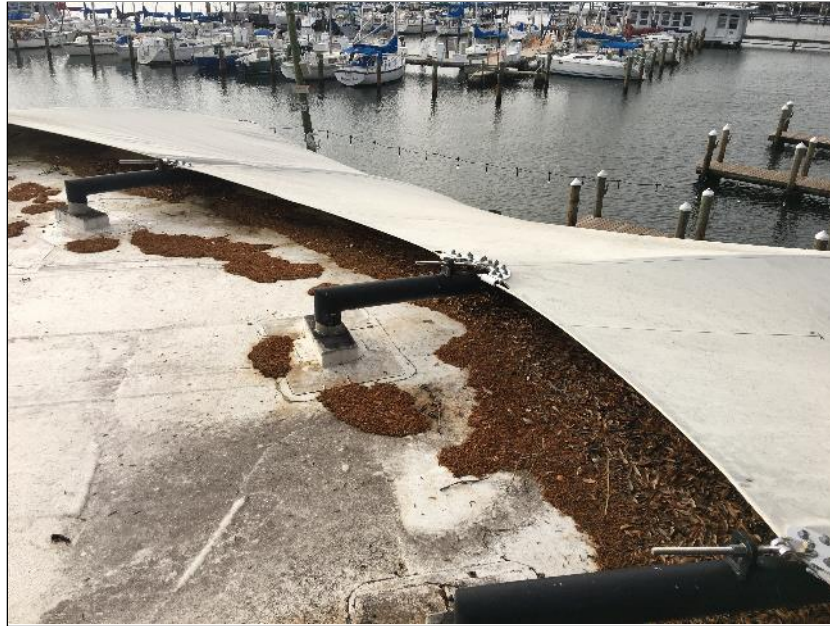
Photo 27: Accumulation of leaves and debris at canopy transition near gutters. The gutters are covered by the canopy and were not visible.

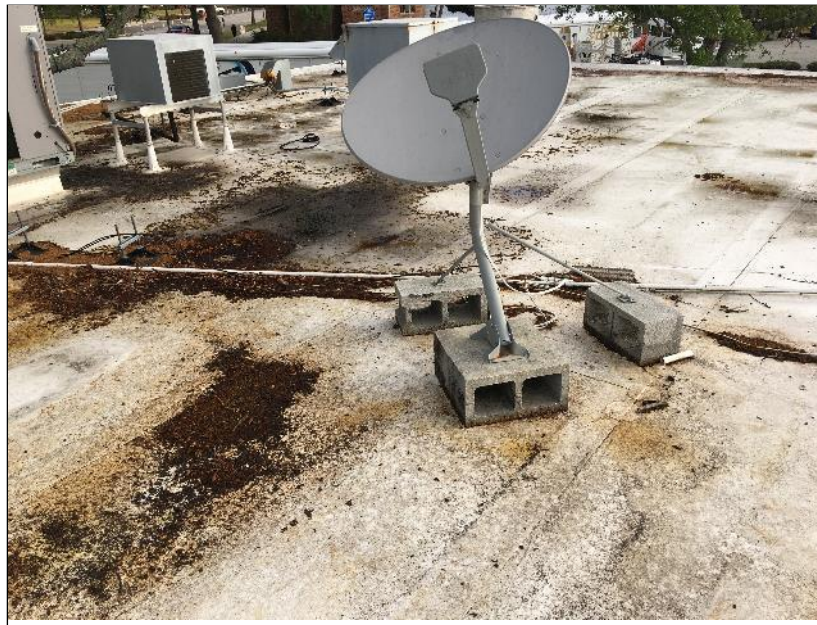
Photo 28: Accumulation of grease on roof. The satellite dish is attached to CMU blocks that are in direct contact with the roof membrane.

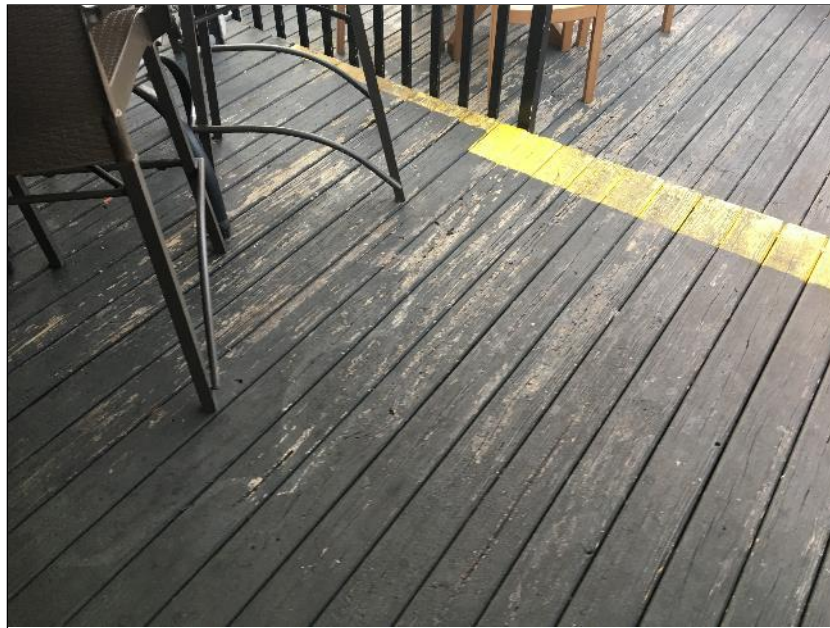
Photo 31: Typical wood decking with marked changes in elevation.

- The exterior decking should be replaced in Year 8.

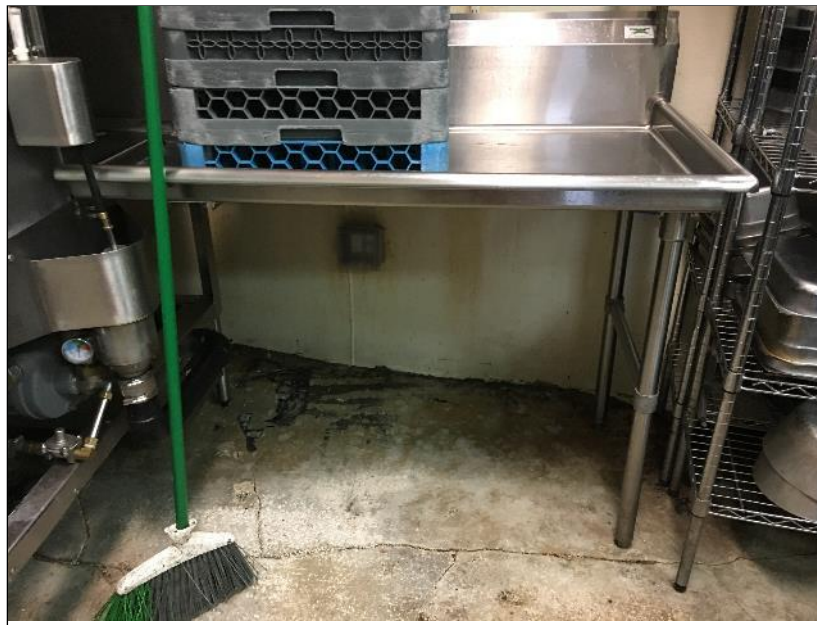
Photo 36: Minor cracking observed in exposed concrete floor area at kitchen.

- Repair deteriorated drywall around service entrance.
- Seal cracks in concrete flooring in kitchen and behind the bar area.

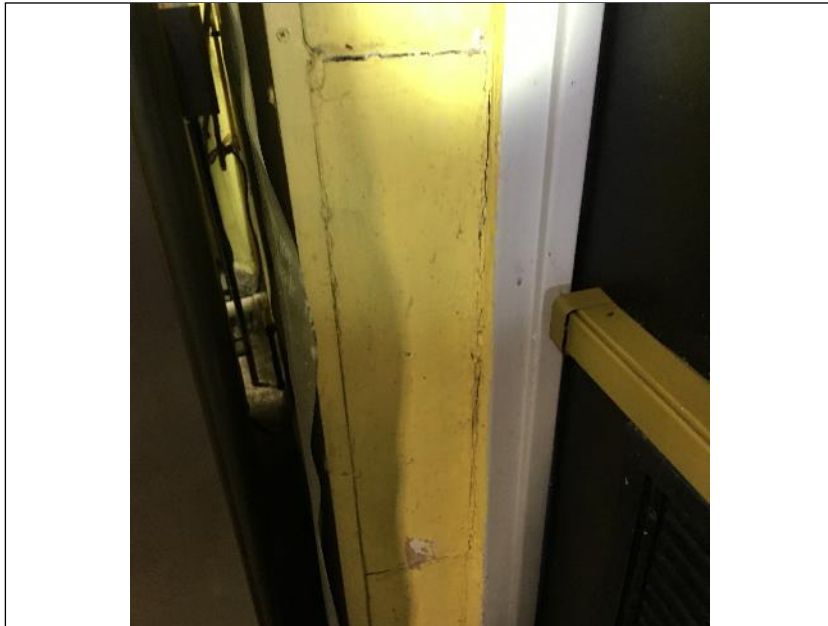
Photo 37: Deteriorated drywall around service door entrance.

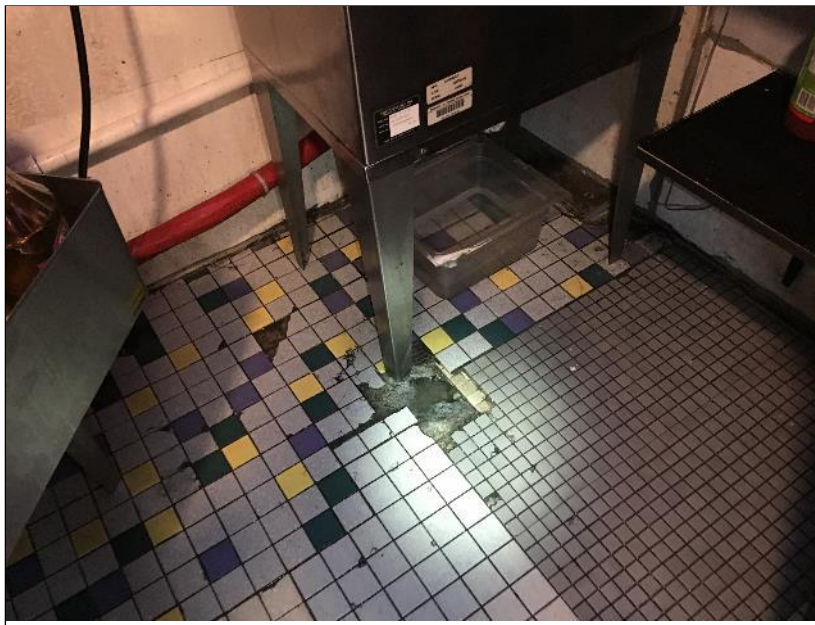
Photo 38: Minor cracking in floor tile behind bar area.

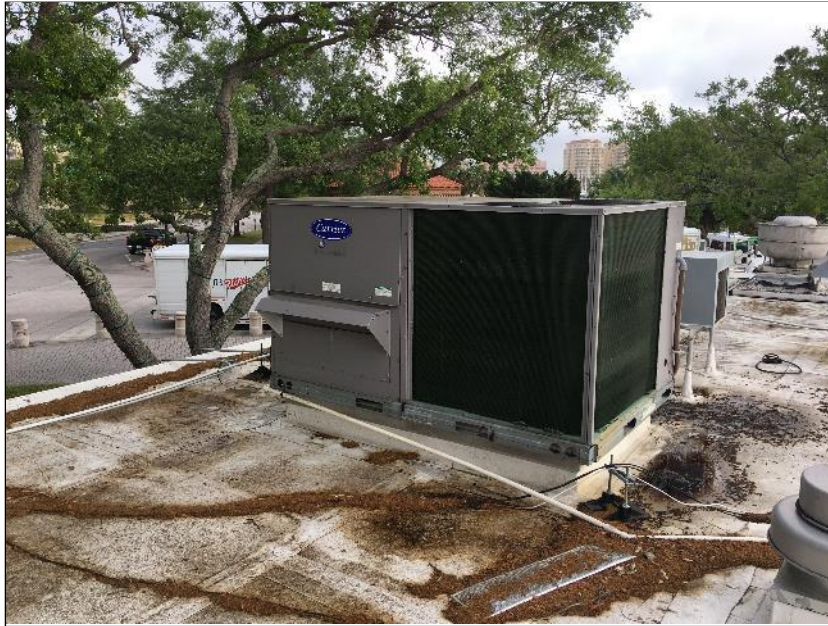
Photo 39: Roof-mounted HVAC unit.

- Replace 9.5-ton rooftop unit in Year 10.

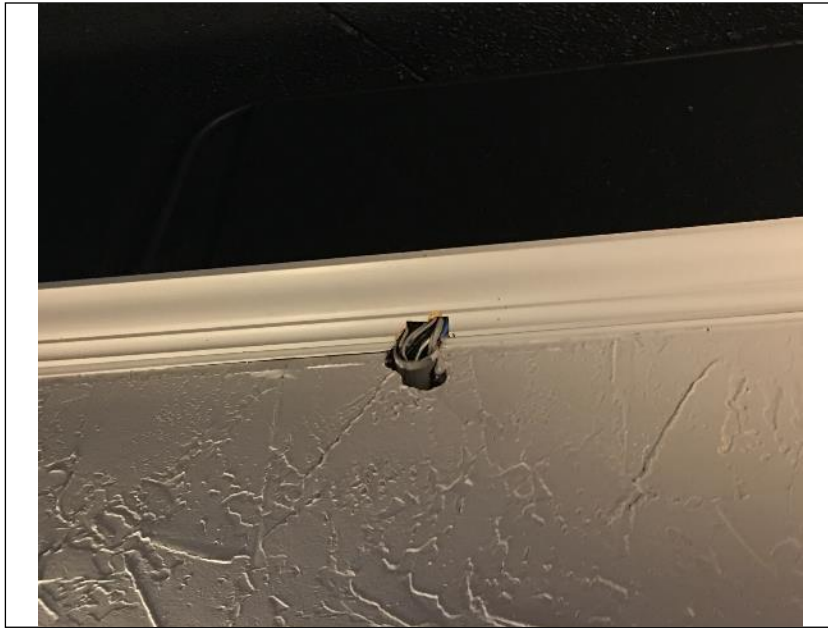
Photo 51: Unfinished low-voltage electrical wiring at top of interior wall due to sound system upgrades. According to the property manager, the wiring will be covered when upgrades are complete.

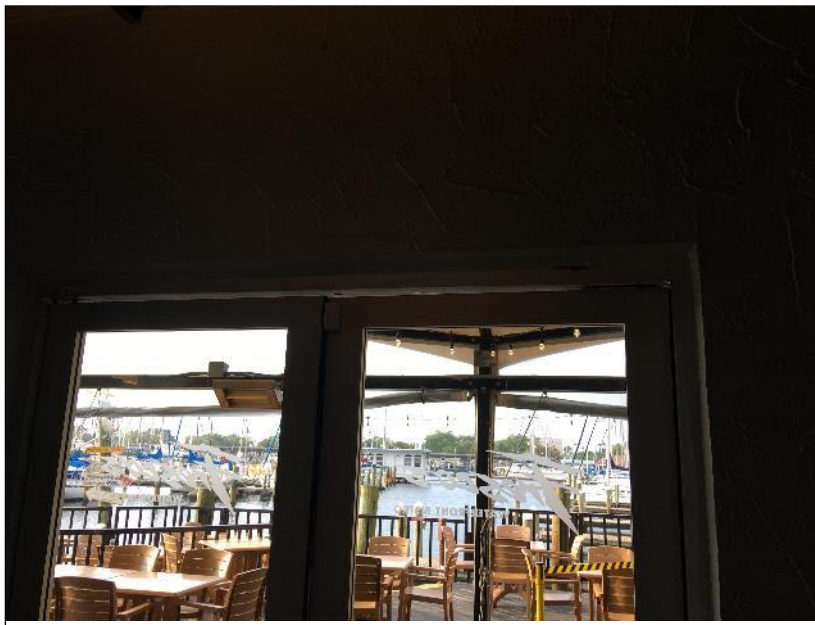
Photo 56: Emergency exit sign was not observed over doorway leading to outdoor seating area.
