CITY OF ST. PETERSBURG MARINA REDEVELOPMENT

St. Petersburg Task Order # 21-01-MCL-MP(S) St. Petersburg Project # 21077-119 McLaren Project # 210154.01

ENGINEER'S ESTIMATE MEMO REVISION 1

MARCH 18, 2022

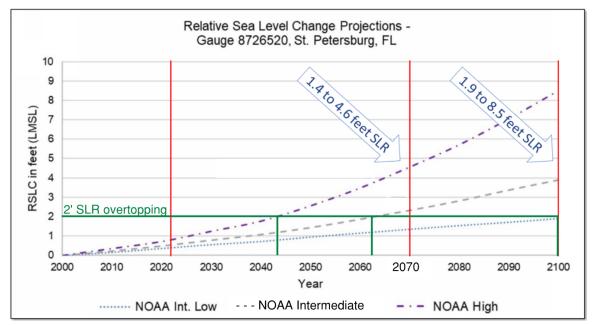
Figure 1. Marina Re-Development Vulnerability Assessment – November 2021 with additional interpolation

projections provided below, the South Basin has a projected remaining service life of approximately 40 to 80 years (See Figure 1). As a result, a significant capital investment into the South Basin facility is justified since a 50-year service life is probable.

It should be assumed that the South Basin will need to be converted into a floating dock marina, similar to the layout recommended for the Central Basin, within the next 50 years. Over the next 20 to 30 years the impacts and trajectory of SLR will become apparent and the overall timeline to replace the facility can be re-assessed. However, at this time the project impacts of SLR should not alter the rehabilitation program recommended for the South Basin.

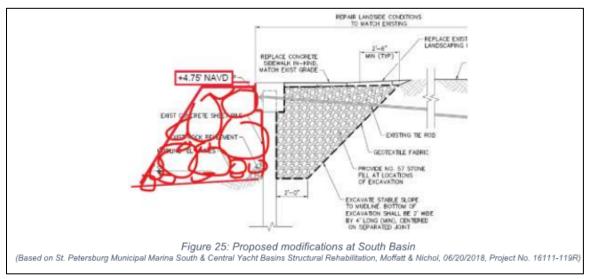
Figure 2. Concrete bulkhead repair detail as presented in Figure 25, of the GPI Marina Re-Development Assessment, dated November 2021.

Deflection of isolated segments of the concrete perimeter walkway and sinkholes are present along the southern and eastern perimeter of Demens Landing. Based on the observed condition of the seawall, the primary mechanisms for fill loss are noted as erosion of the seawall concrete panel joints and deterioration of existing outfalls.

Though these observations are occurring at isolated locations, based on the age of the seawall and consistent observed conditions, fill loss will likely be an ongoing maintenance issue. As a result, a global seawall rehabilitation program should be implemented to address this issue and ensure the continued safe operation of the walkway.

As noted in the GPI report this rehabilitation should comprise installation of riprap revetment along the offshore perimeter of the bulkhead as well as excavation along the inshore perimeter to allow the installation of granular fill wrapped in geotextile (See Figure 2). Where obstructions exist, i.e., existing piers, slips, or mangroves, alternate repairs along the offshore perimeter may be considered. These may comprise reinforced concrete encasements or non-structural encapsulations, pending the condition of the segment.

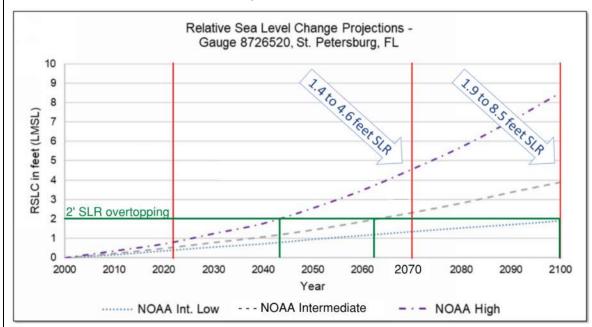
Figure 1. Marina Re-Development Vulnerability Assessment – November 2021 with additional interpolation

Based on site observations and available reference documents it is assumed that the South Basin finger piers will be impacted by Mean Higher High Water (MHHW) elevations with approximately 2 ft of Relative Sea Level Rise (RSLR). Considering the Intermediate Low and Intermediate SLR projections, provided below, the South Basin has a projected remaining service life of approximately 40 to 80 years. As a result, a significant capital investment into the South Basin facility is justified since a 50-year service life is probable.

It should be assumed that the South Basin will need to be converted into a floating dock marina, similar to the layout recommended for the Central Basin, within the next 50 years. Over the next 20 to 30 years the impacts and trajectory of SLR will become apparent and the overall timeline to replace the facility can be re-assessed. However, at this time the project impacts of SLR should not alter the rehabilitation program recommended for the South Basin.

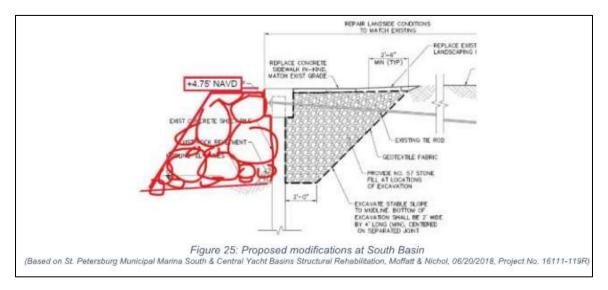
Figure 2. Concrete bulkhead repair detail as presented in Figure 25, of the GPI Marina Re-Development Assessment, dated November 2021.

Though these observations are occurring at isolated locations, based on the age of the seawall and consistent observed conditions, fill loss will likely be an ongoing maintenance issue. As a result, a global seawall rehabilitation program should be implemented to address this issue and ensure the continued safe operation of the walkway.

As noted in the GPI report this rehabilitation should comprise installation of riprap revetment along the seaward perimeter of the bulkhead as well as excavation along the landward perimeter to allow the installation of granular fill wrapped in geotextile (See Figure 2 below). Where obstructions exist, i.e., existing piers, slips, or mangroves, alternate repairs along the offshore perimeter may be considered. These may comprise reinforced concrete encasements or non-structural encapsulations, pending the condition of the segment.

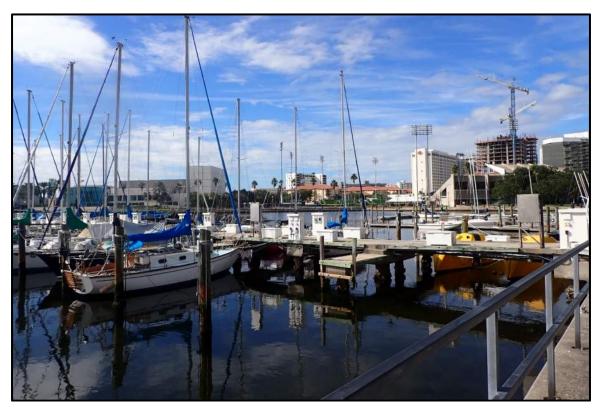
Photograph 1 – Overall view of South Basin Pier 1. Note that the main pier slopes down from the bulkhead.

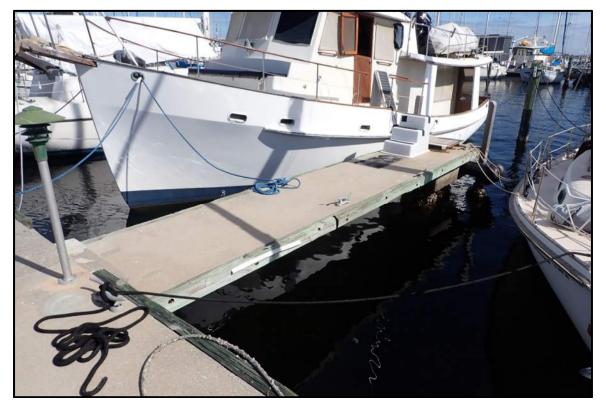
The South Basin finger pier slabs are 6-inch thick prestressed concrete slabs. Observed spalling revealed limited concrete cover, typically less than 2 inches, over two-way wire reinforcement.

As a result of the observed limited concrete cover and the distribution of deteriorated and/or replaced slabs it should be assumed that the original vintage concrete finger pier slabs are saturated with chlorides. This impacts the overall service life requirements for Pier 1 and Pier 2 of the South Basin. Specifically, slab replacements efforts should be integrated into a regular maintenance and rehabilitation program for the South Basin designed to replace the remaining original vintage slabs. Additionally, though the main walkway slabs present fewer signs of deterioration due to the higher elevation, there is a high probability that these elements will begin to present deterioration in the future and will need to be included in the discussed maintenance and rehabilitation program.

Photograph 2 – Typical South Basin finger pier deck slab.

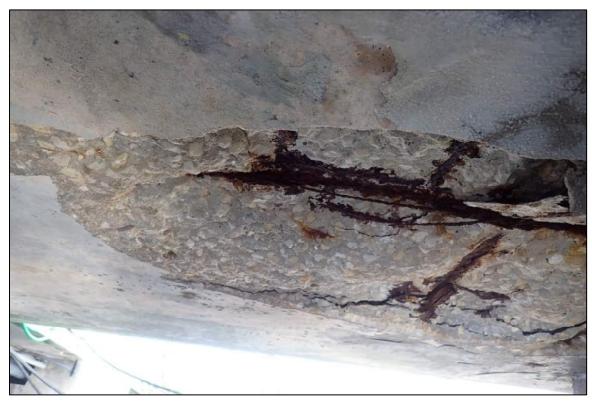
Typical marine construction practices recommend a minimum 3-inch cover for concrete surfaces exposed to the saltwater environment. This concrete cover is important since it slows down the penetration of chlorides through the concrete matrix. Once chlorides reach the embedded reinforcing steel the corrosion process is initiated. As corrosion progresses steel expands resulting in progressively greater deterioration of the concrete structure. Generally, this begins with cracking, followed by closed spalling, and ultimately progresses to open spalling. However, the depth of penetration and the speed of corrosion initiation are not uniform at most facilities and can be impacted by many variables including exposure to wetting and drying, composition of the concrete matrix, and other environmental factors.

Photograph 3 – Typical open spalling with exposed prestressing strands on the underside of a South Basin finger pier deck slab.

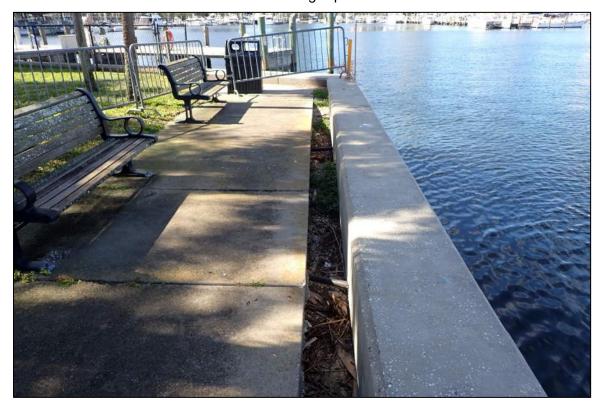
Photograph 4 – Overall view of steel sheet pile bulkhead from the walkway.

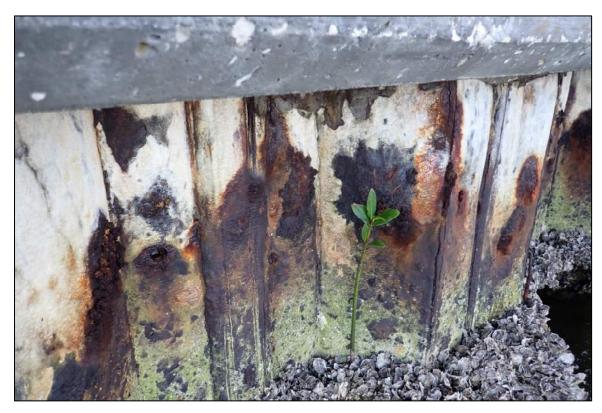
Due to the condition of the steel sheet pile bulkhead in the northern quadrant of the Demens Landing perimeter, McLaren concurs that replacement is recommended. However, considering the limited extents of recommended replacement, the overall impact on resiliency will be negligible since the remaining seawall surrounding Demens Landing is primarily located around an elevation of 3.8 ft NAVD88. Additionally, as stated in the Moffatt and Nichol "Design Criteria Memorandum of Westshore Marina" report dated August 17, 2020, "the design of the waterfront components will consider the NOAA Intermediate Low value", which is +0.50 ft for the 30-year RSLR projection and +0.92 ft for the 50-year SLR projection.

Photograph 5 – Typical condition of steel sheet pile bulkhead with widespread corrosion blistering and delamination at the knuckles.

As a result, replacement of the steel sheet pile bulkhead is still recommended. However, the overall resiliency approach should be considered on a holistic basis before raising the elevation of the seawall. This effort may include segmenting areas to be protected from the impacts of SLR and defining the desired elevation around the perimeter of the island.

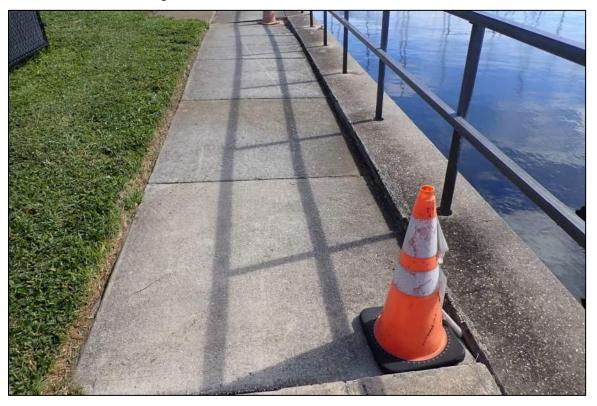
Photograph 6 - Deflection of walkway slab along South Basin seawall.

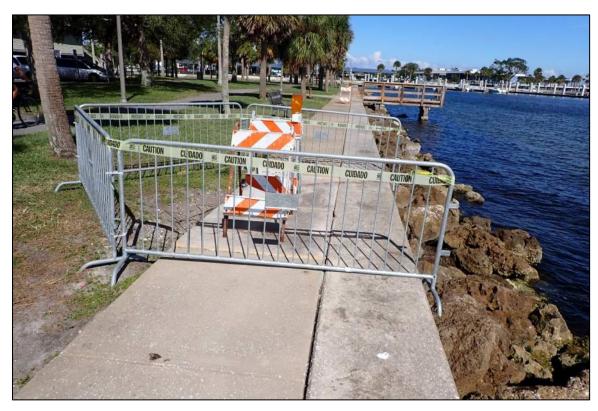
Photograph 7 – Sinkhole below walkway along eastern perimeter of Demens Landing.

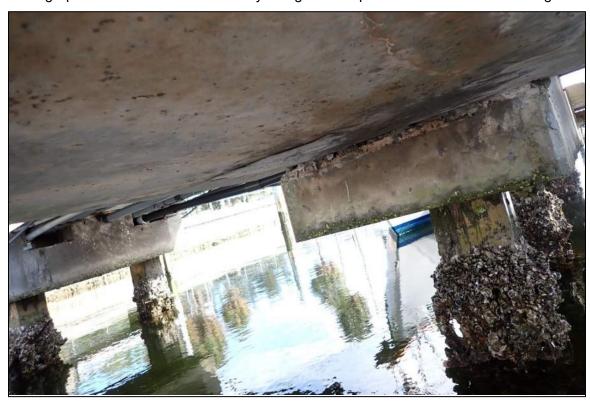
Given that the substructure condition in the South Basin (Piers 1 - 4) is unknown and previous condition ratings of the pile caps were satisfactory/fair, it is important to note the risk that this

Photograph 8 – View of substructure in South Basin. Marine growth visible on piles and some cracking and deterioration visible on pile cap.

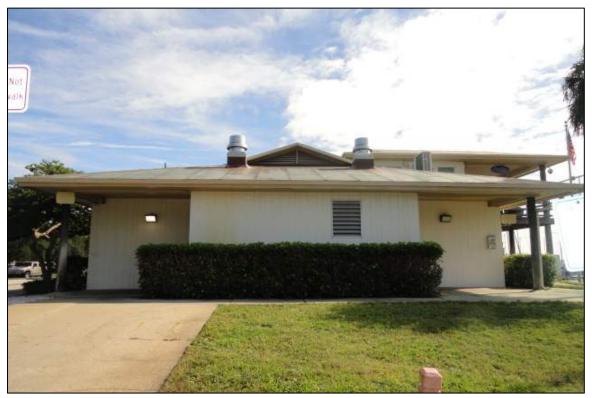
Photograph 10 – West Elevation of South Basin Comfort Center, View of Existing Roof to be Replaced.

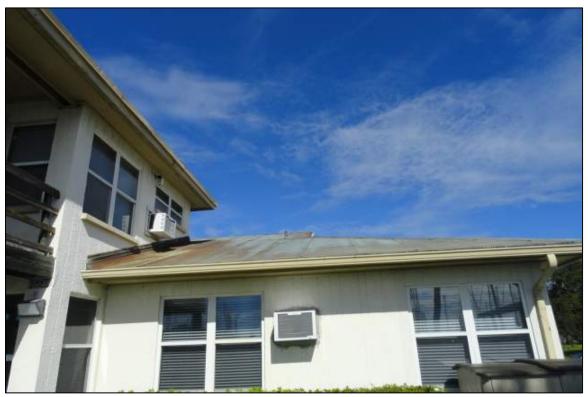
Photograph 11 – Partial South Elevation of South Basin Comfort Center, View of Existing Roof to be Replaced.

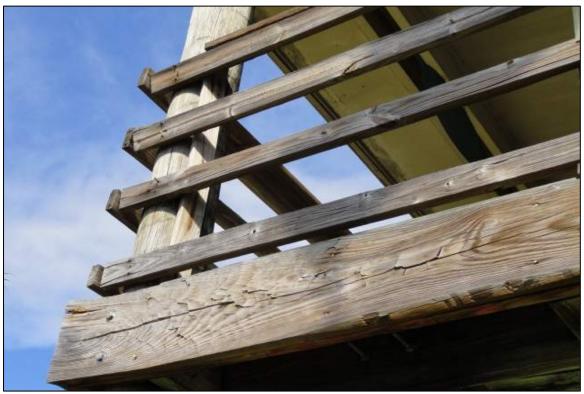
Photograph 12 – South Basin Comfort Center, View of Warped Timber Guardrails and Girder.

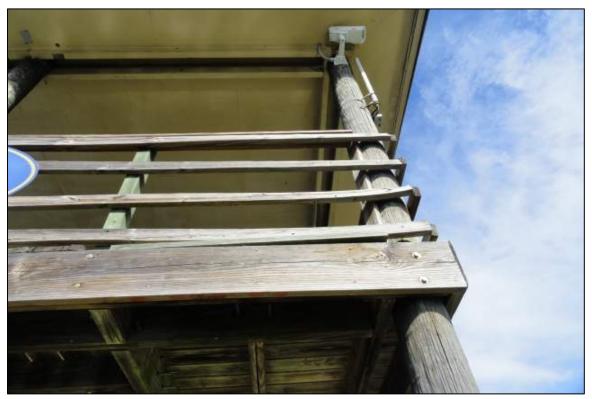
Photograph 13 – South Basin Comfort Center, View of Warped Timber Guardrails.

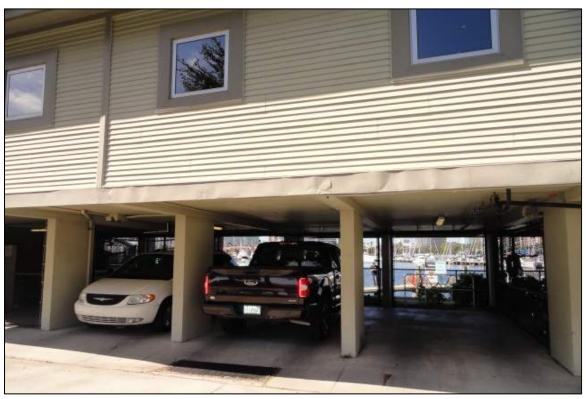
Photograph 25 – East Elevation of Marina Office and Ship Store, View of Damaged Metal Flashing just above Open-Air Carport.

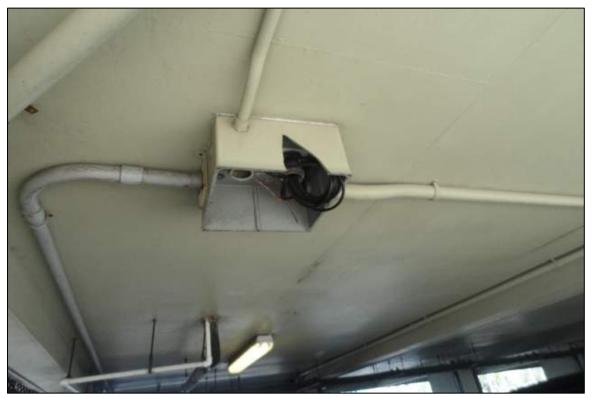
Photograph 26 – Marina Office and Ship Store, View of Damaged Electrical Junction Box at the Ceiling of the Open-Air Carport Ceiling.

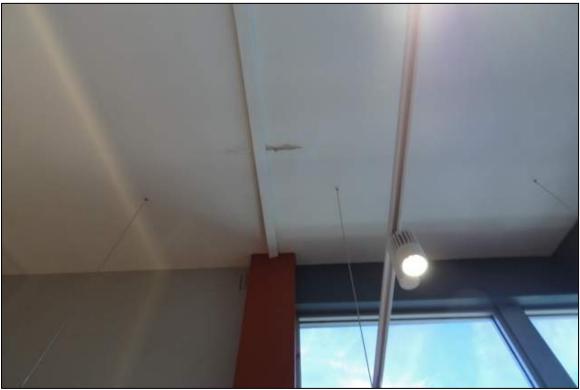
Photograph 28 – Marina Office and Ship Store, View of Damage to Local Area of Gypsum Board Ceiling due to Roof Leak.

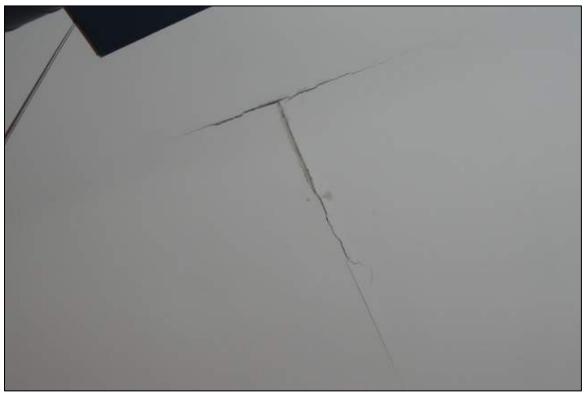
Photograph 29 – Marina Office and Ship Store, Close-up View of Damage to Local Area of Gypsum Board Ceiling due to Roof Leak.

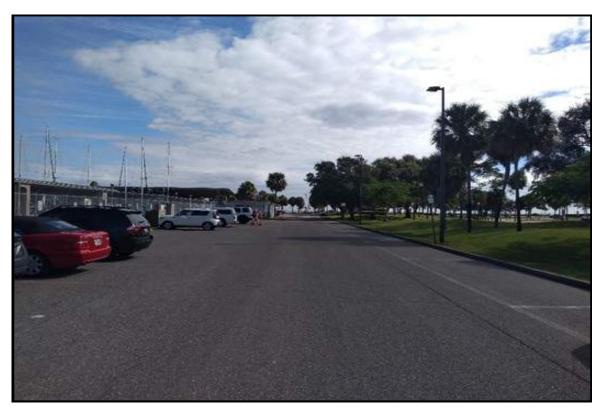
Photograph 30 – View of North Side of Demens Landing Parking Lot where pavement is in good condition.

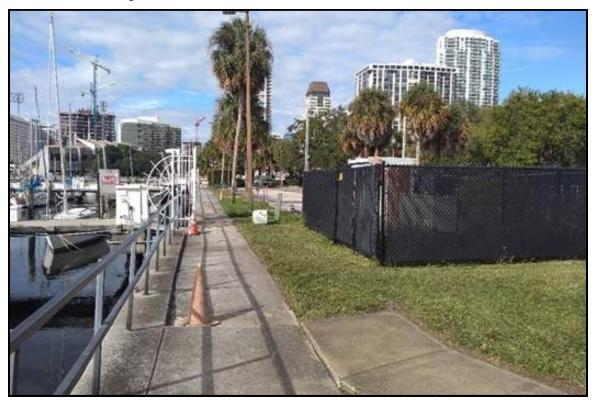
Photograph 31- View of South Side of Demens Landing where sidewalk is collapsing in.

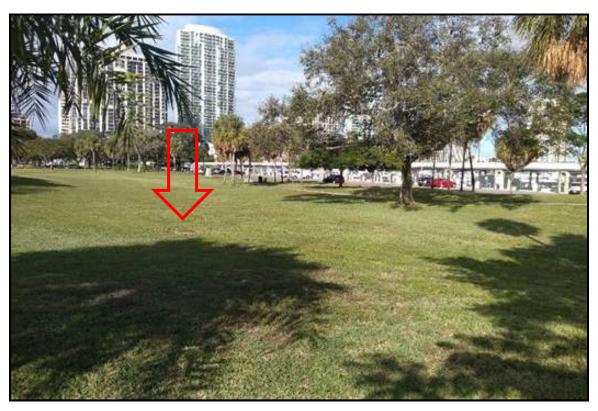
Photograph 32 – View of grate inlet, identified by red arrow, that is potentially modifiable to retain stormwater runoff for treatment.

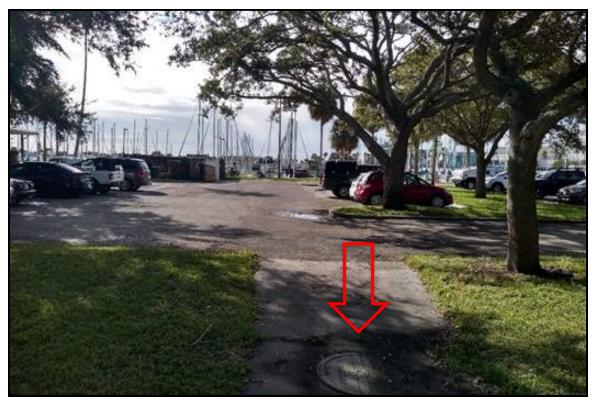
Photograph 33 – View of potential stormwater management system not identified on the City Utilities Atlases.

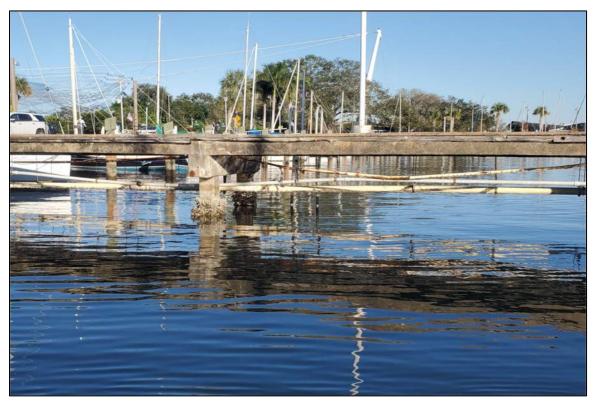
Domestic water appeared to be a mix of plastic pipe; (PVC, CPVC) that has been repaired over the years. It was in varying conditions based on age of repairs. As an overall system it appeared to be at end of life. Some hangars were loose or missing on occasion with sagging pipe.

Photograph 34 – View of sagging utility (domestic water) lines at Central Basin.

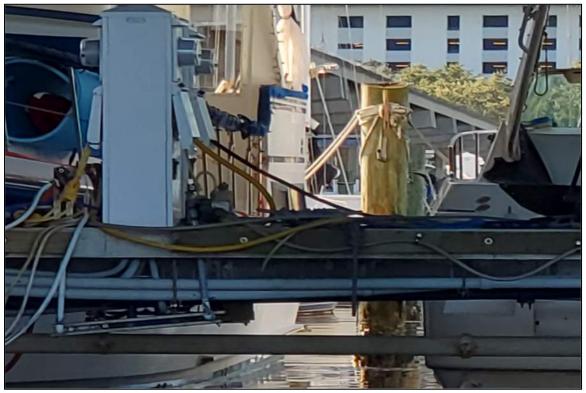
Conduits and piping under piers and attached to structures were often co-mingled and with other services such as water and sanitary piping. Some hangars were loose or missing on occasion with sagging pipe.

Photograph 35 – Existing comingled utility piping under piers at Central Basin.

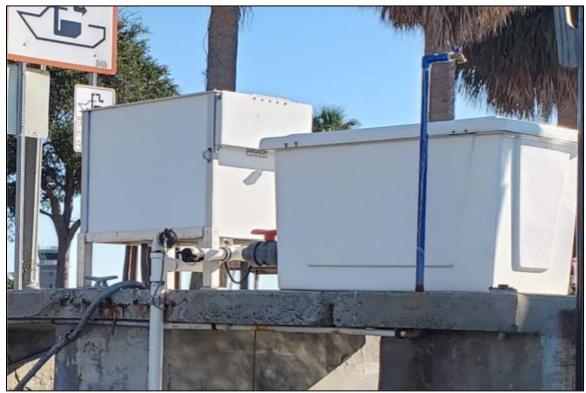
There is an existing pump out station that appears to be in good condition. It is our understanding that the marina is also served with mobile pump out services and wishes to continue with this service.

Photograph 36 – View of existing sanitary pump in Central Basin.

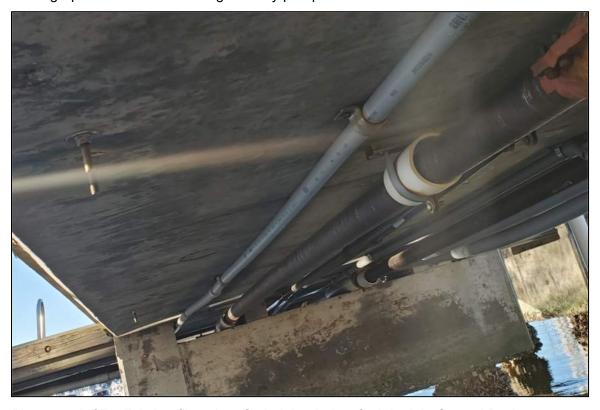
The short section of fuel piping located under the pier appears to be fiberglass with bonded clamshell sealed fittings. The system appears to be in good condition. The clamshell fitting fasteners are the only items with signs of higher levels of corrosion. If further conditional analysis is warranted a specialty contractor will be needed to investigate the hidden fuel components and offer a detailed report.

Photograph 37 – Existing fiberglass fuel piping below fuel dock in Central Basin.

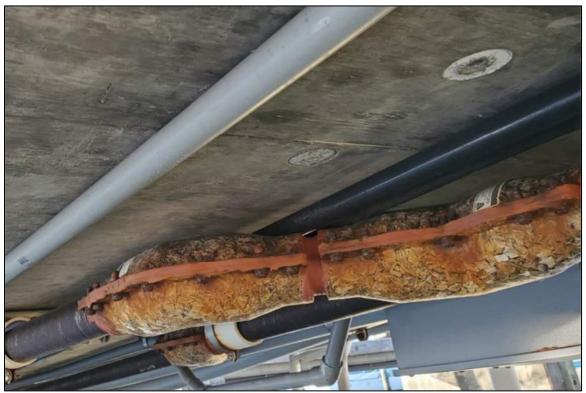
Photograph 38 – Existing clamshell sealed fitting fuel lines in Central Basin.

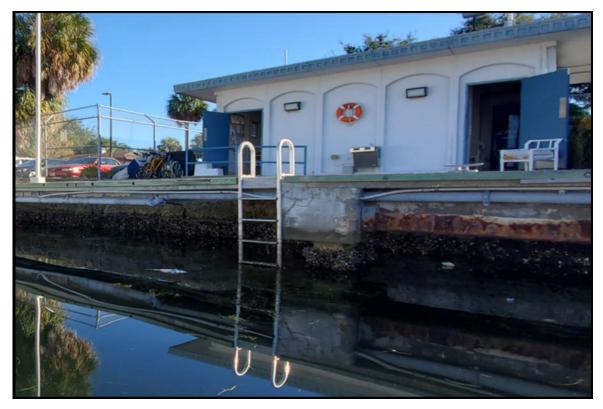
The area is served through a manual dry standpipe system with fire department connections near the pier entrances and respective site fire hydrants. Hose valves are placed out on the piers at intervals for coverage. The system appears to be mainly galvanized pipe with mechanical couplings. The piping was not heavily corroded but looked aged.

Photograph 39 – View of Existing galvanized standpipe at Central Basin.

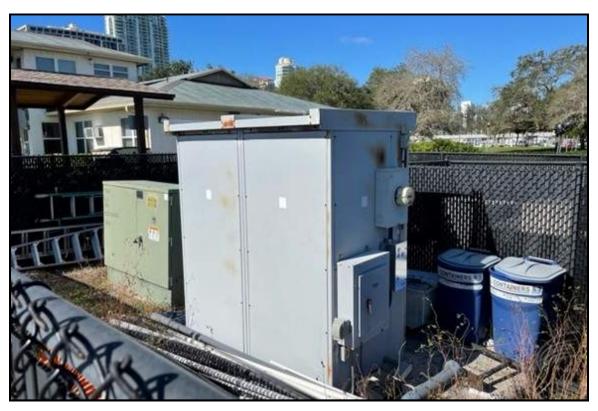
There were four (4) Duke Energy 75 kVA pad-mount transformers feeding electrical services to the docks. Multiple landside electrical services located on the landside, fed different sections of the existing piers. Electrical services appeared to range from small to large and voltages 208/120 V. Electrical feeders were routed in PVC conduits mounted below pier structures or attached to the side of bulkhead walls. Generally, each slip was fed from a marina style pedestal of sufficient capacities and voltages for the slips served. Two (2) electrical meters were generally observed on each pedestal indicating one electrical meter per slip.

Photograph 40 – View of typical Duke Energy transformer and 208/120 V switchgear in the South Basin.

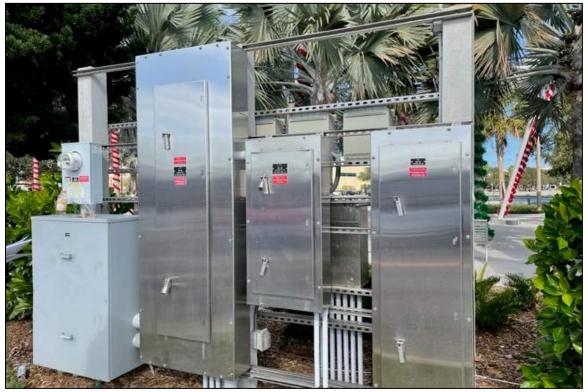
Photograph 41 – View of 208/120 V switchgear that will need to be re-fed in the South Basin.

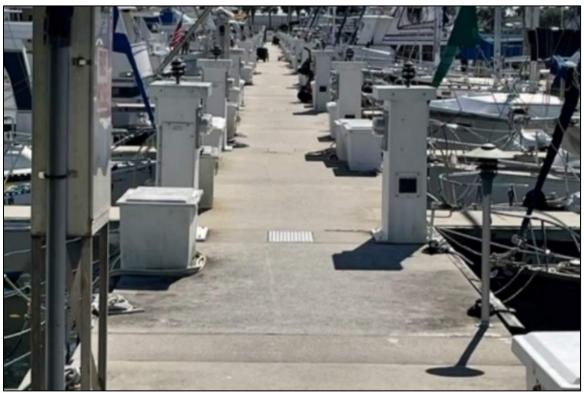
Pedestals appeared to be in satisfactory condition but considering their harsh, saltwater environment and of unknown age, are not recommended to be reused and the Electrical cost estimate includes new pedestals for all slips.

Photograph 42 – View of typical dock with pedestals in the South Basin.

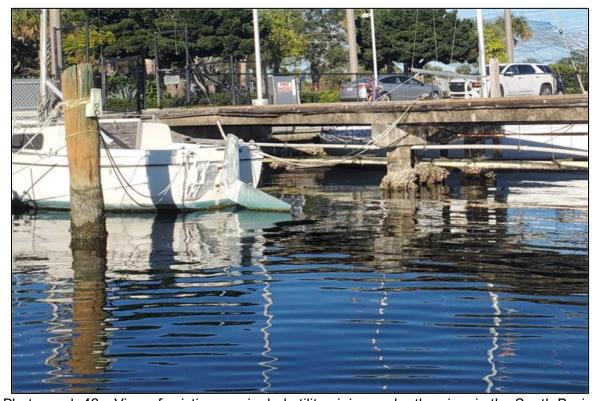
Photograph 43 – View of existing comingled utility piping under the piers in the South Basin.
