PHYSICAL NEEDS ASSESSMENT

PHYSICAL NEEDS ASSESSMENT AND ENERGY AUDIT
OF
JORDAN PARK
1245 JORDAN PARK STREET SOUTH
ST. PETERSBURG, FLORIDA 33712

April 4, 2016

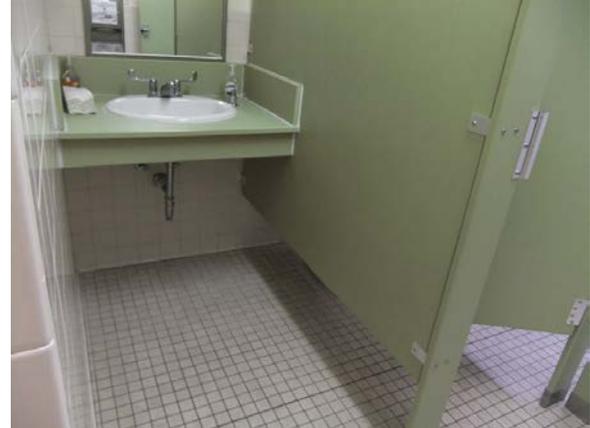
PHOTO #10: COMMON AREA RESTROOM (MISSING INSULATION BENEATH SINK)
