CITY OF ST. PETERSBURG, FLORIDA
PLANNING AND DEVELOPMENT SERVICES DEPARTMENT
URBAN PLANNING AND HISTORIC PRESERVATION DIVISION

STAFF REPORT

Community Planning and Preservation Commission Certificate of Appropriateness Request

Review of a Certificate of Appropriateness for replacement of historic windows, repairs to the garage, and a street-side porch enclosure at 2863 Burlington Ave. N., a contributing resource to the Kenwood Section – Seminole Park Local Historic District (17-90300003)

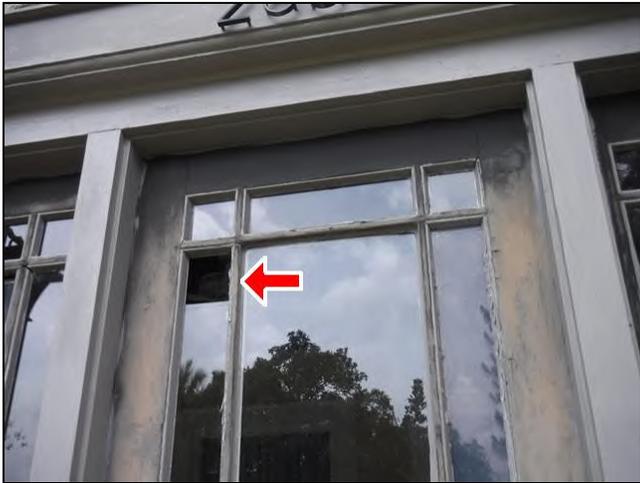
2.1 Item 1(Picture)

2.1 (1) Exterior doors and door frames/trim were in poor condition and were in need of repairs or replacement. Repairs recommended by a licensed window/door contractor. Repairs recommended.

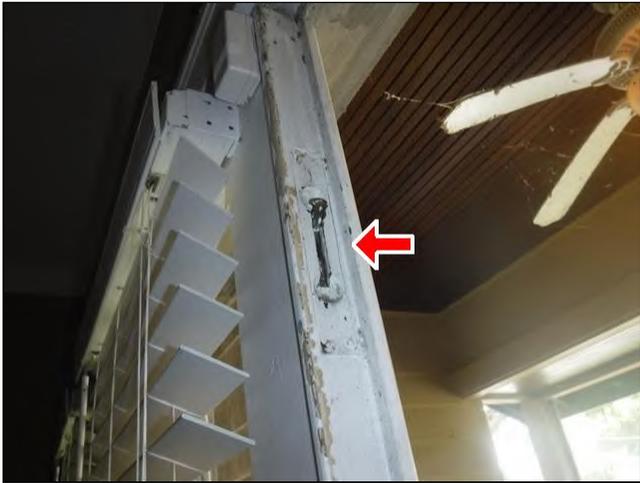
2.1 Item 7(Picture)

(2) Patio doors were in need of weather stripping and hardware repairs. Repairs recommended.

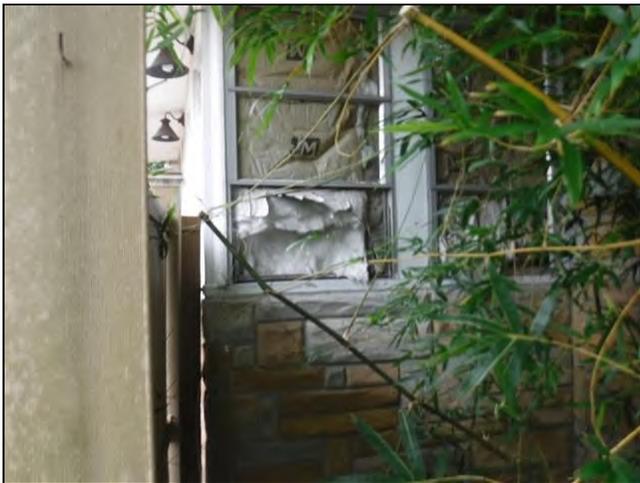
2.2 Item 8(Picture)

(2) Missing windows at the rear addition left side. Replacement recommended by a licensed window/door contractor. Repairs recommended.

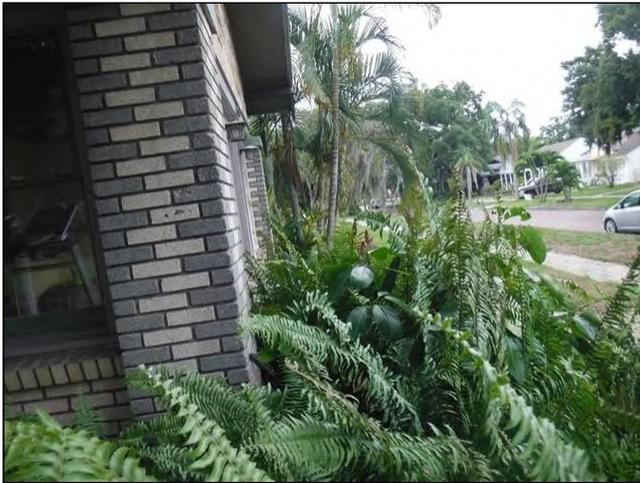
2.4 Item 1(Picture)

2.4 (1) Vegetation/tree too close to the building can contribute to damage from the roots to the foundation and walkway, branches abrading the roof and siding, and leaves providing a pathway for moisture and insects into the building. Trim all foliage to be 1-2 feet from the structure.

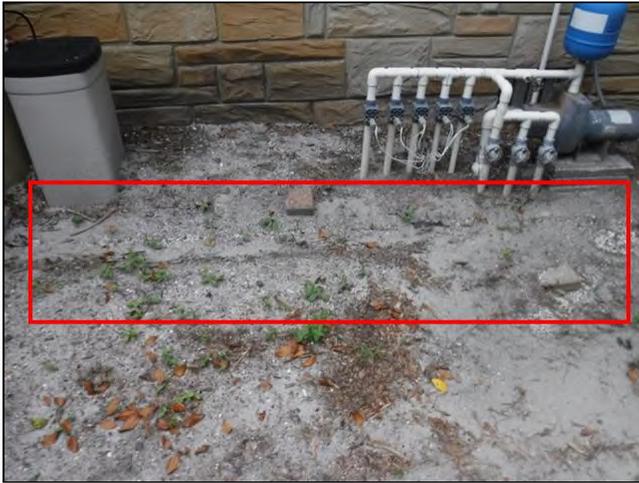
2.4 Item 4(Picture)

(2) Trenching conditions were present at the perimeter of the house. Directing more moisture towards the foundation increases the risk of moisture intrusion. Water should be directed away from all foundations to prevent potential water intrusion and foundation shifting. The drainage strategy of the foundation is important. Expansive soils can be very destructive to the foundation if the moisture content of the perimeter varies. Gutters are the best solution for this condition and should be considered as an upgrade.

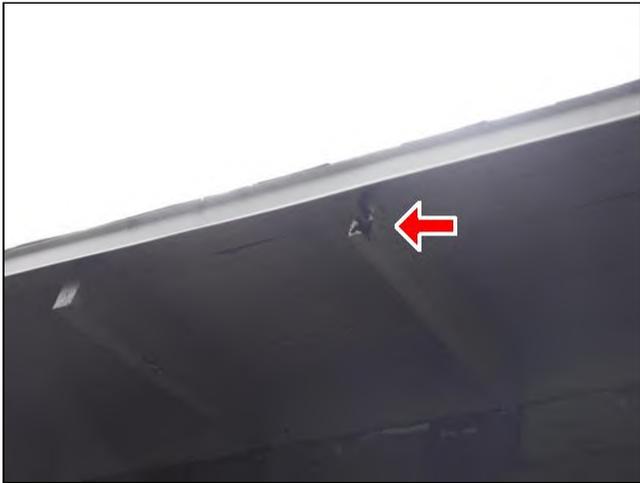
2.5 Item 1(Picture)

2.5 There were rafter tails and fascia boards that were deteriorated and/or rotting. Repairs recommended as needed by a licensed contractor. The buyer should also consider adding metal or vinyl cladding at all rafter tails to prevent further deterioration.

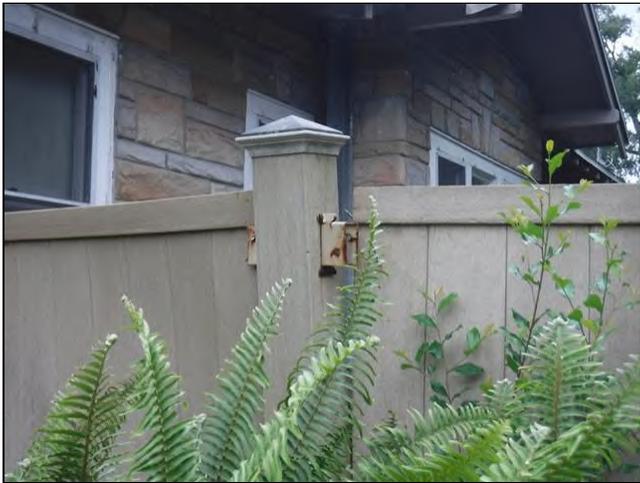
2.8 Item 1(Picture)

2.8 The left side fence was damaged and in need of repairs.

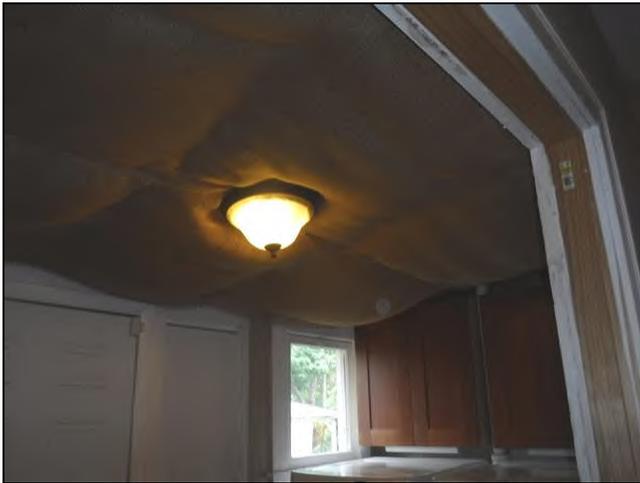
4.0 Item 1(Picture)

4.0 (1) There was fabric installed at the ceiling in the rear addition. The material was not removed or pulled back by the inspector. The material should be considered a fire hazard due to proximity to electrical components and removed.

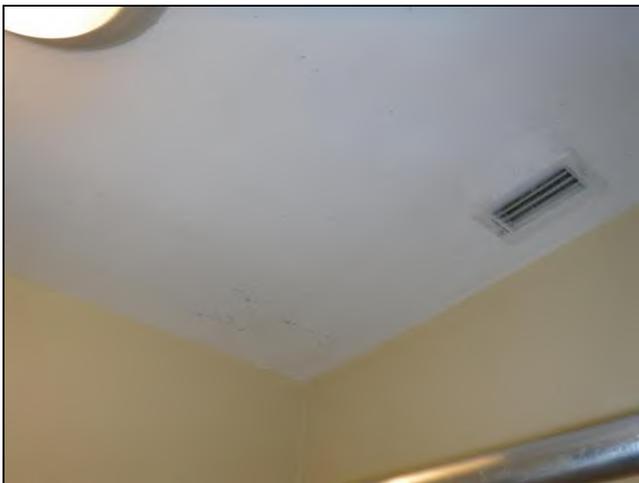
4.0 Item 3(Picture)

(2) The master bathroom ceiling had peeling paint and was in need of re-painting with a paint rated for use in wet locations. Repairs recommended.

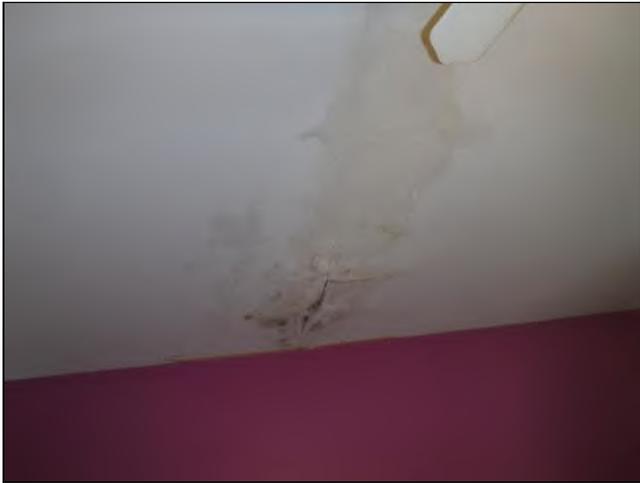
4.0 Item 4(Picture)

(3) The master bedroom ceiling was damaged and in need of repairs. Repairs recommended by a drywall/plaster contractor.

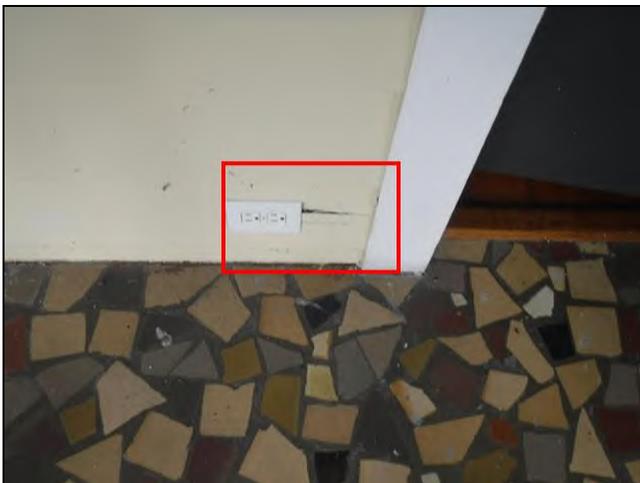
4.1 Item 1(Picture)

4.1 (1) Minor wall repairs recommended at the front porch area by a licensed professional.

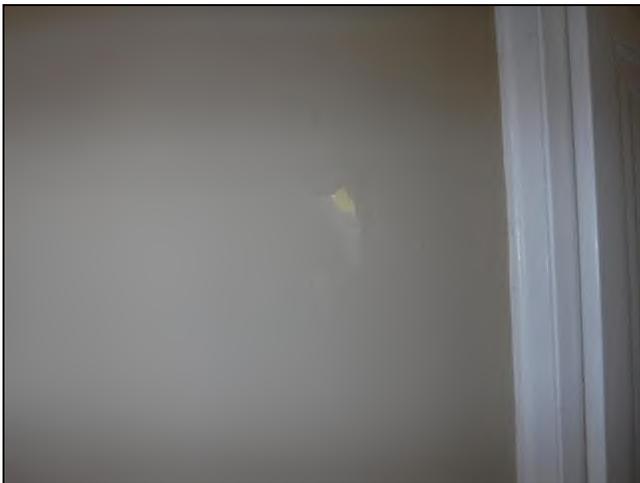
4.1 Item 4(Picture)

(3) Peeling paint present at kitchen. Removal and re-painting recommended using a paint rated for wet locations. This is cosmetic.

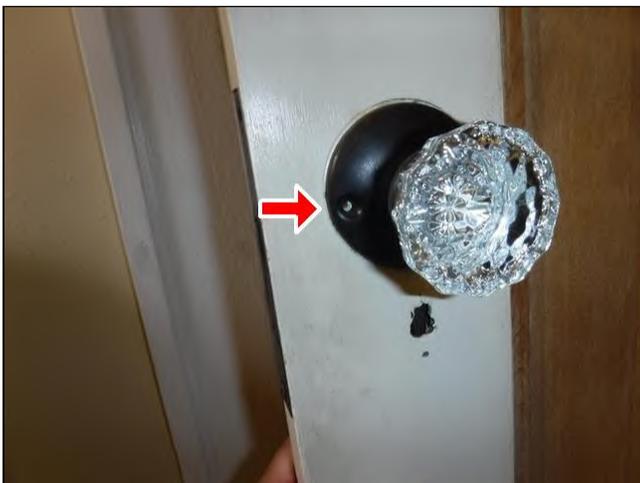
4.4 Item 8(Picture)

(3) Hardware at several doors was loose and/or missing screws. Repairs recommended as needed.

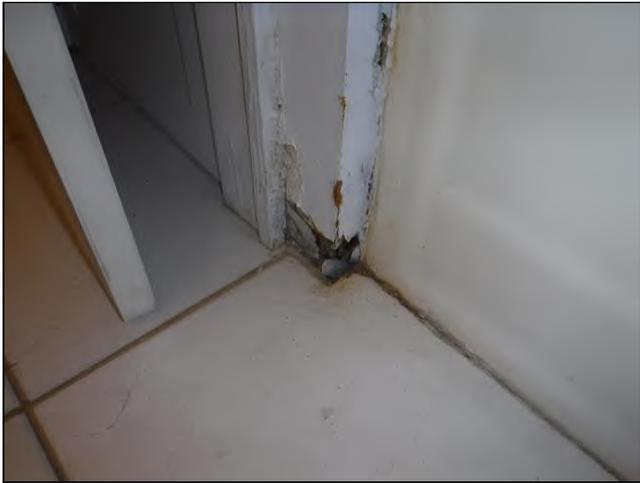
6.6 Item 3(Picture)

(2) There was water damage at the exterior of the hall bathroom tub. Repairs recommended.

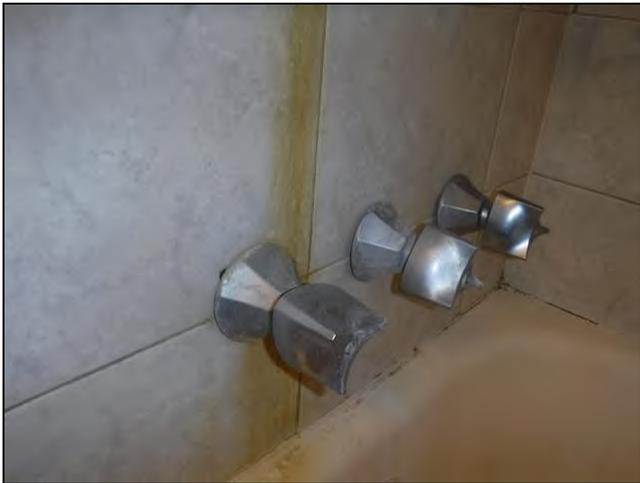
6.6 Item 5(Picture)

(3) The hall bathtub fixtures were loose and not caulked. Repairs recommended by a licensed plumber.

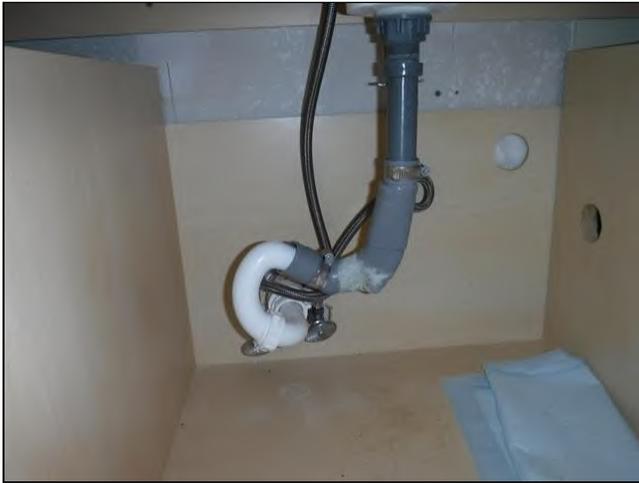
6.7 Item 1(Picture)

6.7 (1) Improper drain trap installed at the master bathroom sink. Repairs recommended by a licensed plumber.

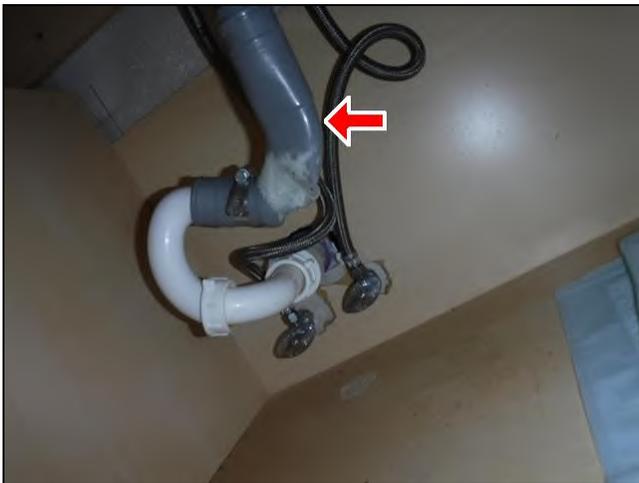
6.7 Item 3(Picture)

(2) Flexible drain piping installed where permanent rigid piping is needed at both bathroom sink drain pipes. These components can cause premature failure, leaks, and drain clogs. Replacement by a licensed plumber recommended using rigid permanent drain piping.

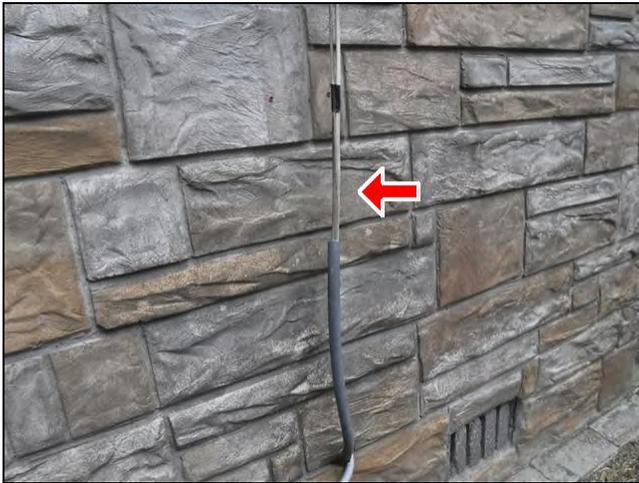
7.2 Item 1(Picture)

7.2 Wires were exposed at the kitchen, exterior, and garage. All wires should be protected in conduit for safety. Have repaired by a licensed electrician.

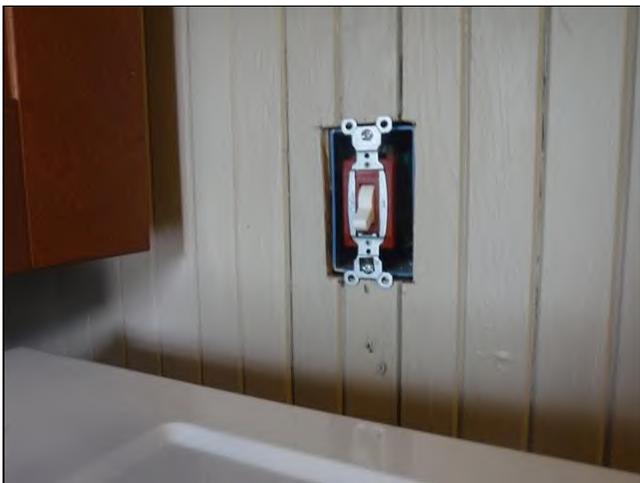
7.3 Item 1(Picture)

7.3 (1) Outlet covers missing at the kitchen. Replace covers.

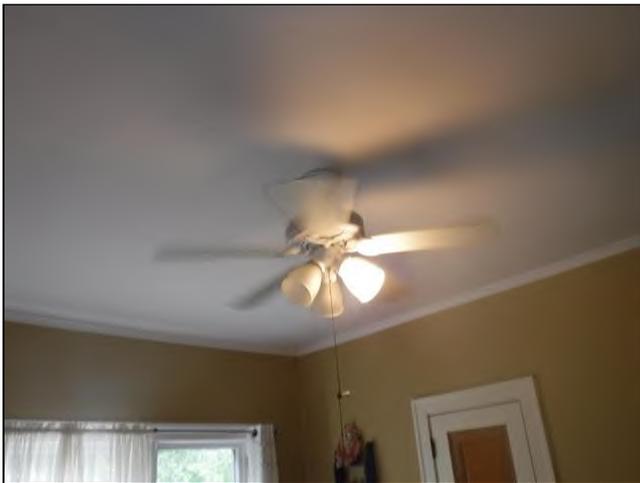
7.3 Item 4(Picture)

(3) The center bedroom ceiling fan wobbled and was in need of proper installation. Repairs recommended.

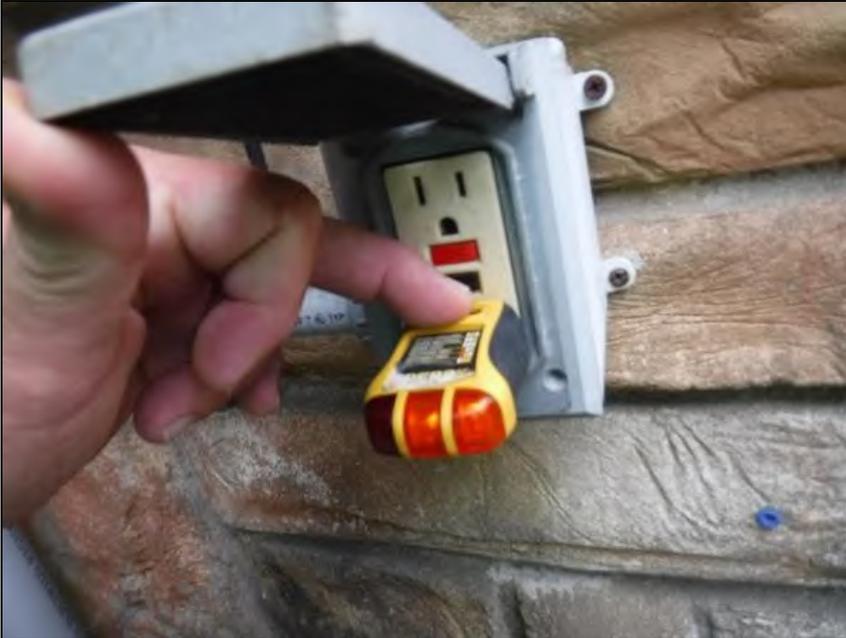
7.5 Item 1(Picture)

7.5 The rear exterior GFCI outlet was not tripping when tested. Repairs or replacement recommended by a licensed electrician.

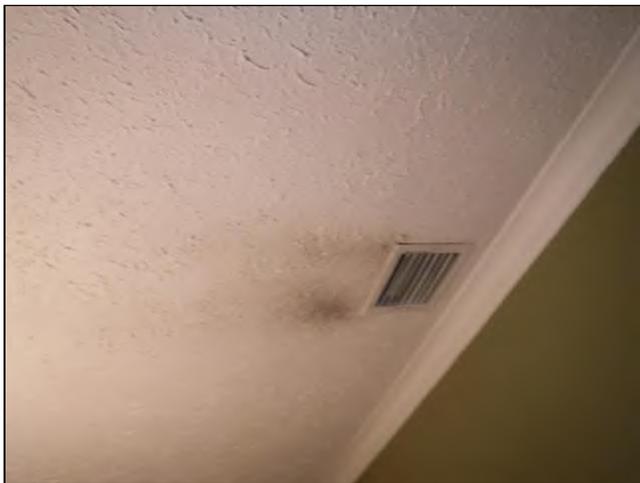
8.3 Item 1(Picture)

8.3 (1) Duct cleaning is recommended so that there is a good quality of indoor air circulating throughout. Duct cleaning is recommended by a licensed HVAC contractor. Repairs recommended.

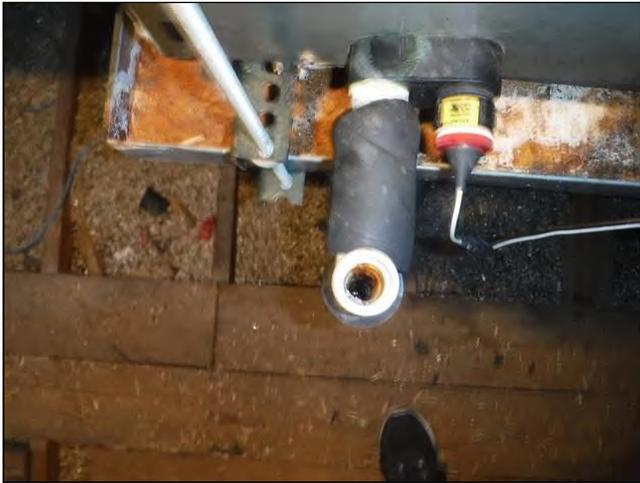
8.3 Item 5(Picture)

(2) The HVAC condensation line had build-up and was in need of cleaning by a licensed HVAC contractor.

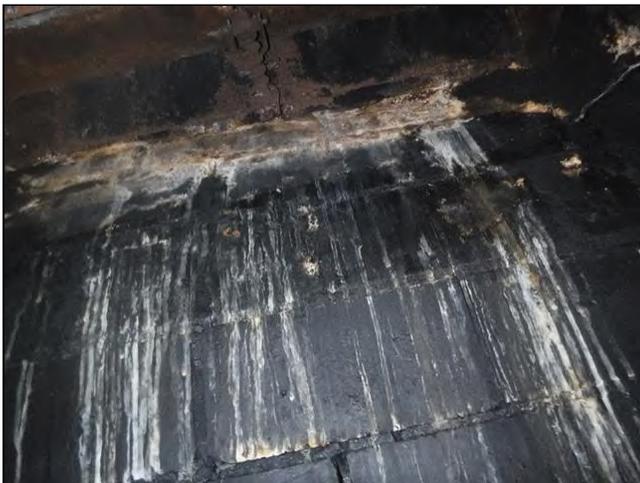
8.4 Item 1(Picture)

8.4 The fireplace and flue had built-up Creosote which is highly flammable, and signs of water entering the flue and firebox. Additionally the chimney was missing a chimney cap and spark arrestor. Prior to operating the fireplace/chimney it is recommended to have a licensed Chimney Sweep fully evaluate, make repairs as necessary, and clean the firebox and flue. Repairs recommended.

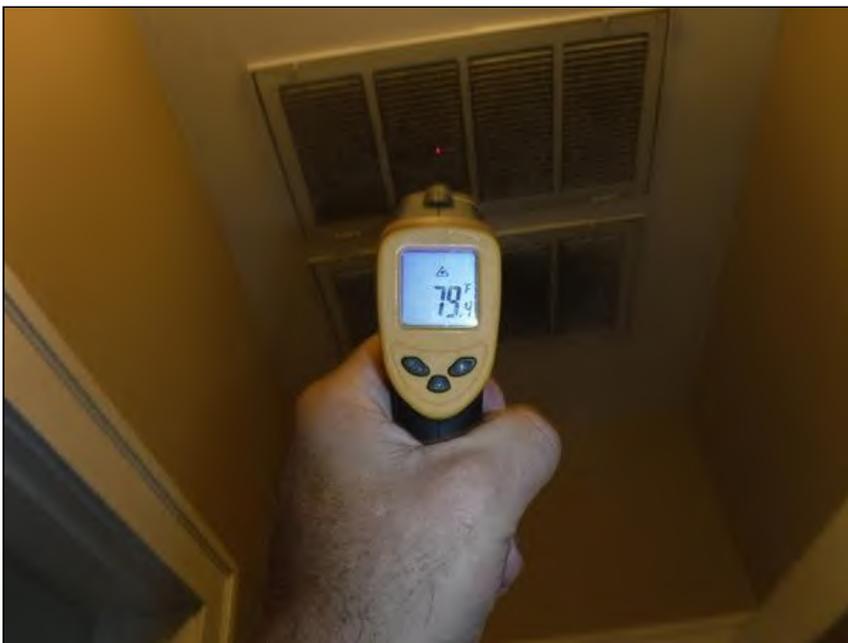
8.7 Item 1(Picture)

8.7 Multiple ambient air tests were performed by using thermometers on the conditioned supply and return of the air handler to determine if the difference in temperatures were between 14 degrees and 22 degrees. Temperature splits between 14-22 degrees indicate whether the system was cooling as intended. The supply air temperature on your system read 69 degrees, and the return air temperature was 79 degrees. This indicated that the system was in need of service by a licensed HVAC contractor.

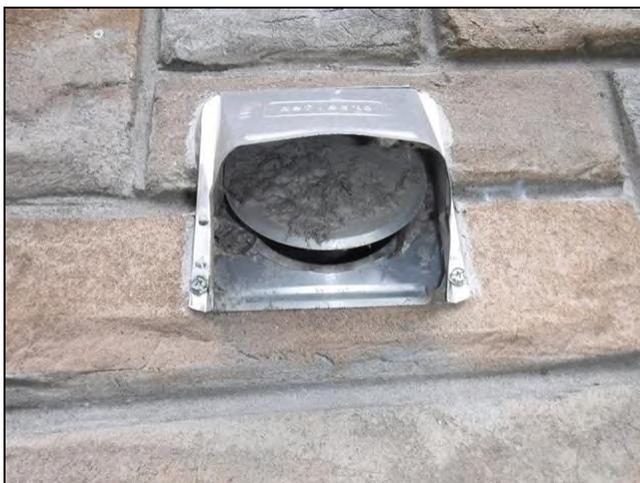
9.2 Item 1(Picture)

9.2 (1) Dryer vent cleaning was recommended now and annually thereafter.

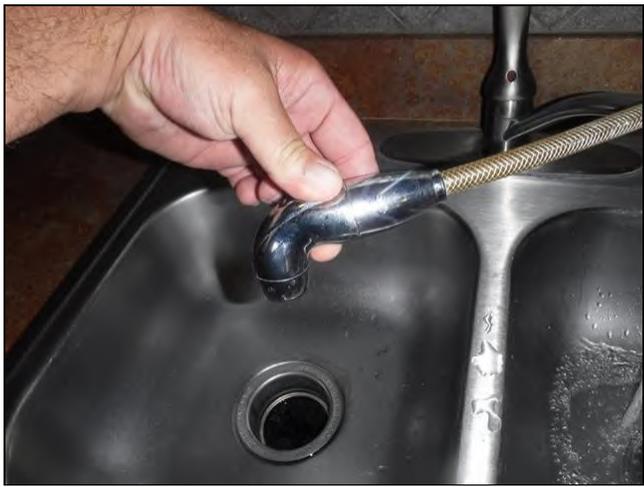
10.7 Item 1(Picture)

10.7 The kitchen sink sprayer was not operating at the time of inspection. Repairs recommended by a licensed plumber.

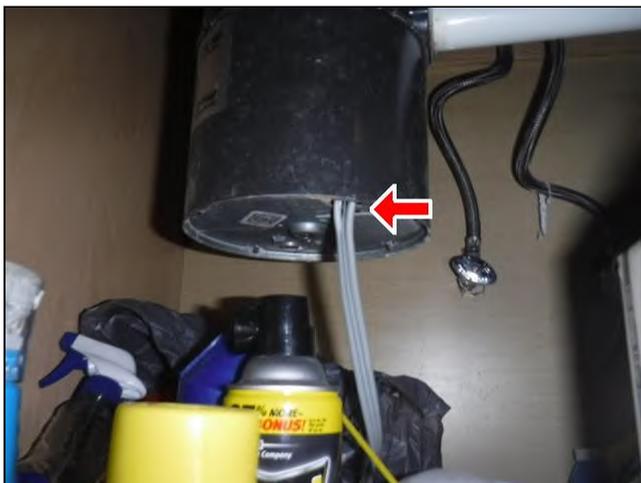
10.12 Item 1(Picture)

10.12 The garbage disposal wiring was missing a wire clamp to secure the wires to the appliance. Repairs recommended by a licensed electrician.
