CITY OF ST. PETERSBURG, FLORIDA
PLANNING AND DEVELOPMENT SERVICES DEPARTMENT
URBAN PLANNING AND HISTORIC PRESERVATION DIVISION

STAFF REPORT

Community Planning and Preservation Commission Certificate of Appropriateness Request

Review of a Certificate of Appropriateness for replacement of a front door at 2726 Burlington Avenue North, a property proposed for inclusion as a contributing property to a local historic district currently pending public hearing

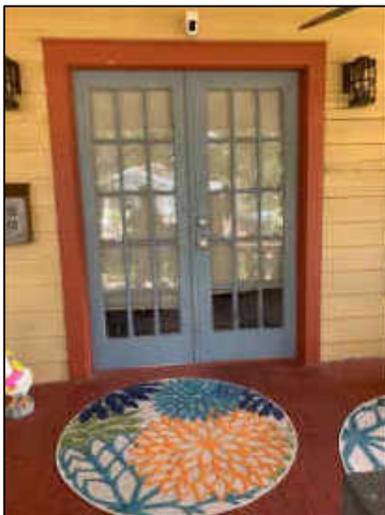
Figure 1: Existing doors, as shown in application

The subject property’s front entrance presently consists of a pair of wooden French doors (Figure 1). The date of the doors’ installation is unknown. Staff concurs with the application’s suggestion that they were likely not original but installed at a later date, possibly in conjunction with the enclosure of the front porch which appears to have occurred in 1962.

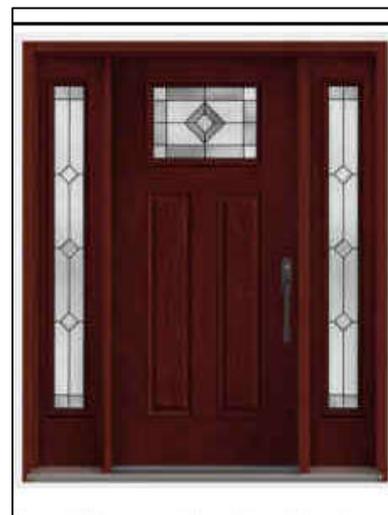
Figure 2: Proposed doors, as shown in application

The proposed replacement door (Figure 2) is a fiberglass single-action door with sidelights. The door itself features a faux-lead glass panel at its upper portion, and the appearance of vertical-panel construction below. The sidelights also feature the faux leaded glass. The overall design and configuration are consistent with recommendations provided by St. Petersburg's Design Guidelines for Historic Properties (Figure 3), although leaded glass is not a typical historic design element found locally on Craftsman-style homes. Nonetheless, the design generally references the Craftsman design aesthetic.

1. The existing entryway opening and trim will be preserved, as proposed.
2. Sidelights will be recessed in wall plane approximately 2"-3" to provide consistency with existing historic windows.
3. All other necessary permits shall be obtained. Any additional work shall be presented to staff for determination of the necessity of additional COA approval.
4. This approval will be valid for 24 months beginning on the date of revocation of the local Emergency Declaration.

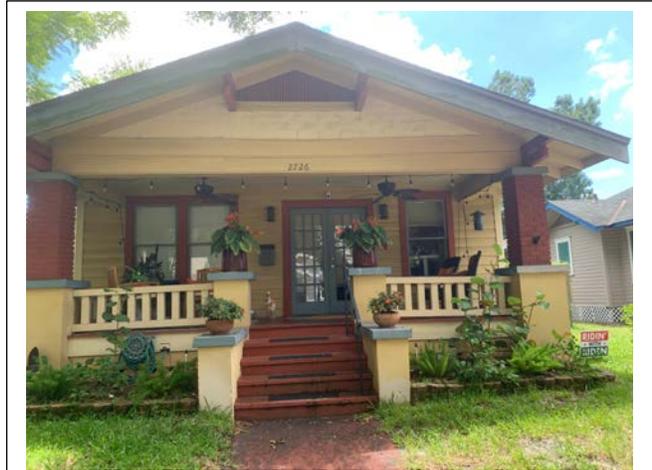
Figure 1. Front façade of 2726 Burlington Ave. N from the sidewalk, showing front porch and current entry doors. Photo taken 27 August 2020.

Our home at **2726 Burlington Ave. N** is in the **Craftsman** style, built in **1924**, with a broad open porch, brick columns and half-columns, and exposed beams. It has wood and stucco cladding (**Figure 1**).

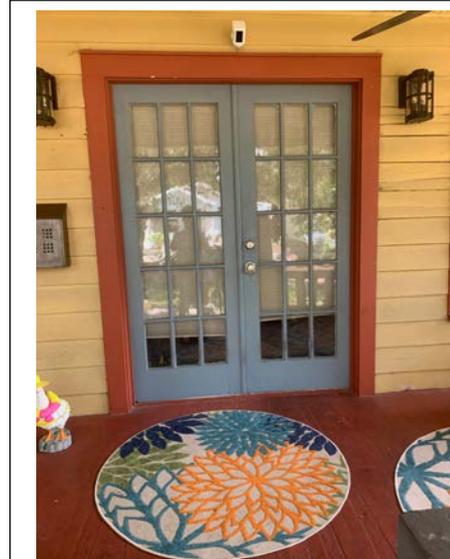
Figure 2. Current entry doors. Photos taken 27 August 2020.

The current doors (**Figure 2**) are rather unusual on 1920s-era Craftsman bungalows, being double-entry, French doors with glass panels. We contend they are not original, which should allow us to choose a design more in line with typical Craftsman architecture. Supporting evidence for this is:

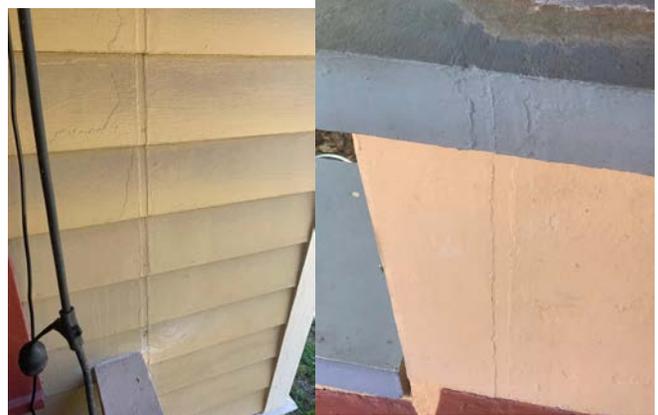
Figure 3. Remnants of former porch enclosure. Photos taken 27 August 2020.

1. ***Our porch was previously enclosed.*** There is residual evidence of the enclosure remaining in the paint and wood of the siding, porch, and columns of the porch (**Figure 3**). These marks include an obvious header and footer for an entryway between the half-columns in the middle of the porch (**Figure 4**), indicating another external door. A picture from a 1994 survey (**Appendix A**) shows the porch enclosure either being removed or converted to a screened porch. Unfortunately, the picture is a black and white scan and of poor quality and the doors are not shown. We suspect this shows the porch being converted to a screened in porch, since neighbors informed us it was still

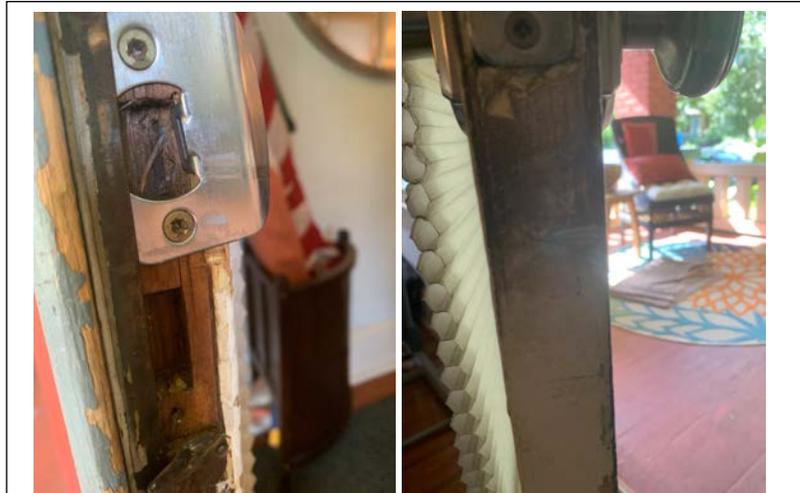
4. ***There is a depression for a mortice lock bolt on one door, but no corresponding place for the mortice lock assembly on the other door (Figure 5).*** This suggests to us that these doors were not originally a pair. Perhaps one was damaged and replaced with a similar salvaged door. Equally plausible is the two doors were salvaged to create the door at some point in the past, most likely when the porch was enclosed and a new external doorway was created.

Figure 5. (left) Door jamb for left door showing slot for a mortice-type lock. (right) corresponding location on right door showing no hole for the mortice-lock assembly. Photos taken 27 August 2020.

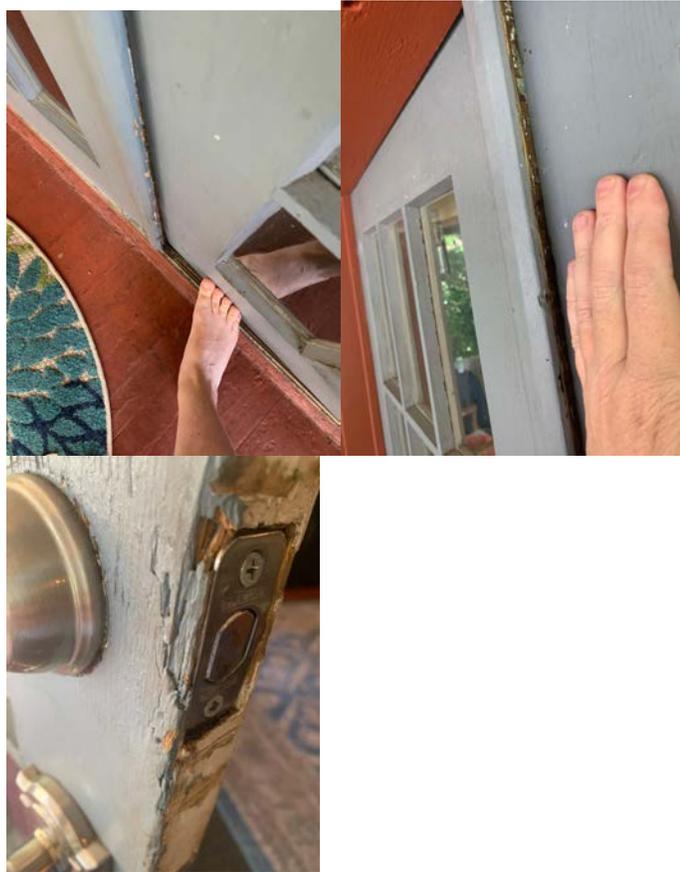
1. ***The doors do not close solidly.*** It is possible to push in the bottom and top by a substantial amount with only a little force – enough to put a pry bar in and force them open (**Figure 6**).
2. ***The doors have considerable damage.***
3. ***It would be easy to break the glass and open the latches keeping the left door “locked” from inside.*** The door latches when we purchased the house were even worse, with only a ½” latch (that was installed backwards!). One could give a good push and the latches would pop open. We have repaired the best we can, but it is still not safe.

Figure 6. Safety issues with the current doors – it is easy to push open top and bottom with gentle pressure. There is evidence of the bolt having been pried open and replaced in the past. The bolt is very close to the edge of the door. Photos taken 27 August 2020.

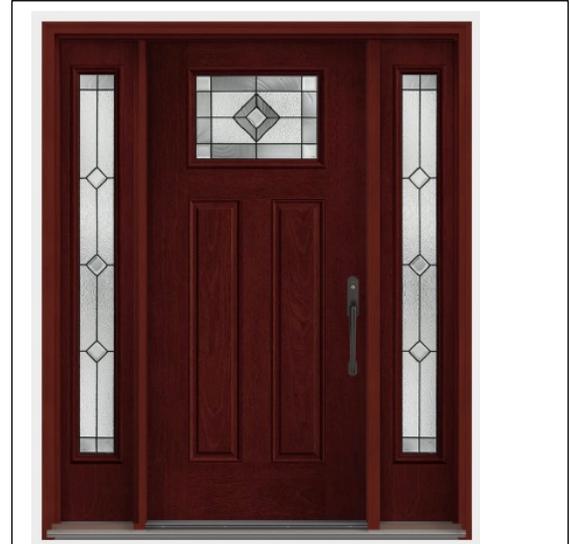
The door we propose to install (**Figure 7**) is a modern, single-entry Craftsman-style solid fiberglass door with an upper window and dentil details, along with coordinating side lights. The full catalog page and contractor’s work plan are included as **Appendix C**. All pieces will be wood grain and be stained a dark red-brown to compliment the red paint on our trim. The existing trim will be removed, saved, and reinstalled to blend them into the house façade. From the street, they will look like wood doors. They are hurricane impact rated and will meet all modern building codes.

Figure 7. Proposed front door. See **Appendix C** for full catalog listing and contractor’s spec sheet.

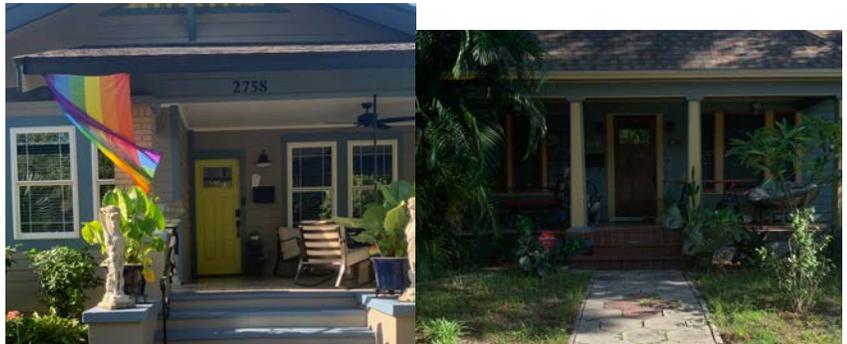
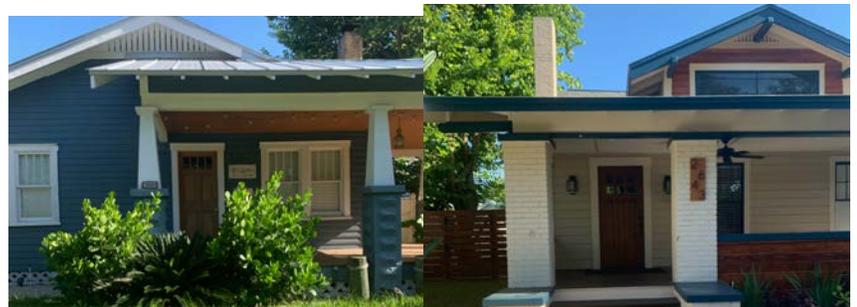
This style of door is quite prevalent in the neighborhood (**Figure 8**) – there are currently 17 doors of similar design that are currently on houses in the proposed historic district; five of them are on our street. The proposed door is consistent with the guidelines.

Figure 8. Examples of doors similar to the one we propose on houses within a block of 2726 Burlington Ave. N. All are new and have been updated in the last several years. Photos taken 27 August 2020.

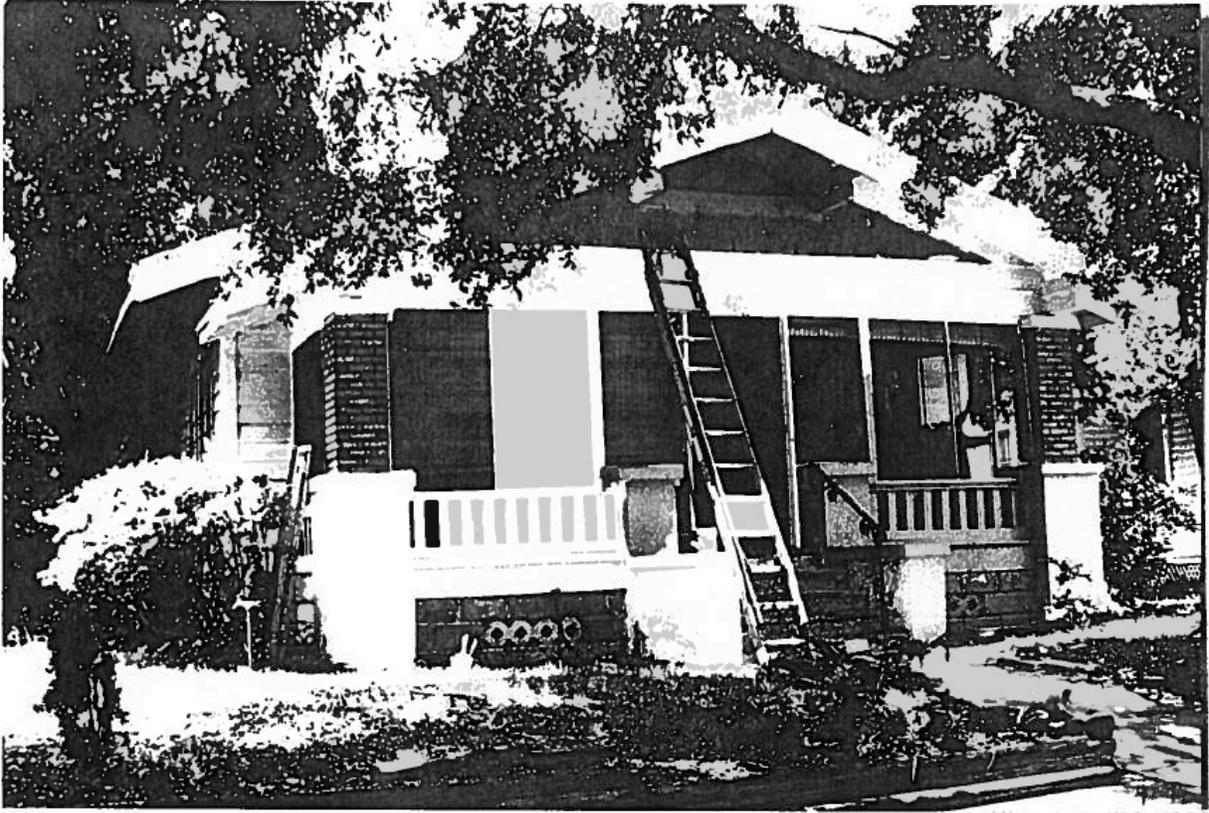
Appendix A – 2726 Burlington Site Survey Picture (1994)

Scanned picture from 1994 Survey of Historic Kenwood showing 2726 Burlington Avenue. An enclosed porch is obvious, although the doors leading into the main house are not shown. It is not clear if the enclosure is being removed or updated in 1994, but neighbors have reported to us that the porch was screened into the mid-2000s. Thus, we interpret this picture as showing a transition from a previous full enclosure to a screened enclosure.
