CITY OF ST. PETERSBURG, FLORIDA
PLANNING AND DEVELOPMENT SERVICES DEPARTMENT
URBAN PLANNING AND HISTORIC PRESERVATION DIVISION

STAFF REPORT

Community Planning and Preservation Commission Certificate of Appropriateness Request

Review of a Certificate of Appropriateness for replacement of historic windows, repairs to the garage, and a street-side porch enclosure at 2863 Burlington Ave. N., a contributing resource to the Kenwood Section – Seminole Park Local Historic District (17-90300003)

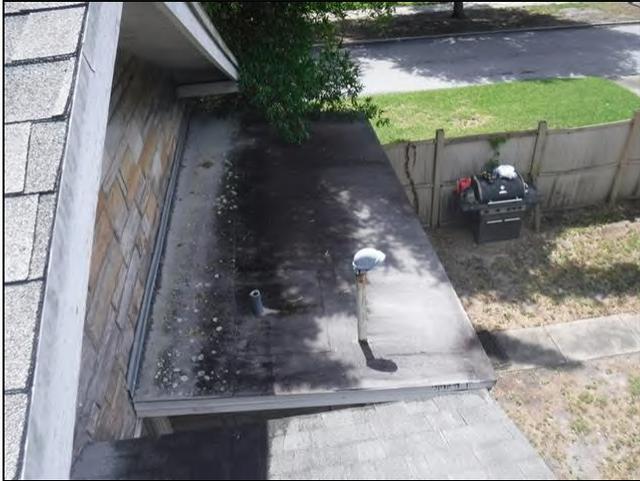
1.0 Item 1(Picture)

1.0 (1) The membrane roof was at/near the end of its useful service life with replacement recommended by a licensed roofer within 12 months. Replacement recommended.

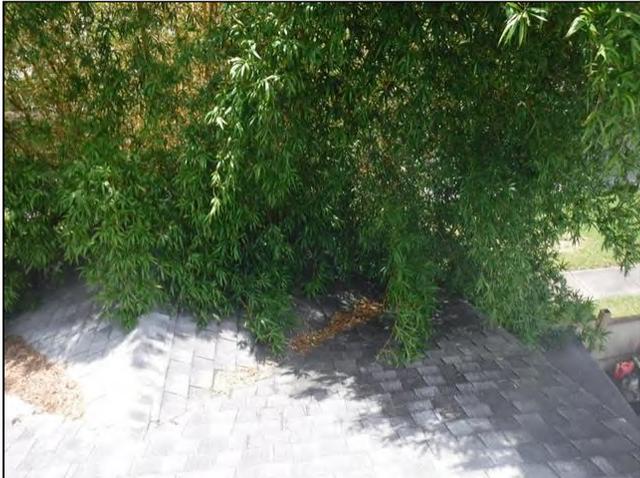
1.0 Item 2(Picture)

(2) The tree limbs that were in contact with roof or hanging near roof should be trimmed. Repairs recommended.

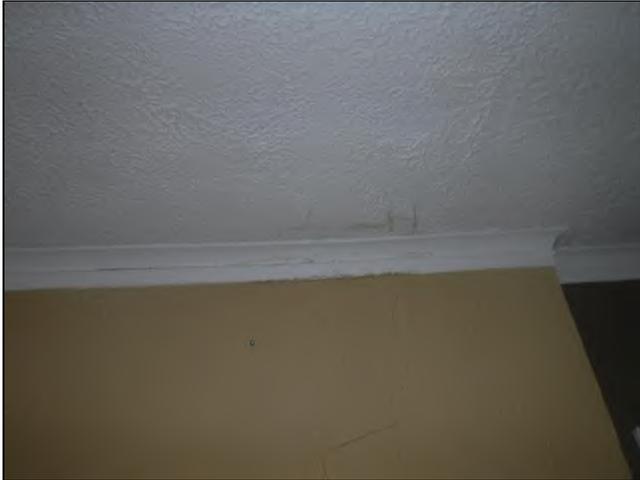
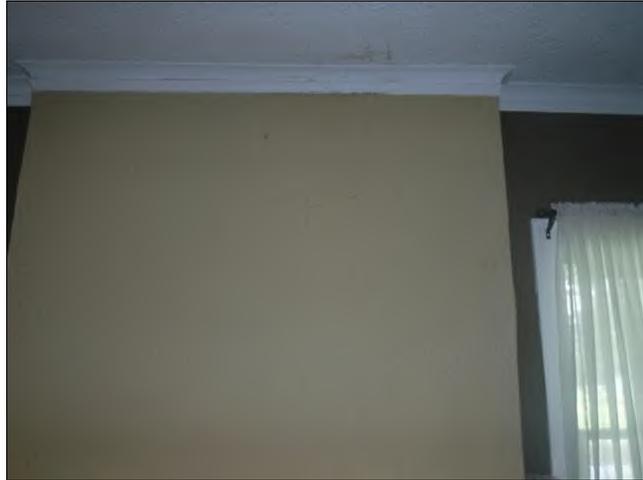
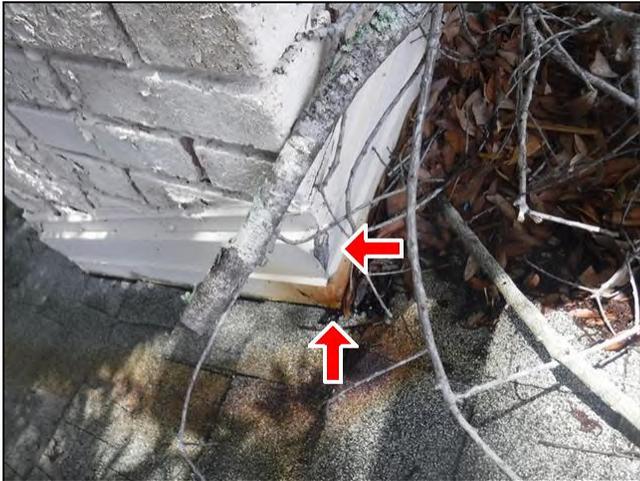
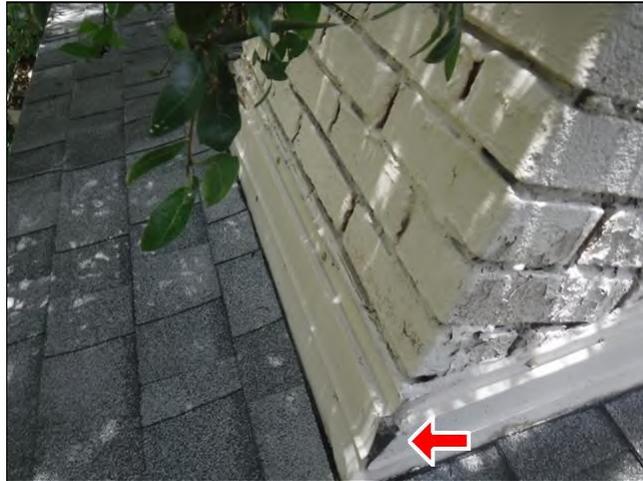
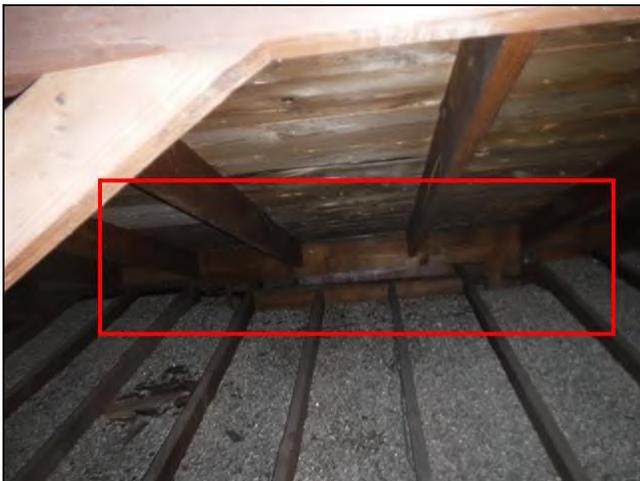
1.2 The chimney flashing had openings and corrosion indicating that water may be entering the structure. Additionally, there was staining in the attic and interior ceilings/walls around the chimney area. The chimney flashing should be replaced/ repaired and sealed by a licensed roofer. Cosmetic interior repairs needed at ceilings and walls by a plaster specialist. Repairs recommended.

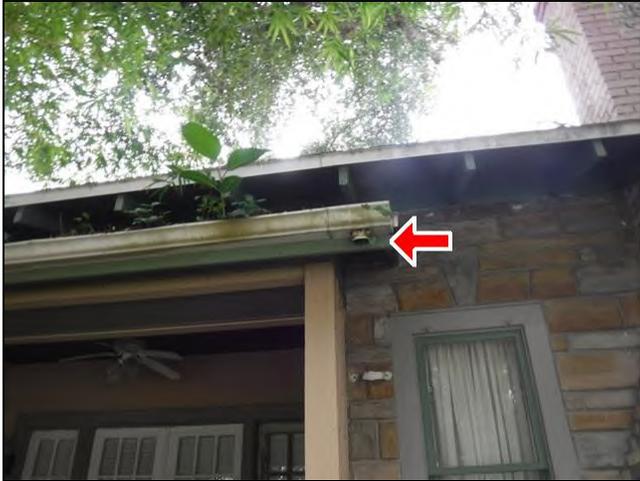
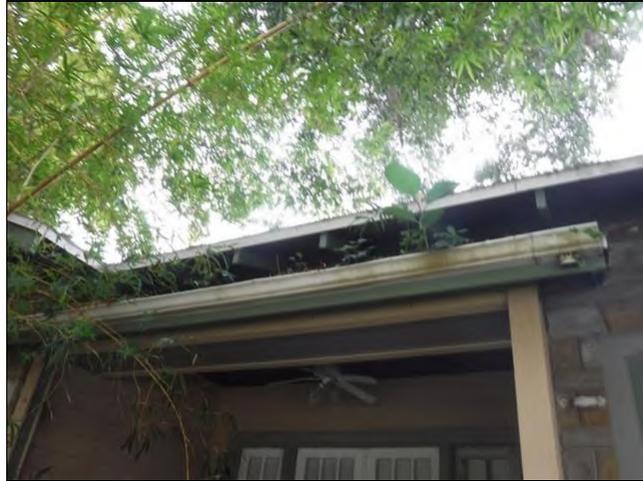
1.4 The left side patio gutter was in non-functional condition due to being debris filled and missing downspouts. Repairs recommended including adding a downspout and gutter cleaning.

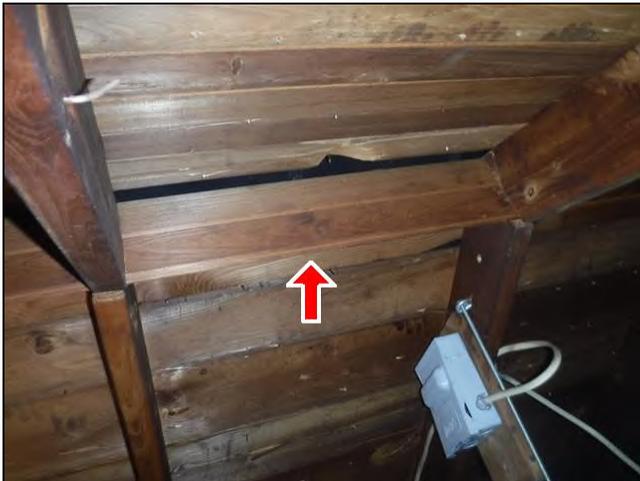
1.5 Item 1(Picture)

1.5 The roof ridge board was constructed of tongue-n-groove hardwood flooring planks. This was likely done when the roof ridge vent was added at the time that the roof was last replaced. Generally with houses of this age the roof ridge board is constructed using 3/4"-1" thick lumber. In the opinion of the inspector, the use of this material is an adequate material due to being hardwood and one inch thick. No repairs are recommended at this time, however we recommend monitoring the roof structure for sagging periodically.

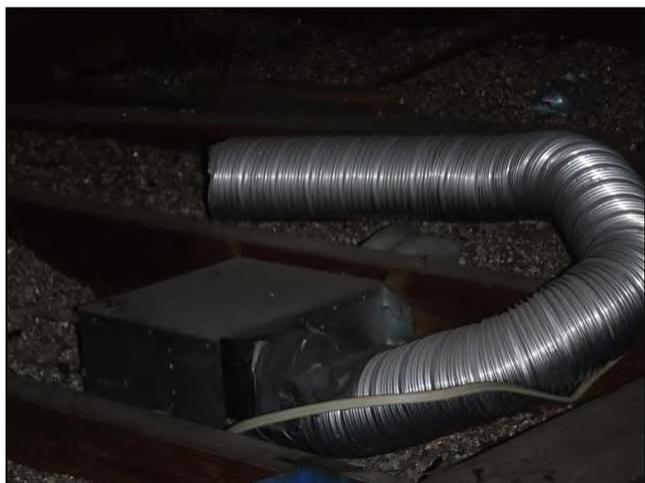
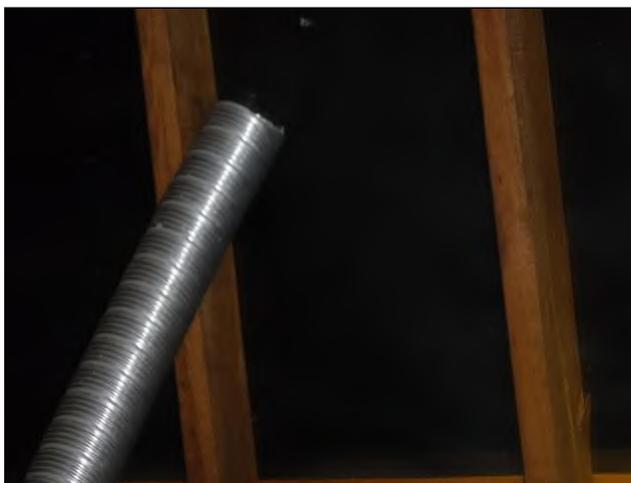
1.6 Both bathroom ventilation fans were discharging into the attic space. This method of installation vents bathroom water vapor into the attic which can lead to microbial growth, shortened shingle life, and may damage insulation and wood. Repairs recommended to include adding discharges at the exterior walls or eaves by a licensed contractor. Repairs recommended.

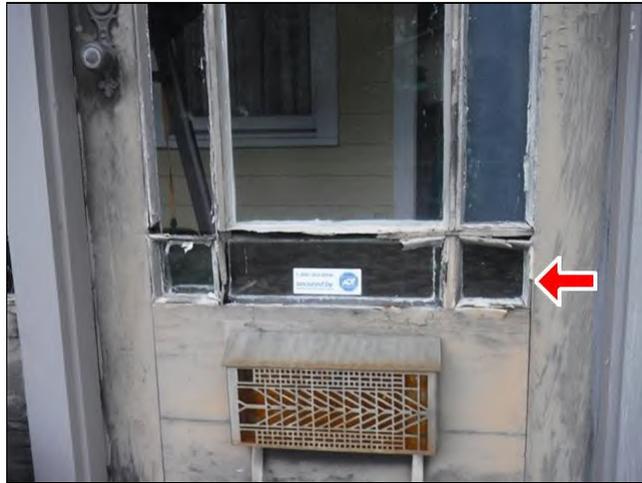
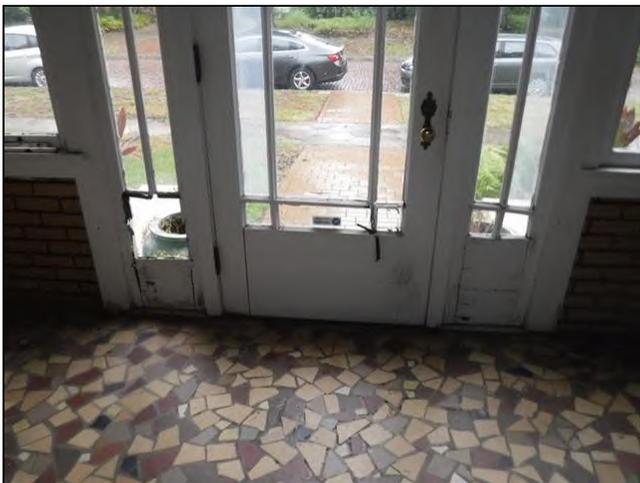
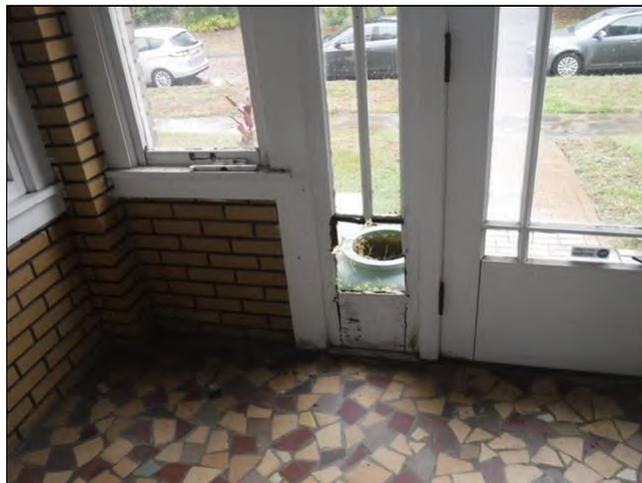
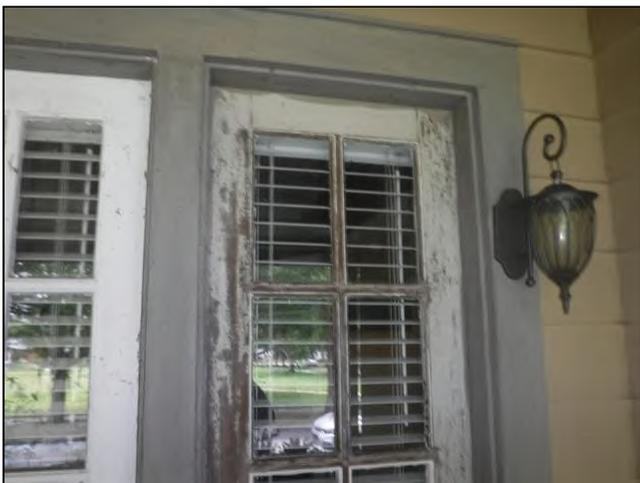
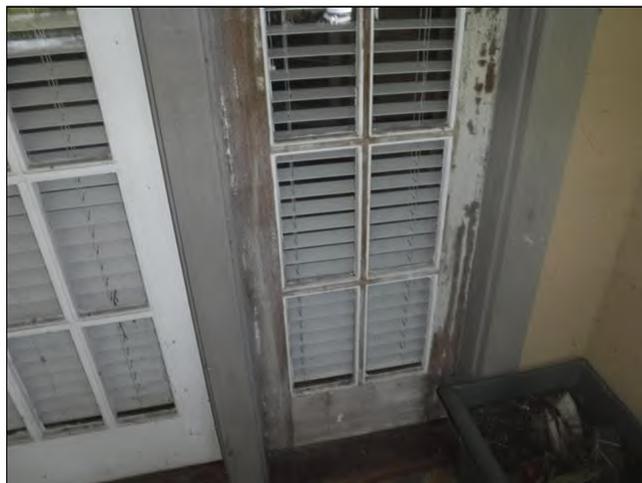
2.1 (1) Exterior doors and door frames/trim were in poor condition and were in need of repairs or replacement. Repairs recommended by a licensed window/door contractor. Repairs recommended.

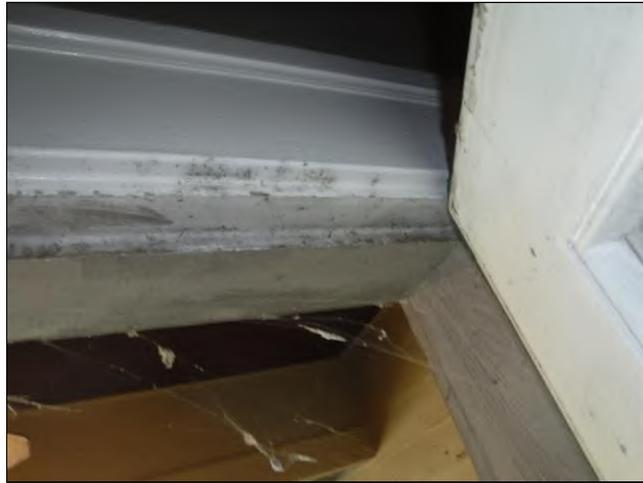
2.1 Item 8(Picture)

(2) Patio doors were in need of weather stripping and hardware repairs. Repairs recommended.

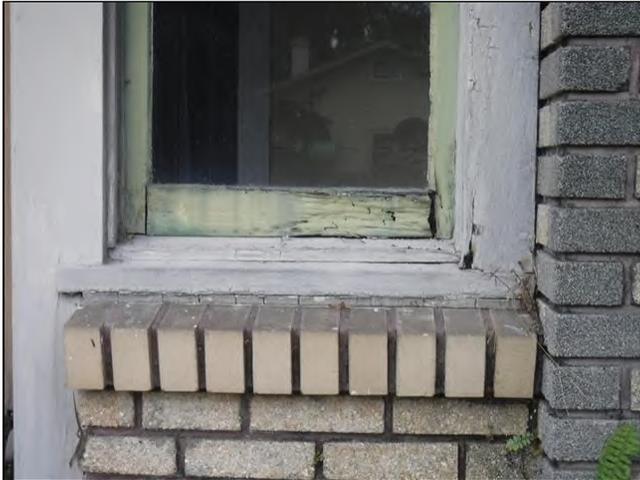
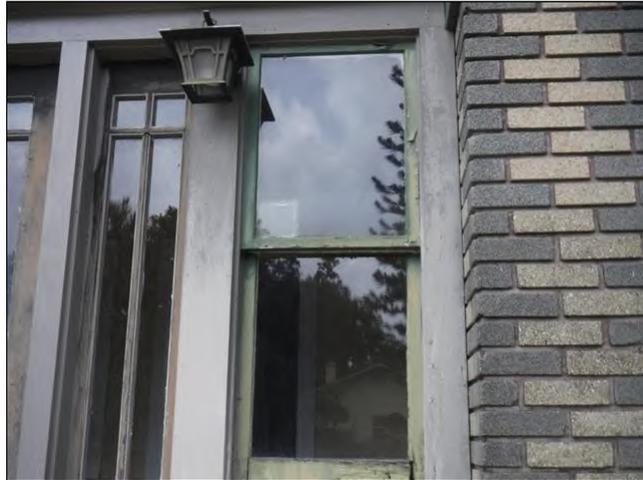
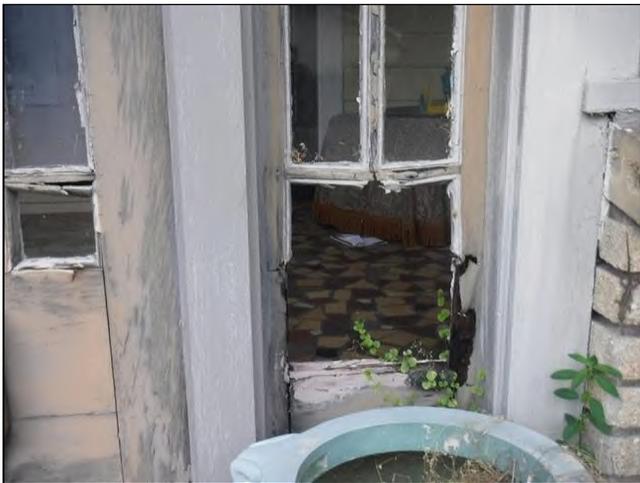
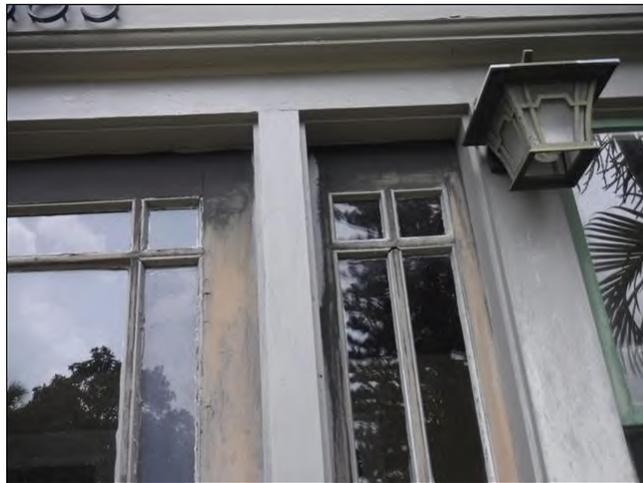
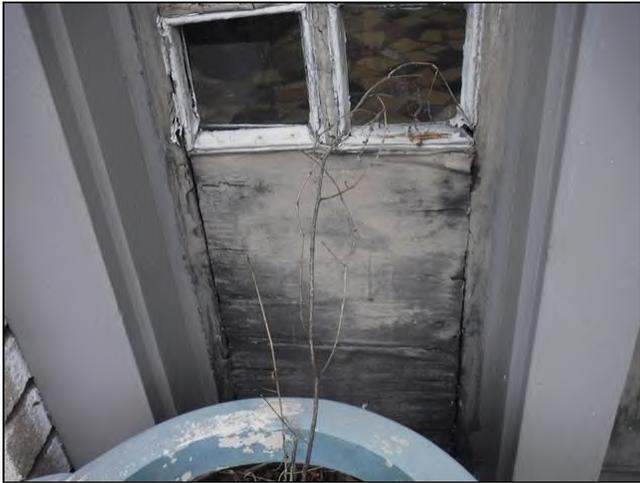
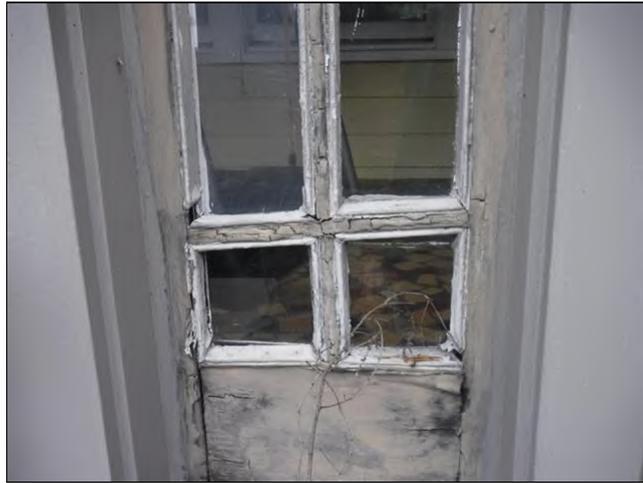
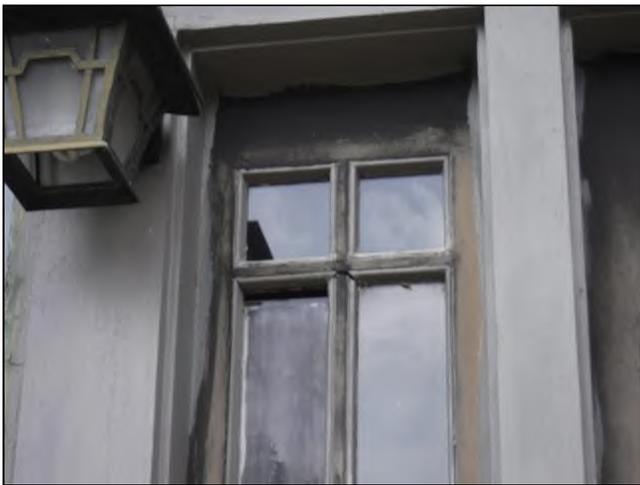
2.2 (1) The front entry windows and frames were in need of replacement by a licensed window/door contractor. Repairs recommended.

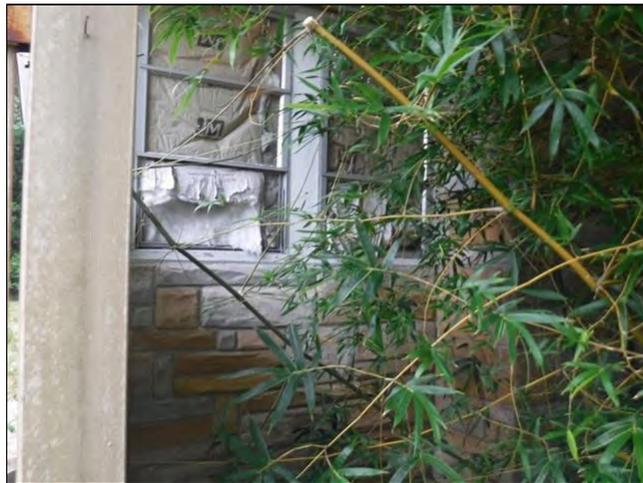
2.2 Item 9(Picture)

(2) Missing windows at the rear addition left side. Replacement recommended by a licensed window/door contractor. Repairs recommended.

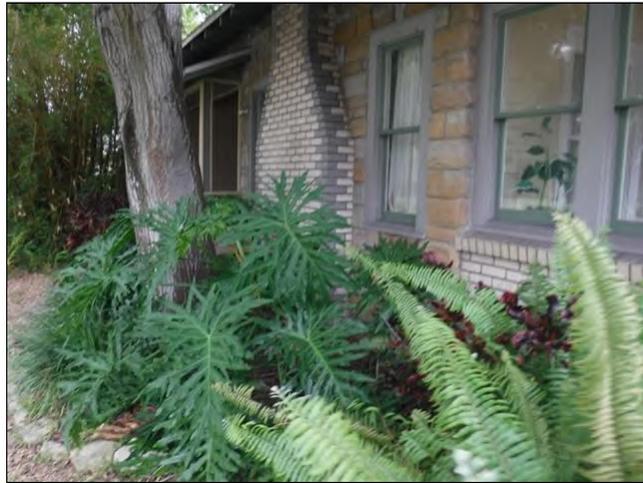
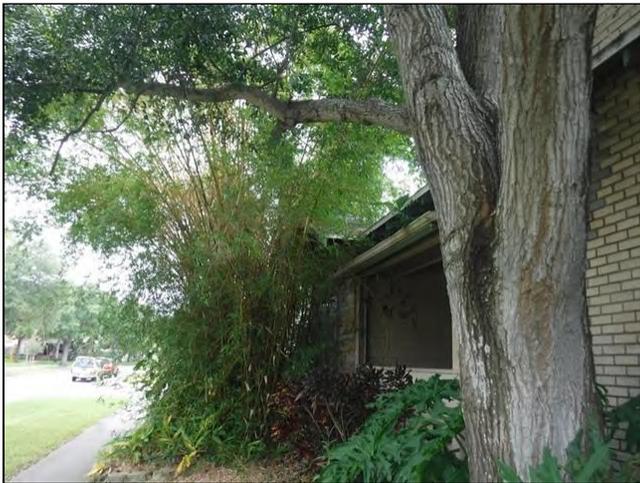
2.4 (1) Vegetation/tree too close to the building can contribute to damage from the roots to the foundation and walkway, branches abrading the roof and siding, and leaves providing a pathway for moisture and insects into the building. Trim all foliage to be 1-2 feet from the structure.

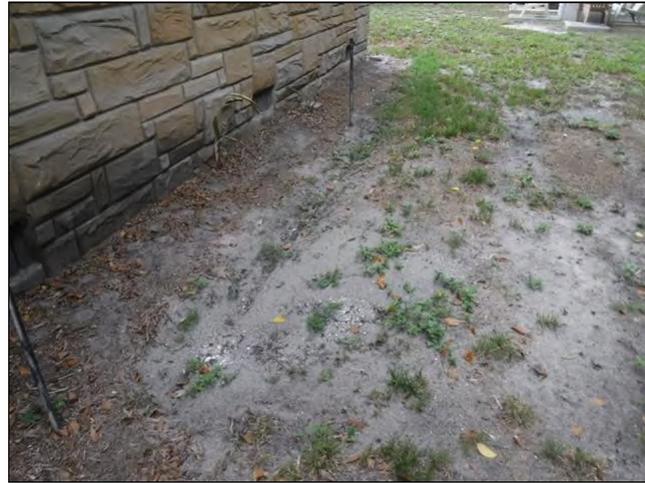
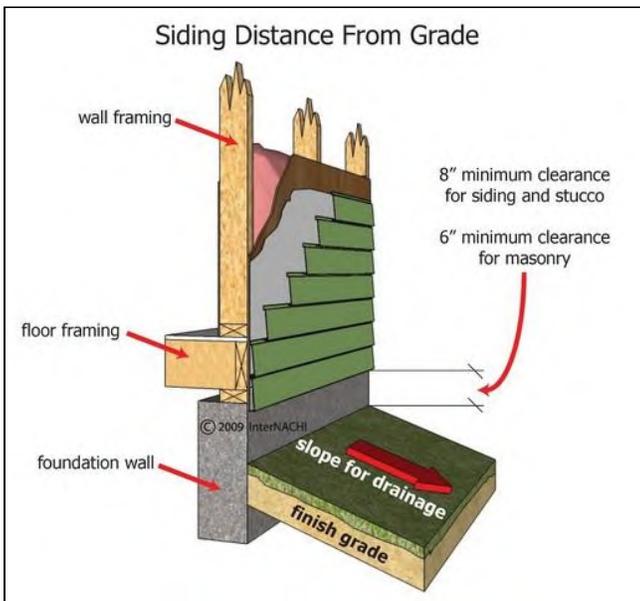
(2) Trenching conditions were present at the perimeter of the house. Directing more moisture towards the foundation increases the risk of moisture intrusion. Water should be directed away from all foundations to prevent potential water intrusion and foundation shifting. The drainage strategy of the foundation is important. Expansive soils can be very destructive to the foundation if the moisture content of the perimeter varies. Gutters are the best solution for this condition and should be considered as an upgrade.

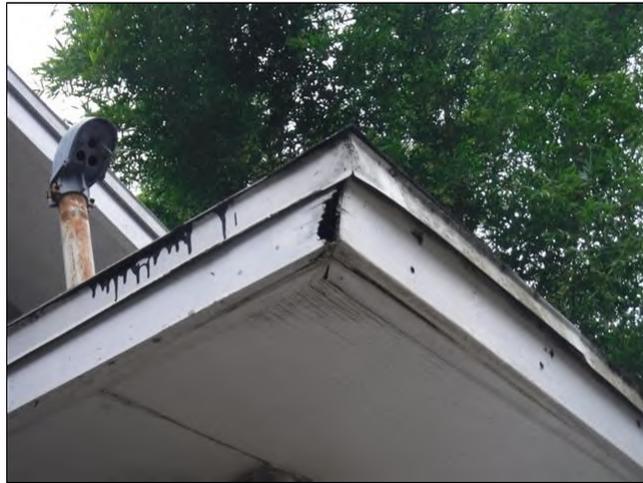
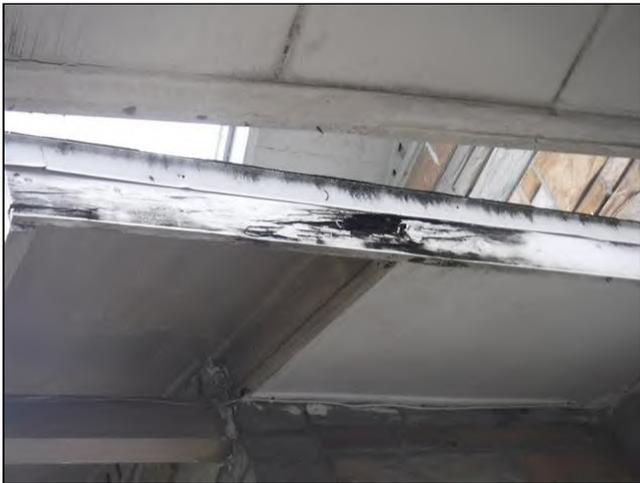
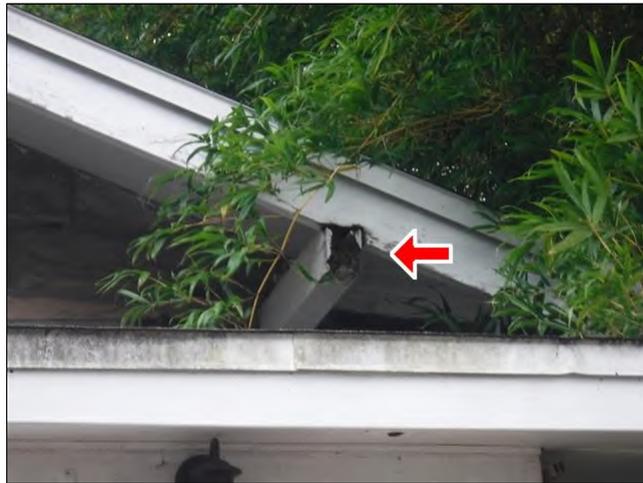
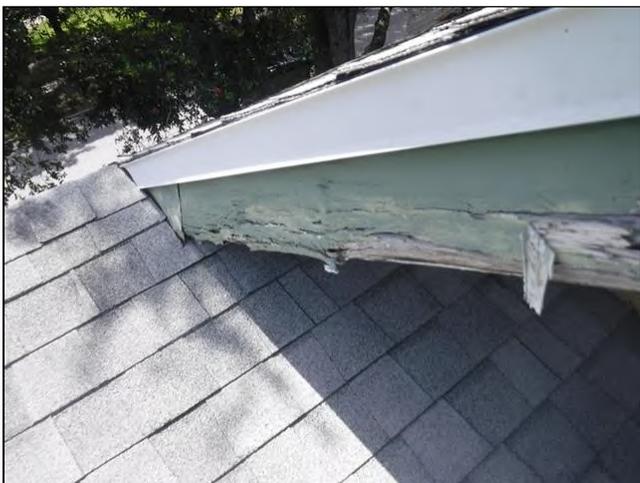
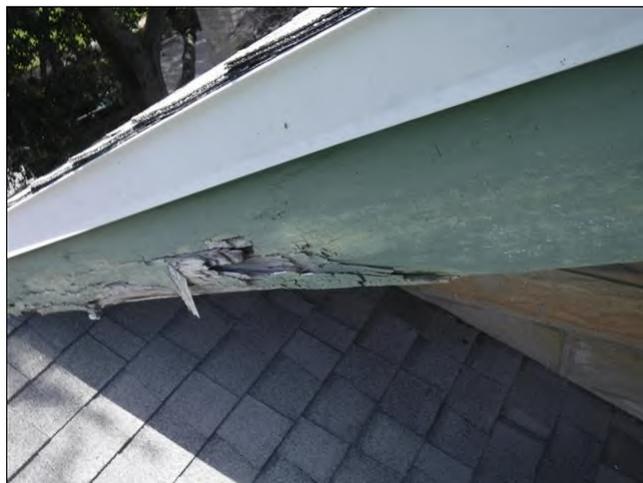
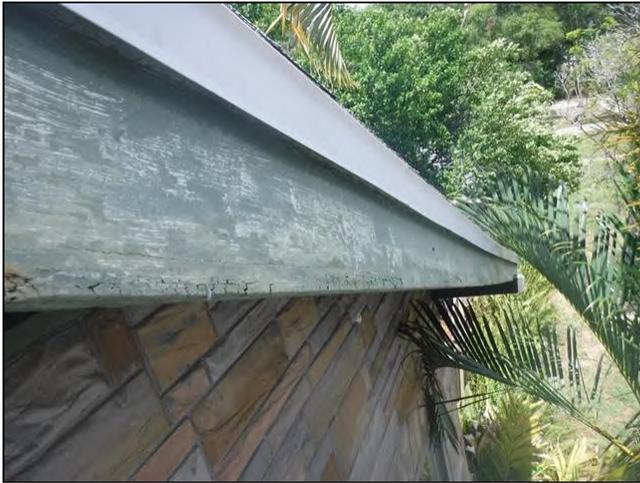
2.5 There were rafter tails and fascia boards that were deteriorated and/or rotting. Repairs recommended as needed by a licensed contractor. The buyer should also consider adding metal or vinyl cladding at all rafter tails to prevent further deterioration.

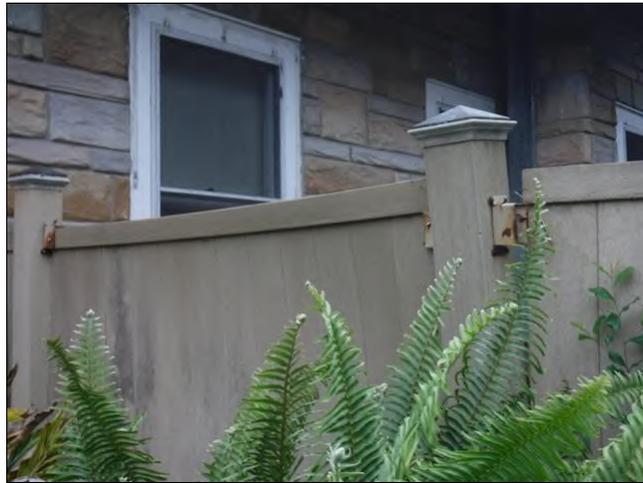
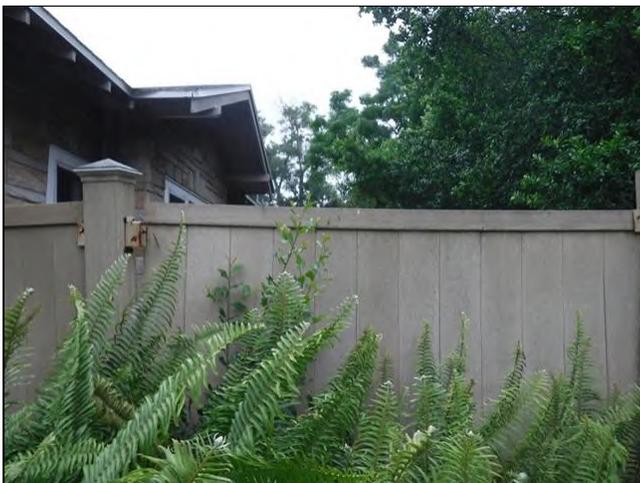
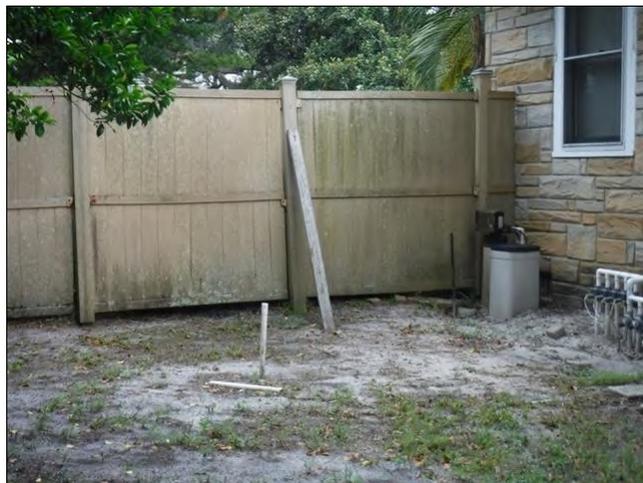
2.8 The left side fence was damaged and in need of repairs.

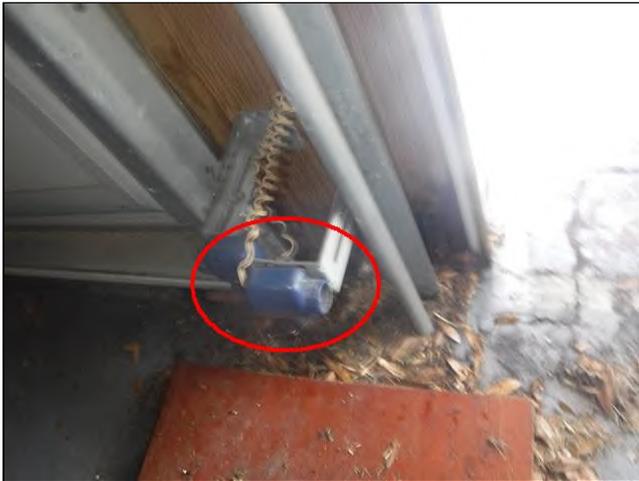
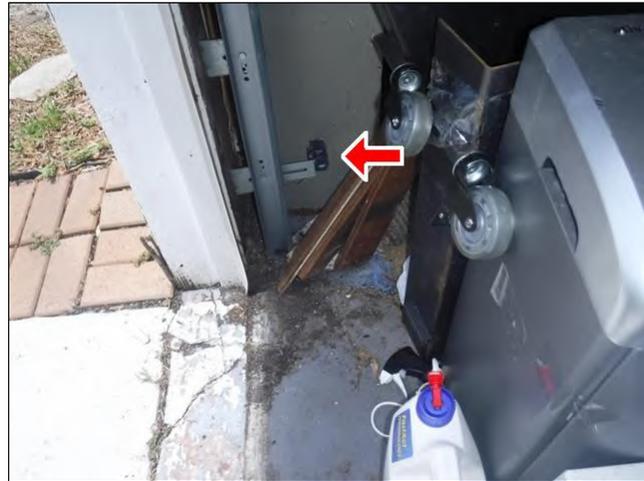
3.3 Safety reversing sensors were not aligned. Unaligned safety reversing sensors make it difficult to close the garage door. Repairs recommended by a licensed garage door contractor.

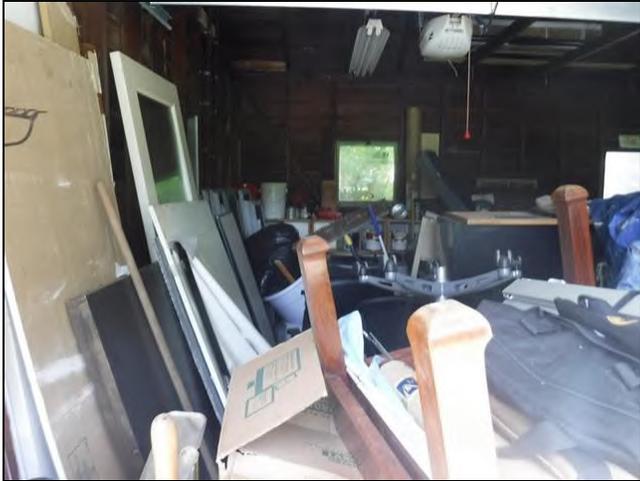
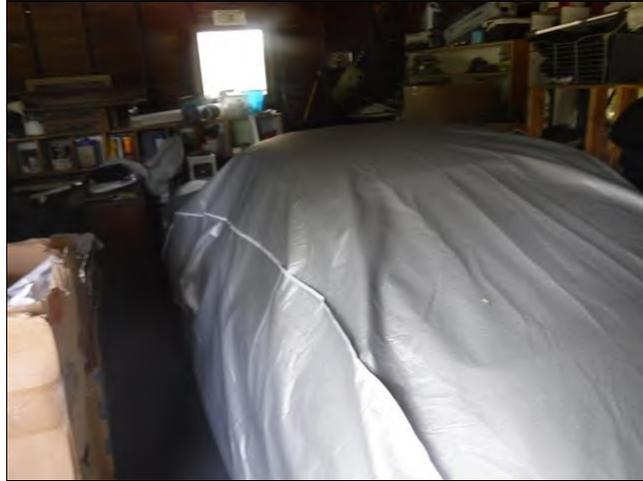
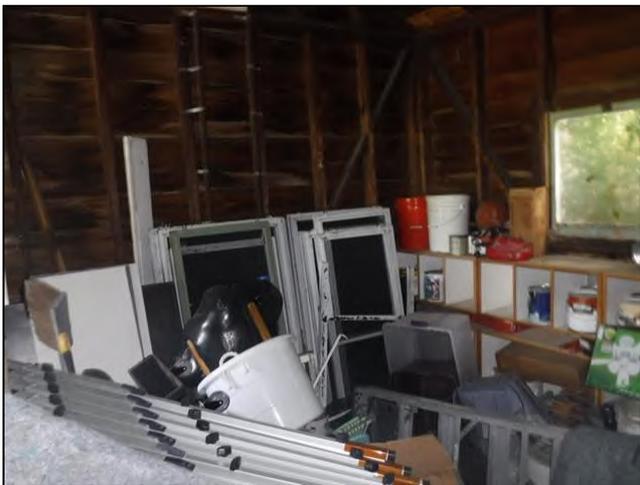
3.4 Full access was not possible due to vehicles/belongings/furniture. Once vacant, minor defects may be present which is considered normal as every area, component, or feature could not be inspected.

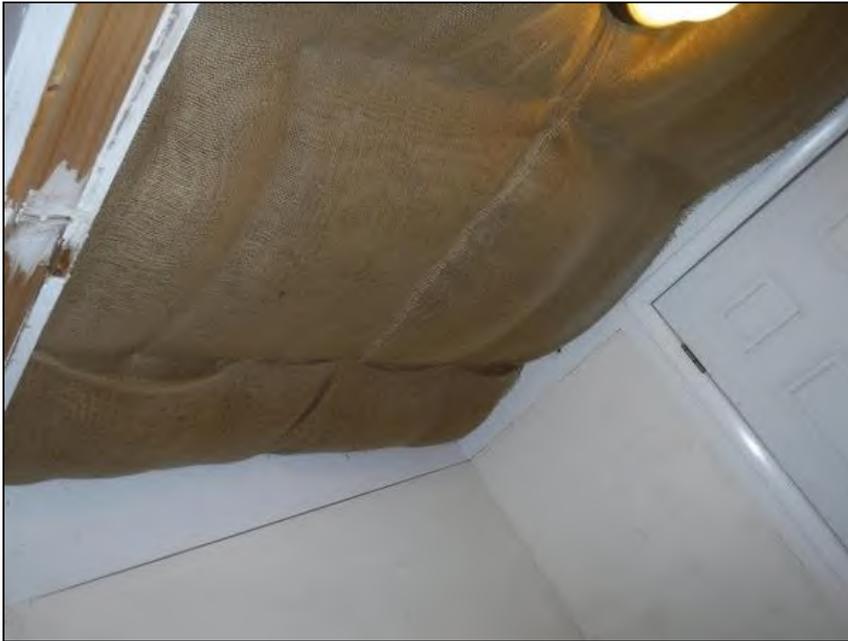
4.0 Item 1(Picture)

4.0 (1) There was fabric installed at the ceiling in the rear addition. The material was not removed or pulled back by the inspector. The material should be considered a fire hazard due to proximity to electrical components and removed.

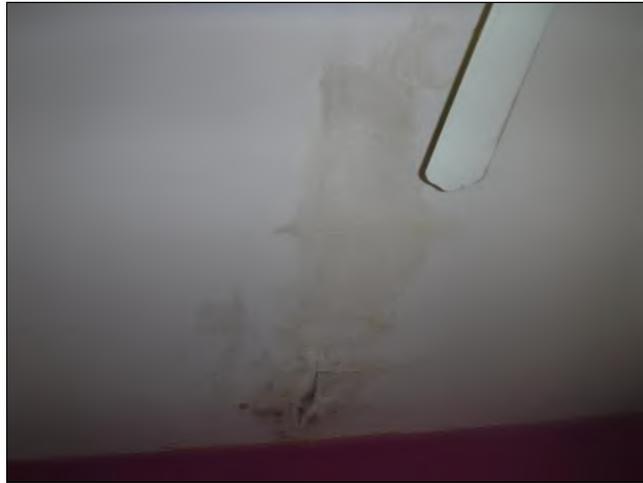
4.0 Item 4(Picture)

(3) The master bedroom ceiling was damaged and in need of repairs. Repairs recommended by a drywall/plaster contractor.

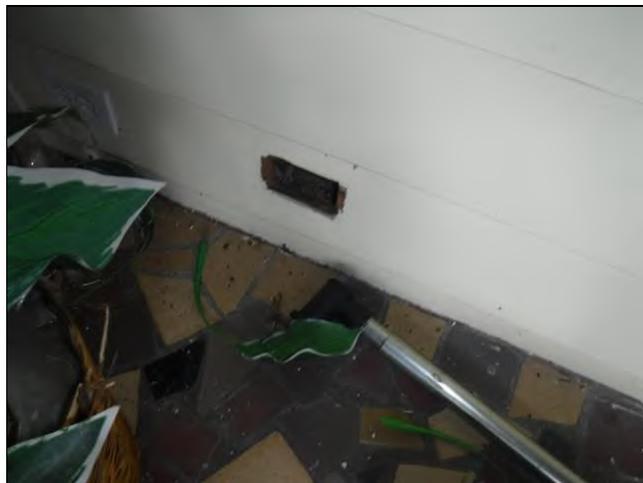
4.1 Item 1(Picture)

4.1 (1) Minor wall repairs recommended at the front porch area by a licensed professional.

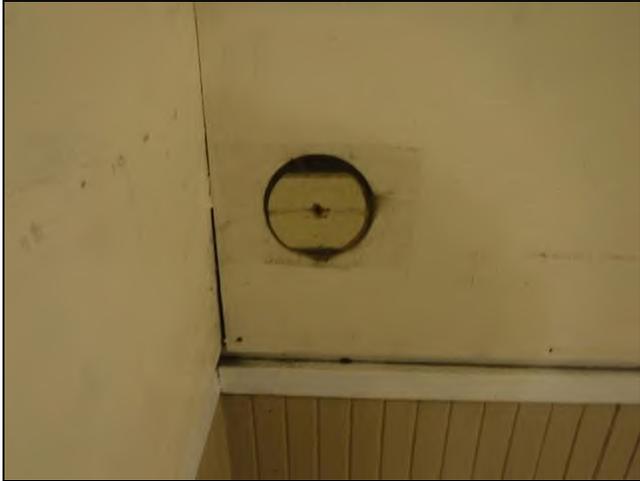
4.1 Item 3(Picture)

(2) There was an unprofessional repair/patch at the rear addition of the house. Repairs recommended by a licensed professional.

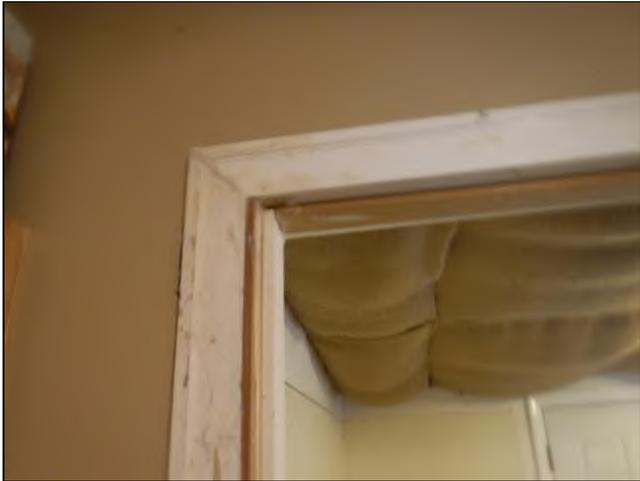
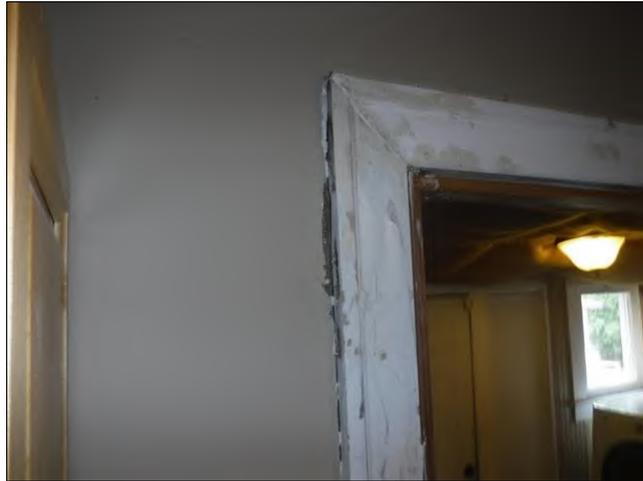
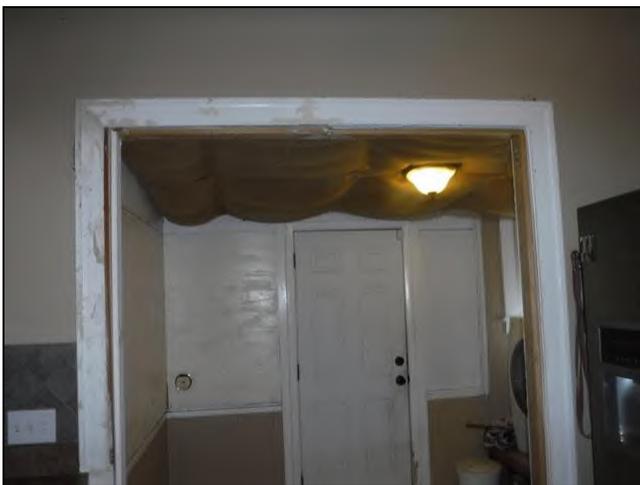
4.4 (1) The door frame/opening at the rear addition was installed in an unprofessional manner. Repairs recommended if desired.

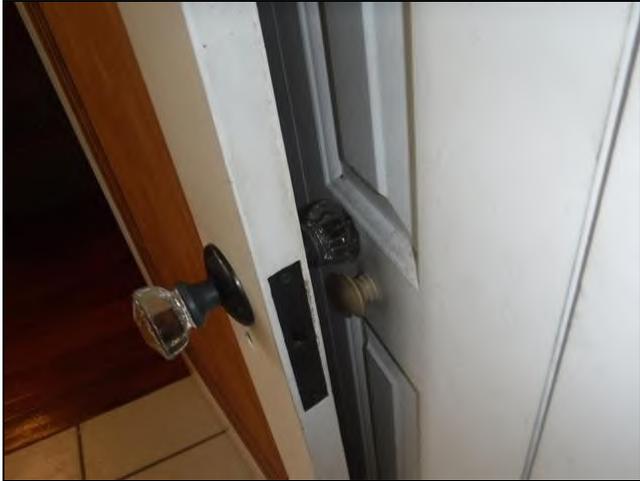
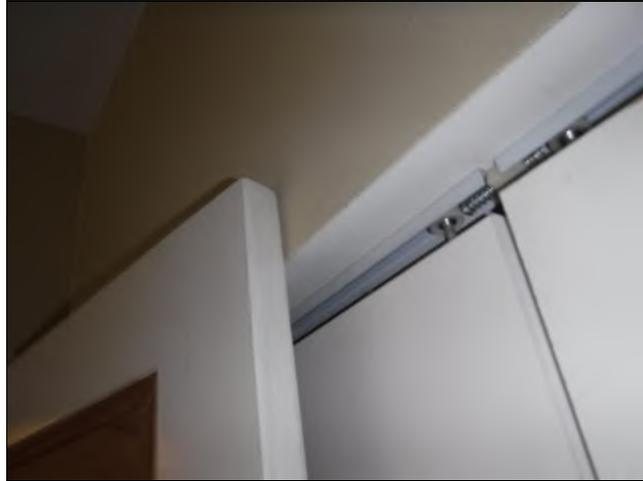
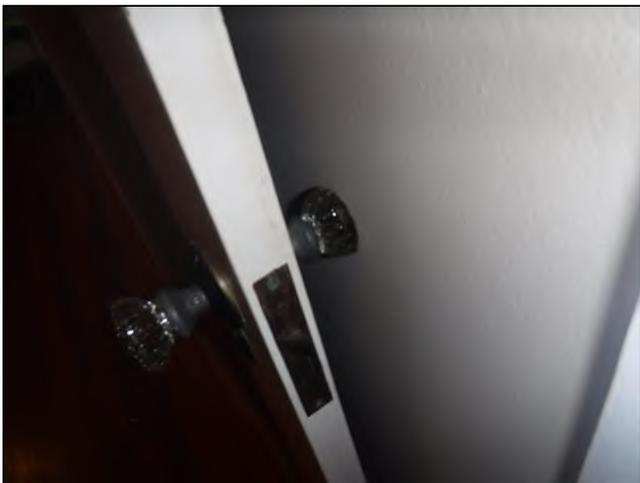
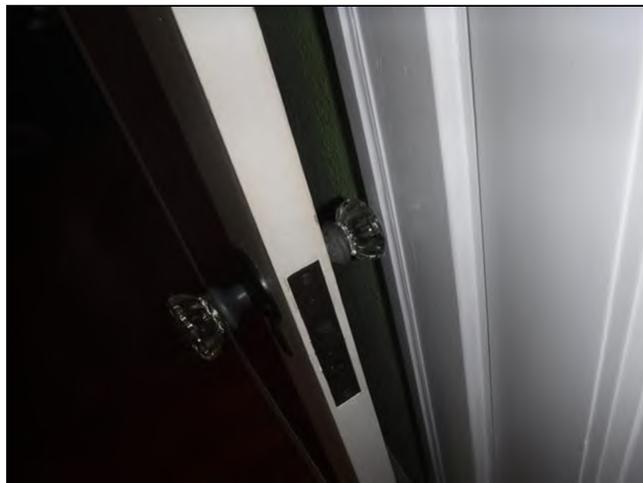
(2) Door stoppers were needed at multiple locations. Door stoppers prevent damage to the walls behind. Repairs recommended.

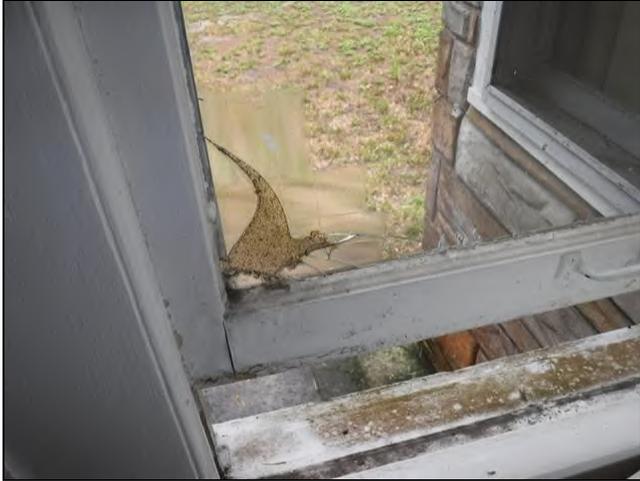
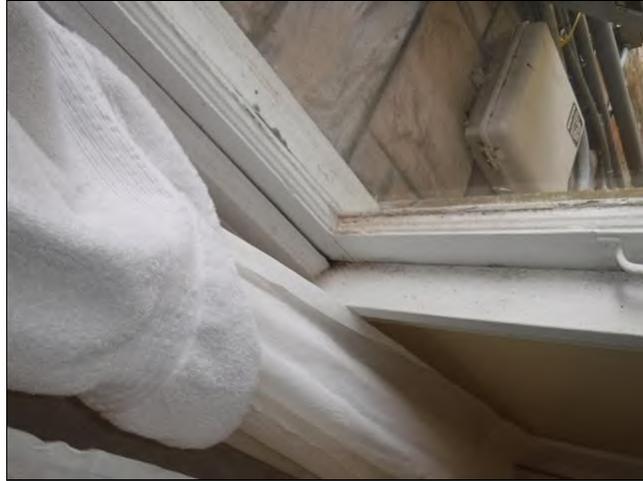
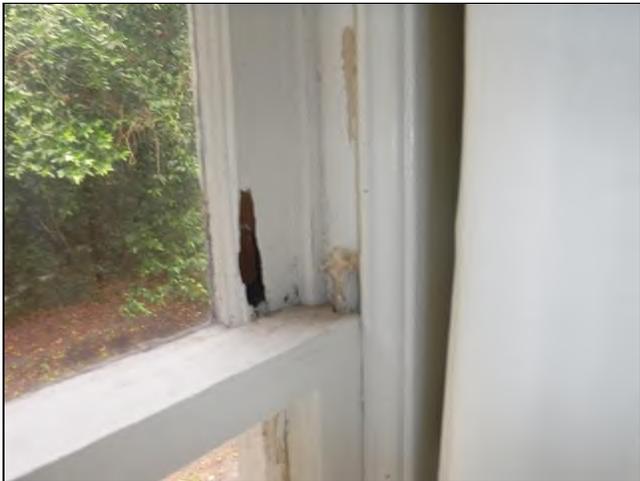
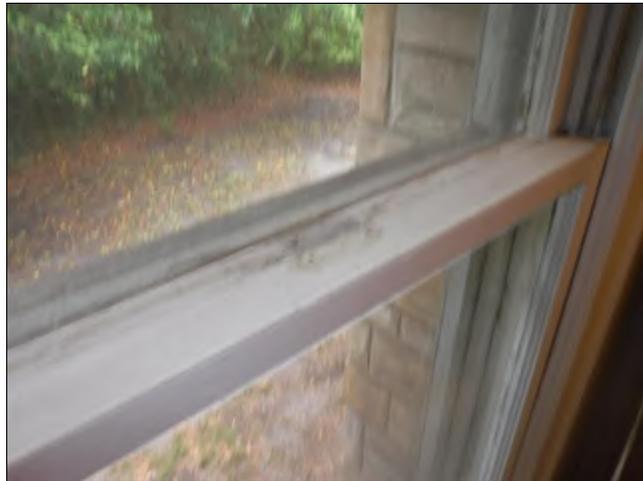
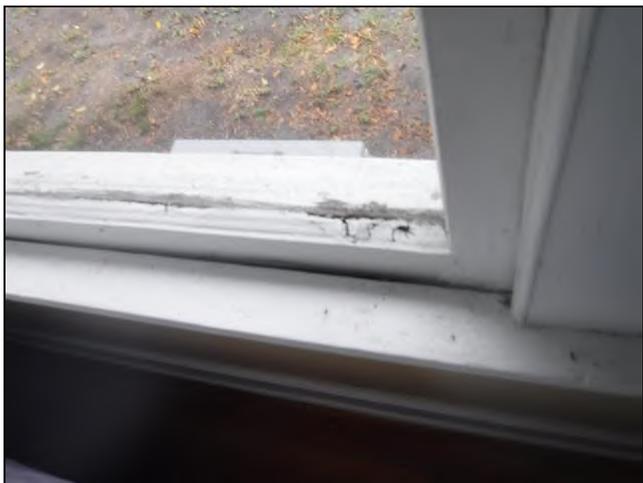
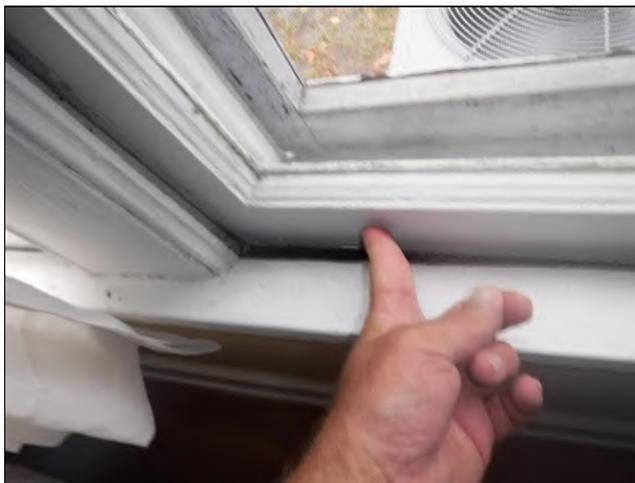
4.5 One or more windows do not operate smoothly, are difficult to latch or are in need of adjustment and/or repairs or replacement. This condition does not generally necessitate immediate repair. Window exteriors require proper maintenance to avoid rot, water or air infiltration. All poorly or non-operating windows and their associated hardware should be cleaned, lubricated, and adjusted for smoother operation. Where needed, essential hardware, such as operator cranks, sash balances and latches should be replaced with compatible components. Generally, improvements are usually made on an as needed basis only however complete window replacement throughout should be considered.

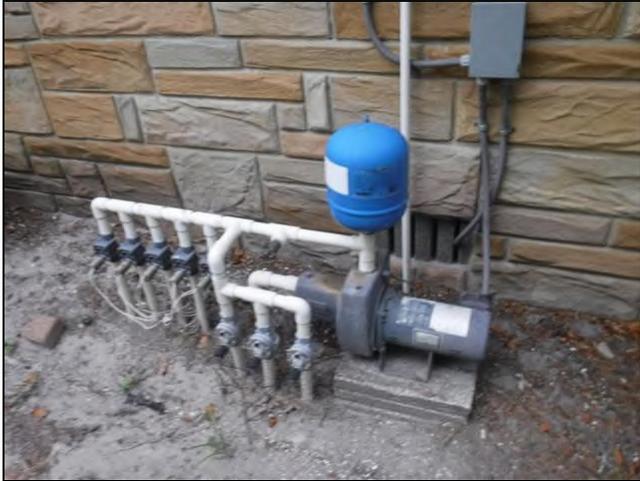
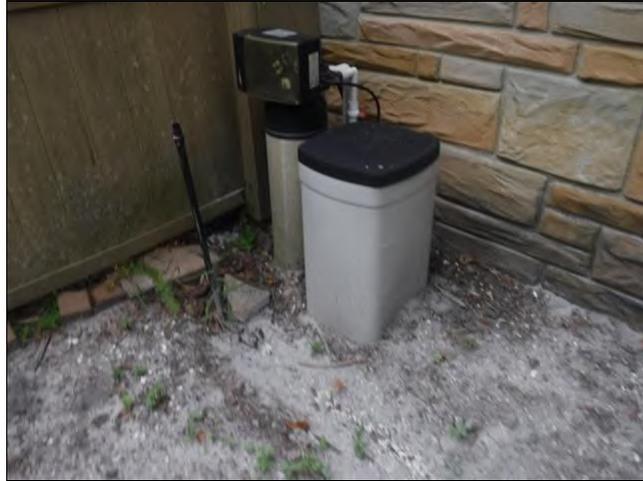
6.1 We do not inspect any water filtration units or sprinkler systems. Recommend contacting the water filter installer for information on life expectancy or condition.

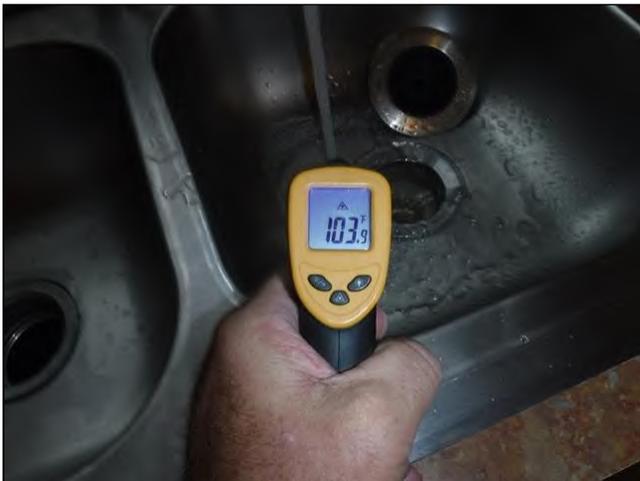
6.2 Item 1(Picture)

6.2 Unit was in working condition.

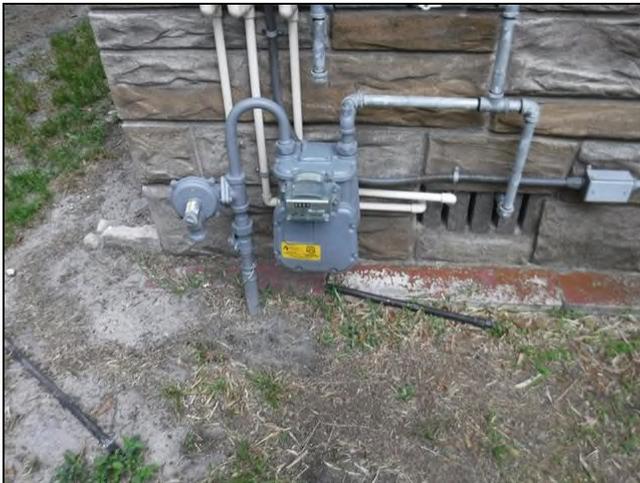
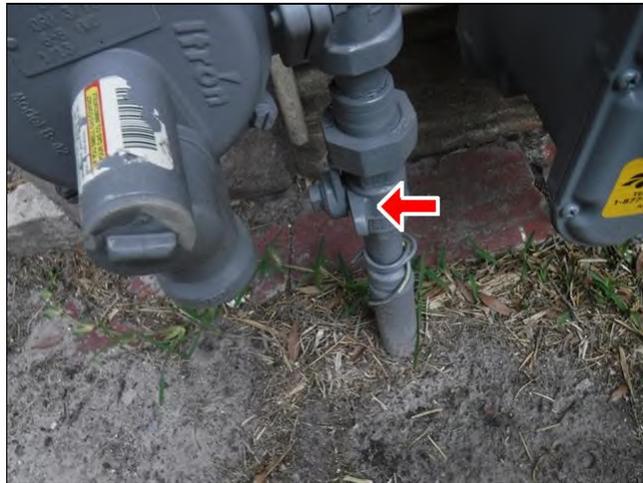
6.5 The gas shutoff was located at the meter to the rear of the house.

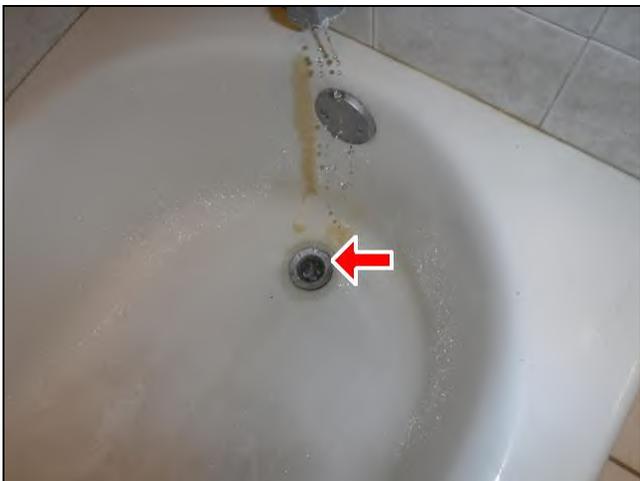
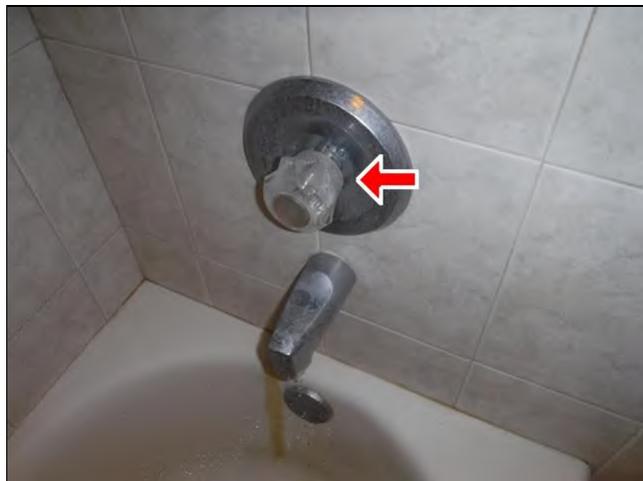
6.6 (1) The master bathroom tub stopper was missing and the tub water valve was not operating as intended. Repairs recommended by a licensed plumber.
