CITY OF ST. PETERSBURG, FLORIDA
PLANNING AND DEVELOPMENT SERVICES DEPARTMENT
URBAN PLANNING AND HISTORIC PRESERVATION DIVISION

STAFF REPORT

Community Planning and Preservation Commission Certificate of Appropriateness Request

Review of a Certificate of Appropriateness for replacement of historic windows, repairs to the garage, and a street-side porch enclosure at 2863 Burlington Ave. N., a contributing resource to the Kenwood Section – Seminole Park Local Historic District (17-90300003)

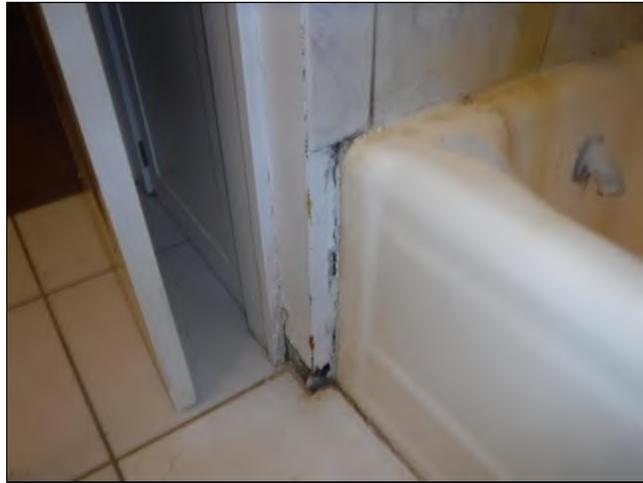
6.6 Item 4(Picture)

(2) There was water damage at the exterior of the hall bathroom tub. Repairs recommended.

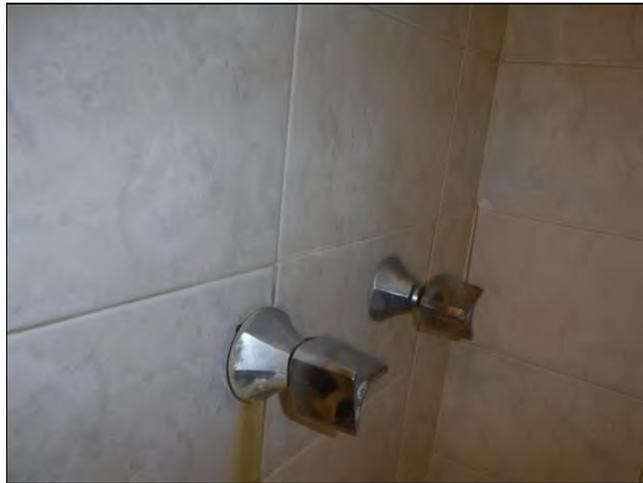
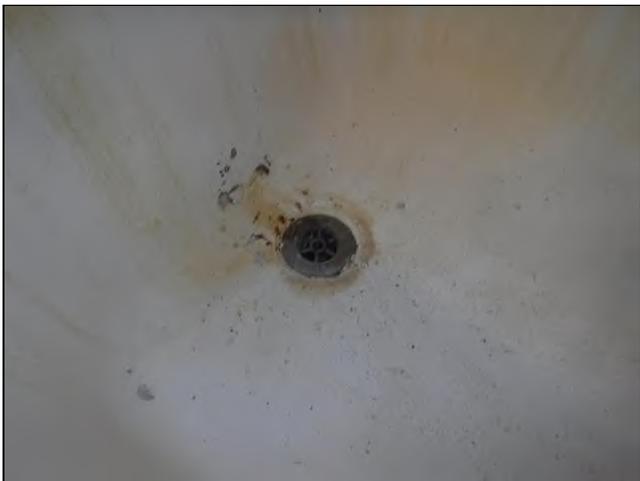
(3) The hall bathtub fixtures were loose and not caulked. Repairs recommended by a licensed plumber.

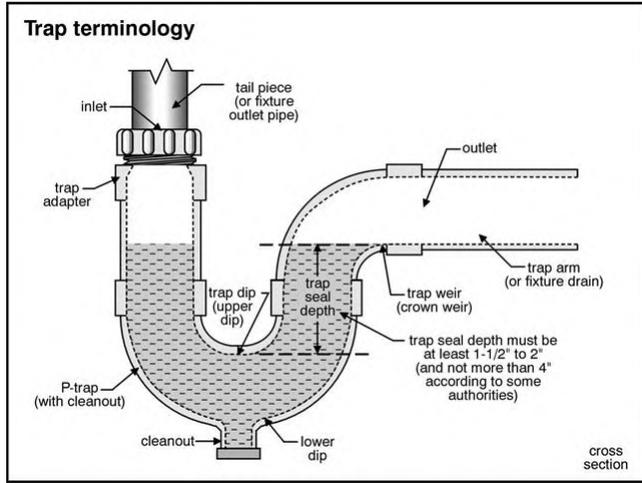
6.7 Item 2(Picture)

6.7 (1) Improper drain trap installed at the master bathroom sink. Repairs recommended by a licensed plumber.

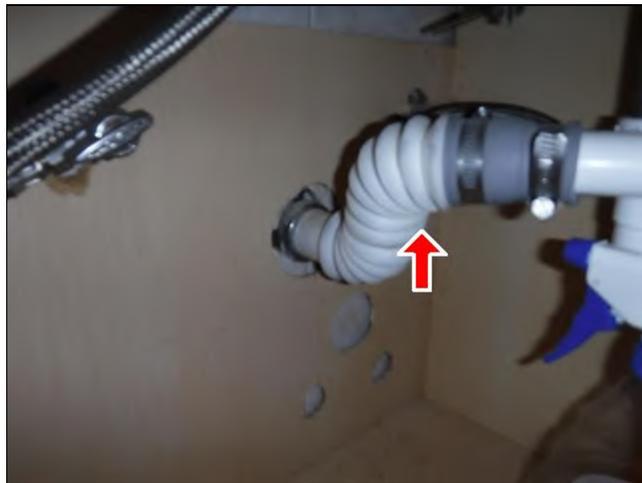
6.7 Item 4(Picture)

(2) Flexible drain piping installed where permanent rigid piping is needed at both bathroom sink drain pipes. These components can cause premature failure, leaks, and drain clogs. Replacement by a licensed plumber recommended using rigid permanent drain piping.

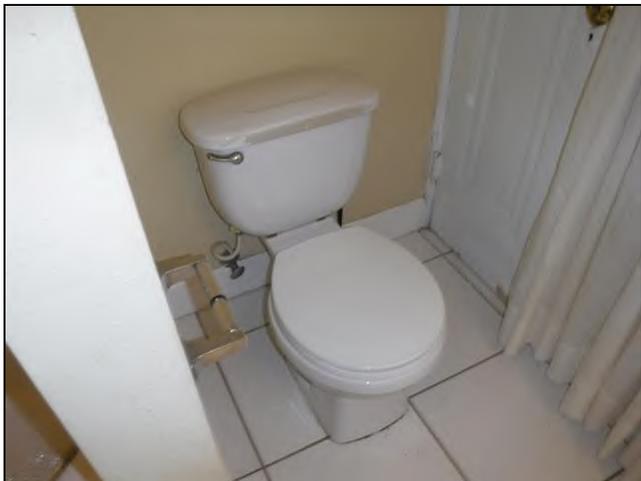
6.8 Item 1(Picture)

6.8 (1) The master bathroom toilet was not operating or holding water in the tank at the time of inspection. Repairs recommended by a licensed plumber.

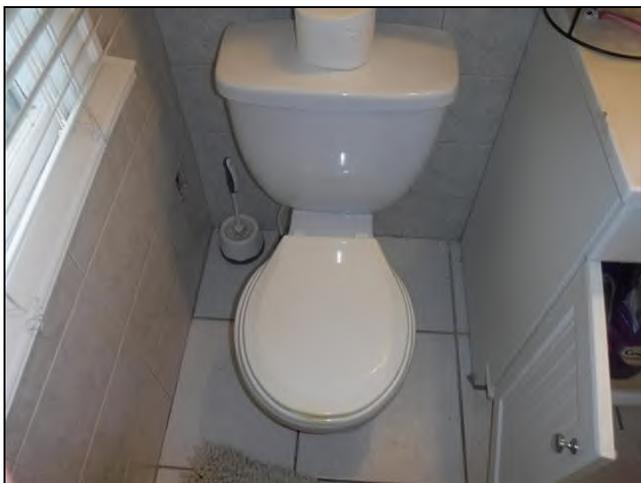
6.8 Item 2(Picture)

(2) The toilet is loose at floor at the hall bath. Repairs may involve re-setting the toilet on a new wax seal. Recommend a licensed plumber repair or correct as needed. Repairs recommended.

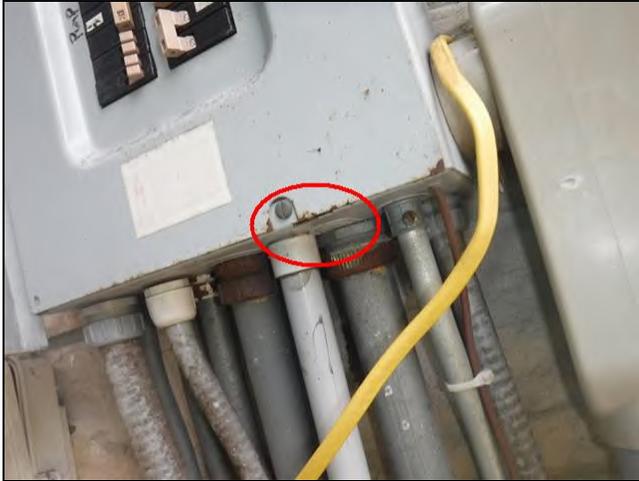
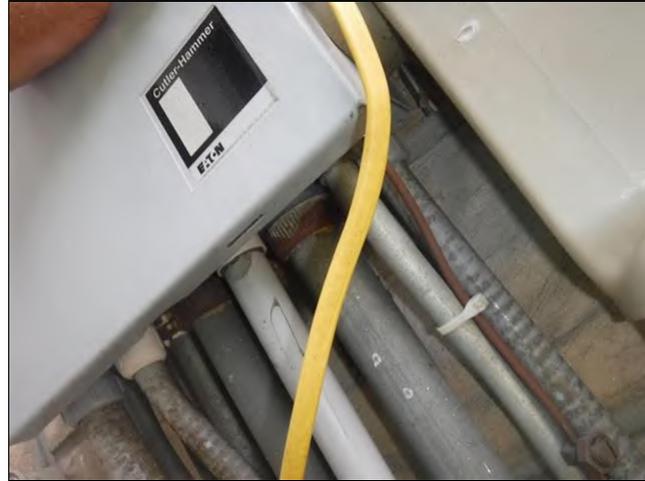
7.1 The electrical panel cover latch was missing preventing the panel cover to be closed fully. Repairs recommended by a licensed electrician.

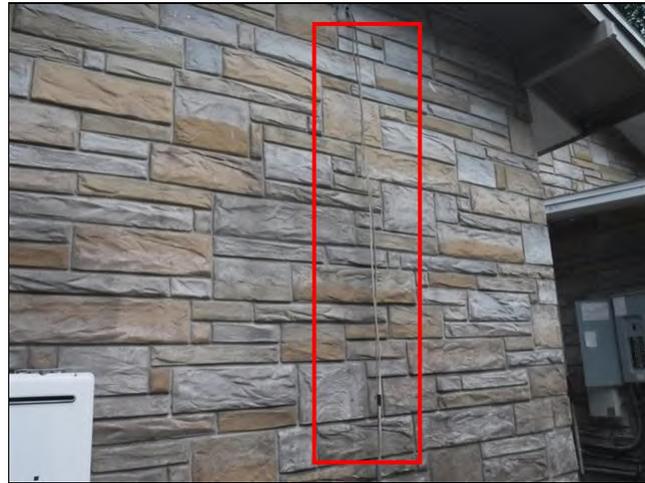
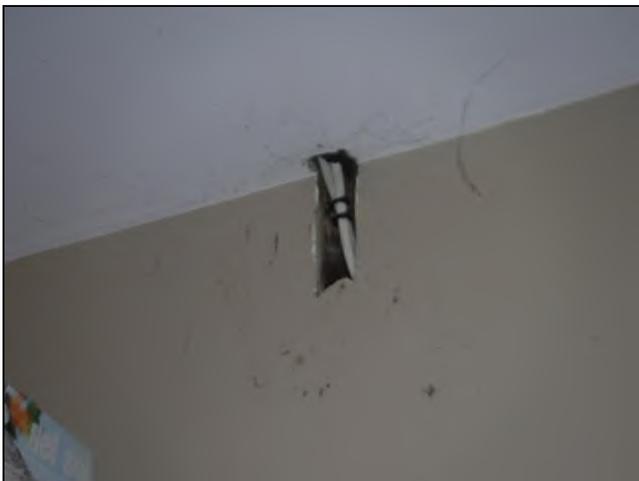
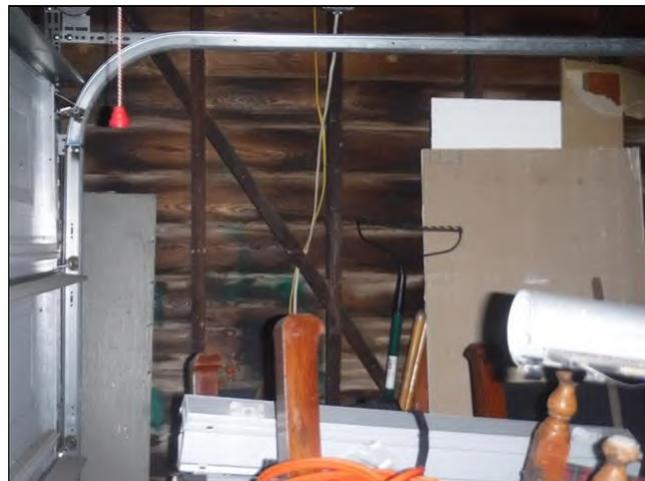
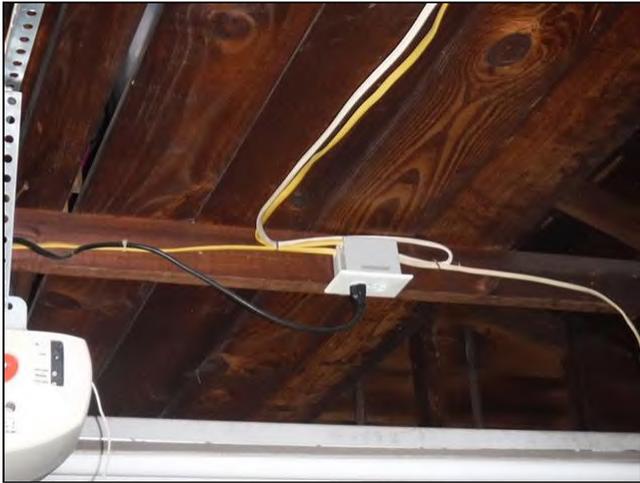
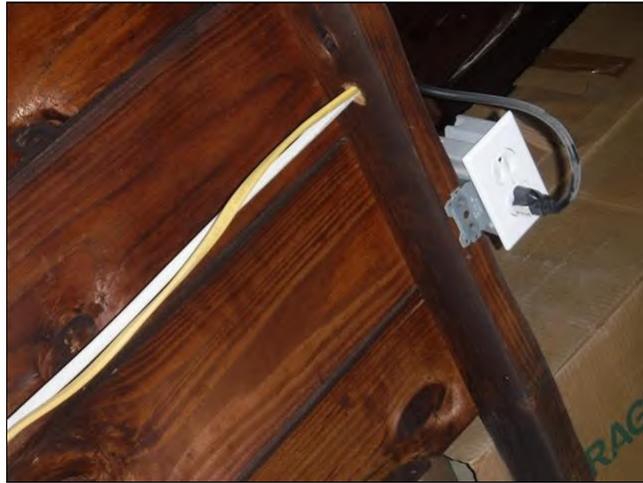
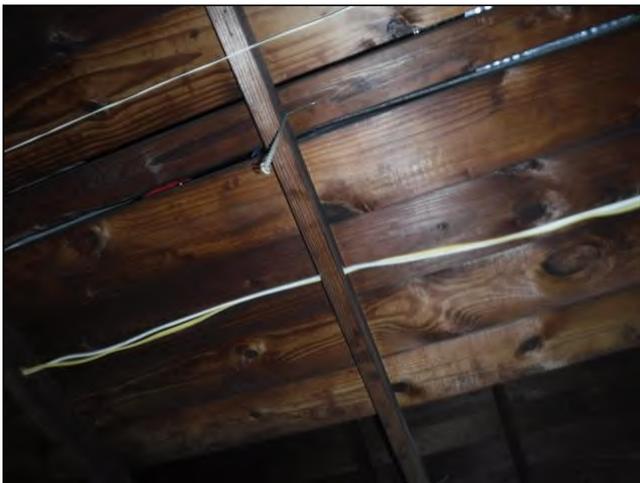
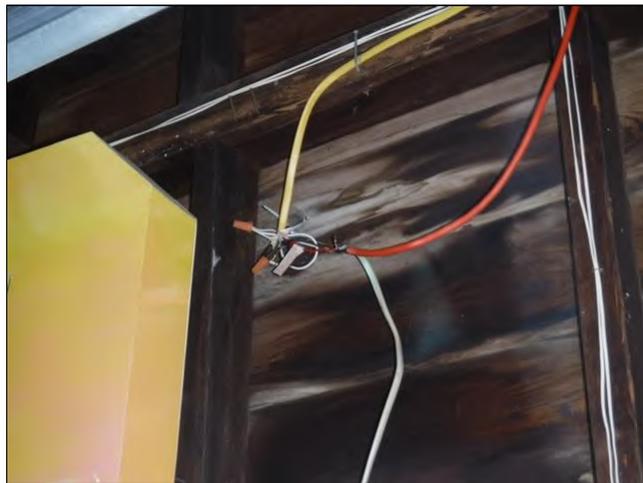
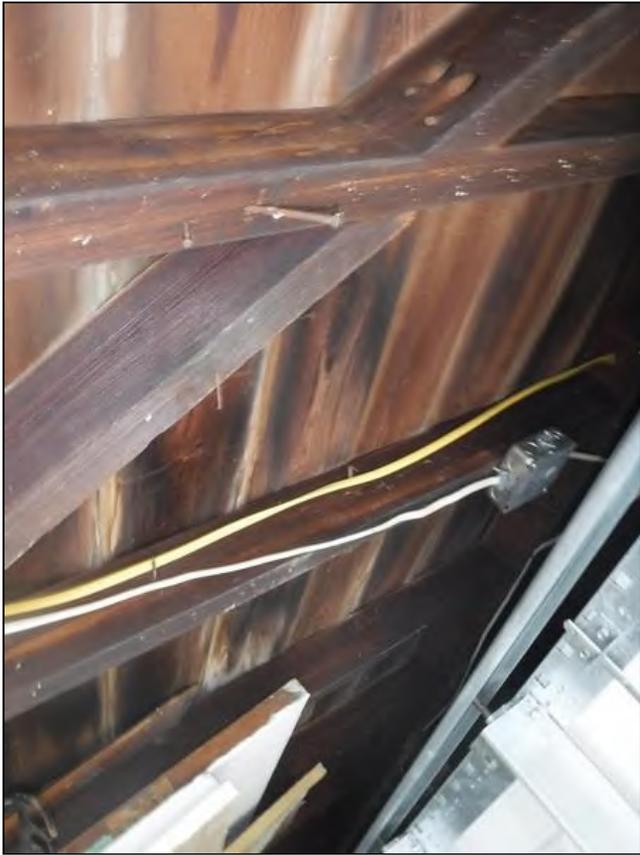
7.2 Wires were exposed at the kitchen, exterior, and garage. All wires should be protected in conduit for safety. Have repaired by a licensed electrician.

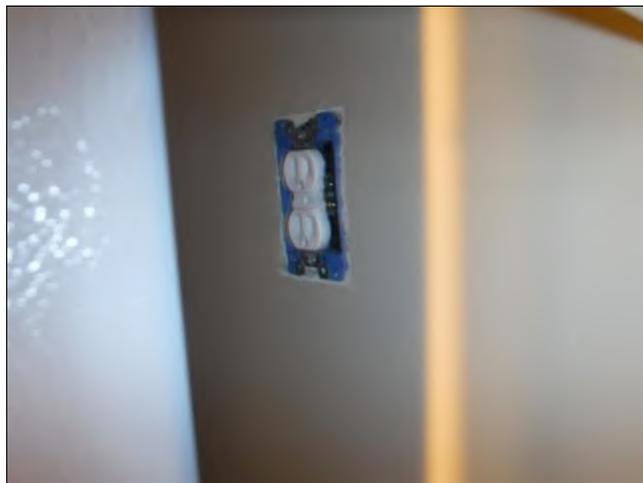
7.3 Item 2(Picture)

7.3 (1) Outlet covers missing at the kitchen. Replace covers.

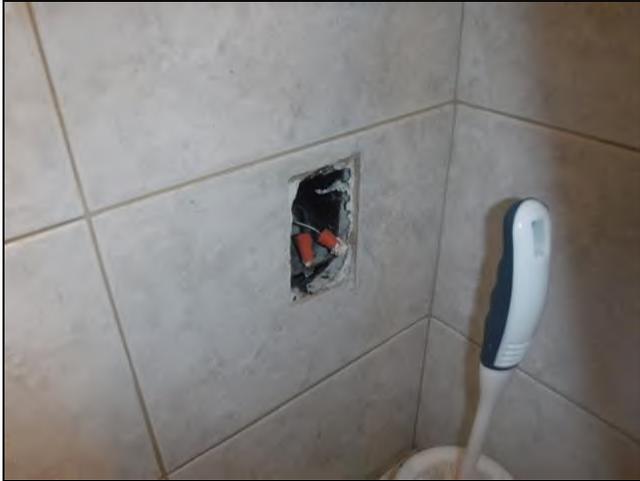
7.3 Item 3(Picture)

(2) In the hall bathroom was an outlet opening that was missing a junction box and cover/outlet. Repairs recommended by a licensed electrician.

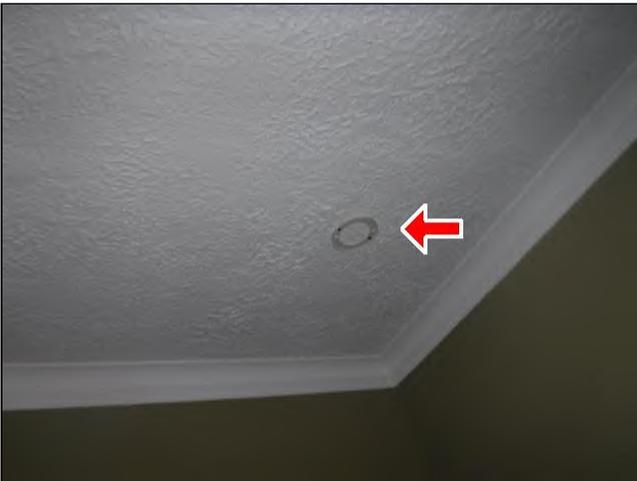
7.7 Item 1(Picture)

7.7 The smoke detector should be installed and tested at common hallway to bedrooms upon moving in to home.

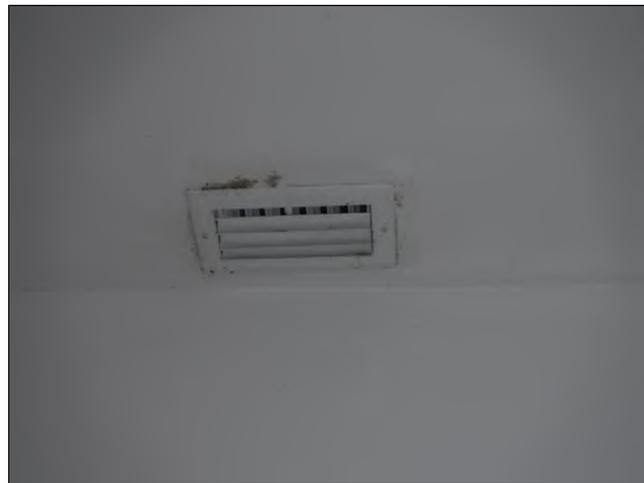
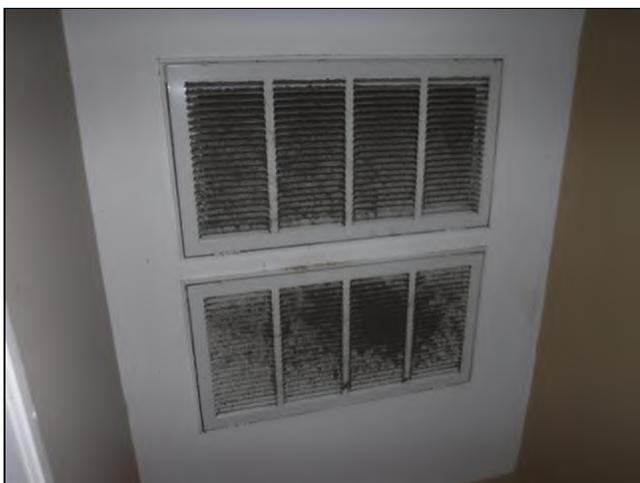
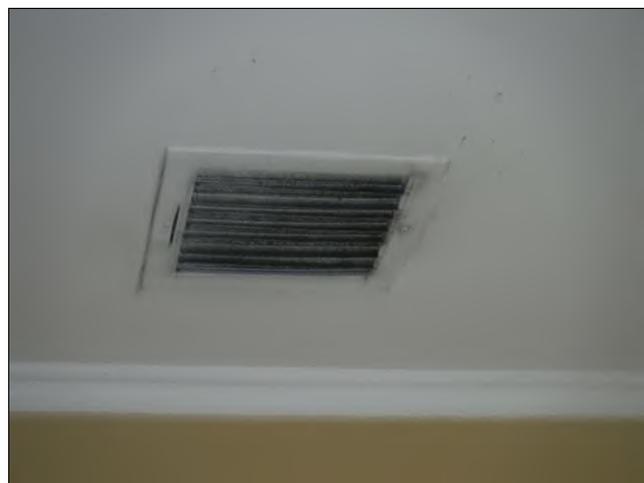
8.3 (1) Duct cleaning is recommended so that there is a good quality of indoor air circulating throughout. Duct cleaning is recommended by a licensed HVAC contractor. Repairs recommended.

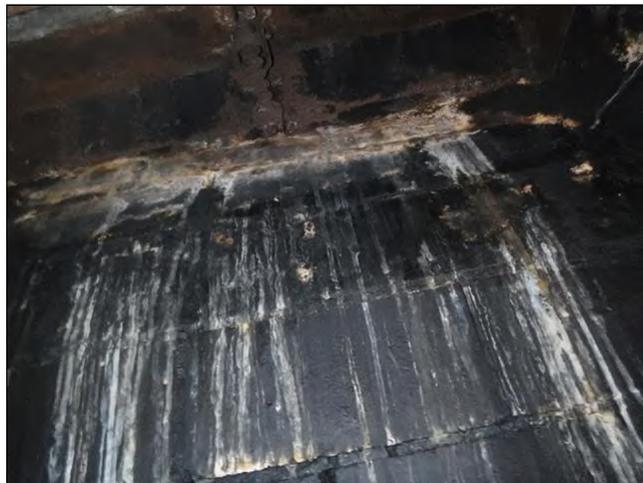
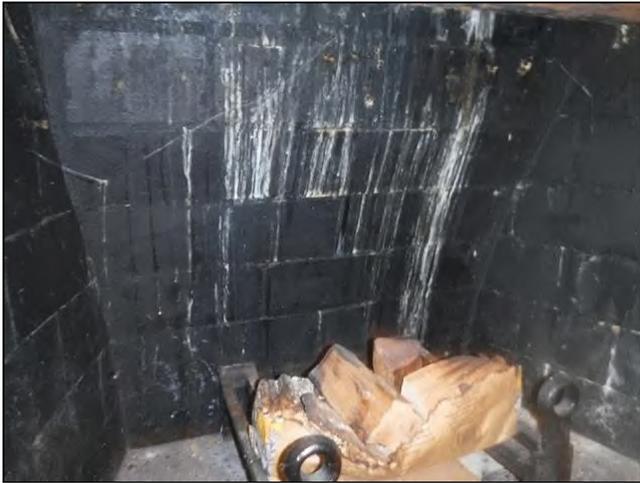
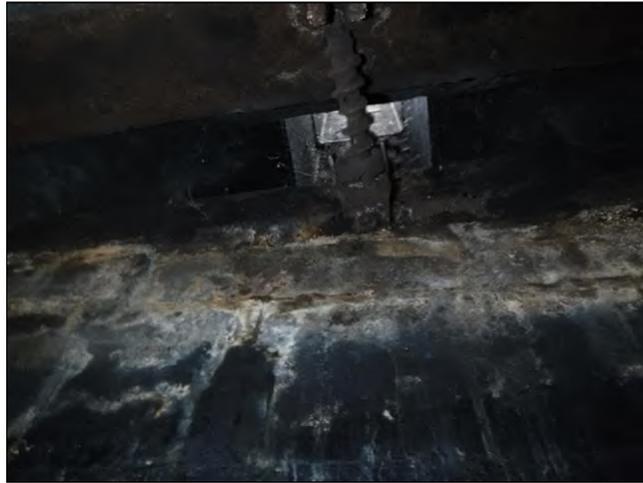
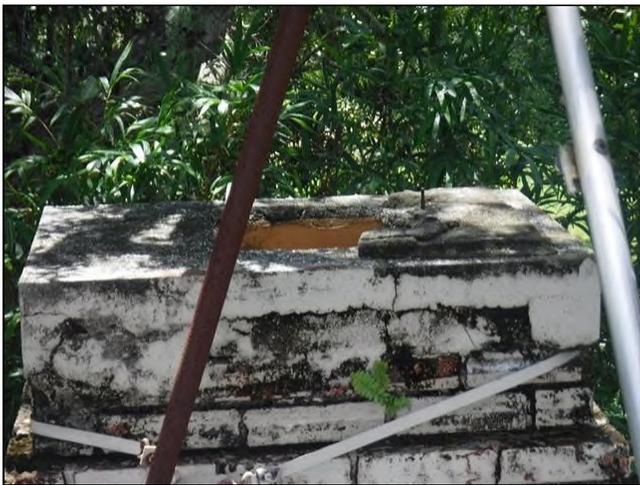
8.4 The fireplace and flue had built-up Creosote which is highly flammable, and signs of water entering the flue and firebox. Additionally the chimney was missing a chimney cap and spark arrestor. Prior to operating the fireplace/chimney it is recommended to have a licensed Chimney Sweep fully evaluate, make repairs as necessary, and clean the firebox and flue. Repairs recommended.

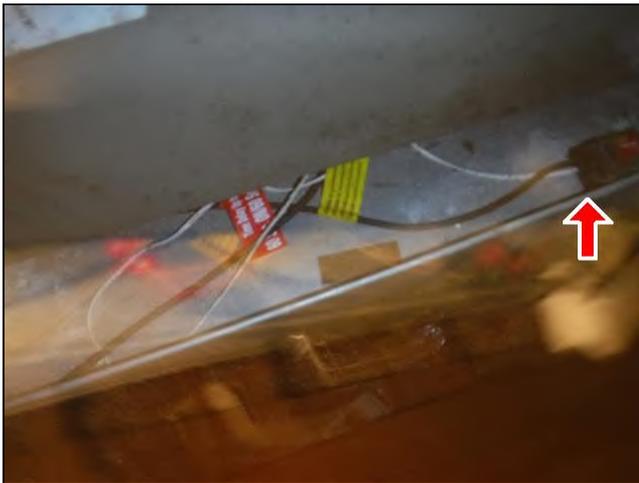
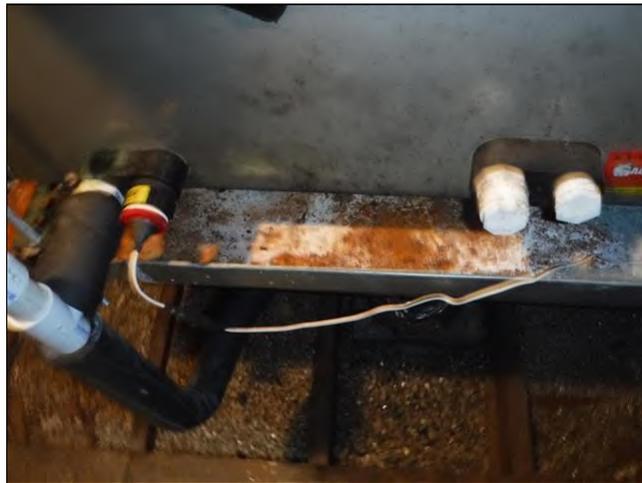
8.5 It was not possible to determine if the catch-pan shutoff was operational and there was rust in the catch-pan. Air handlers installed in attic spaces should ideally have three methods for condensation discharge or system shut-off. 1) Primary condensation line. 2) A secondary condensation line or float type switch installed at the secondary discharge opening. 3) A float type switch installed on/in the catch-pan. It is recommended to have all condensation/shutoff systems evaluated and repaired as necessary by a licensed HVAC contractor.

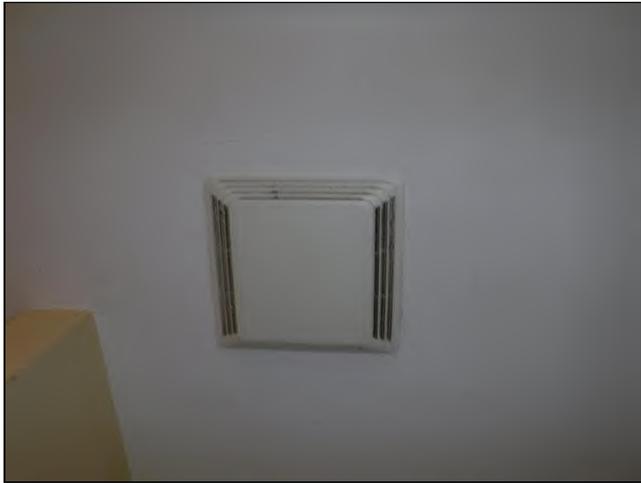
9.2 Item 2(Picture)

(2) Bathroom vent fans were in need of cleaning at the time of inspection.

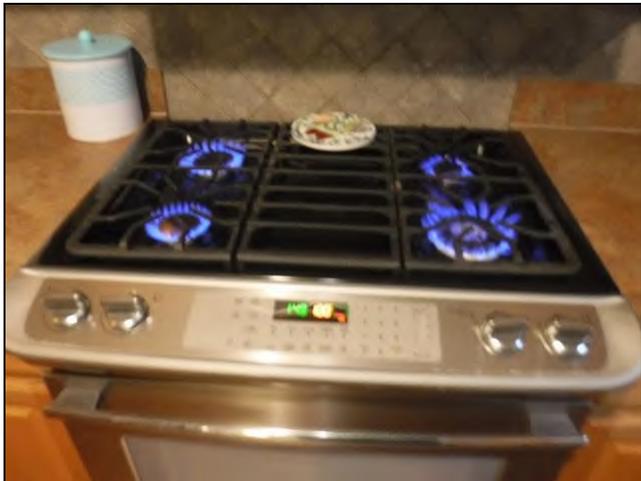
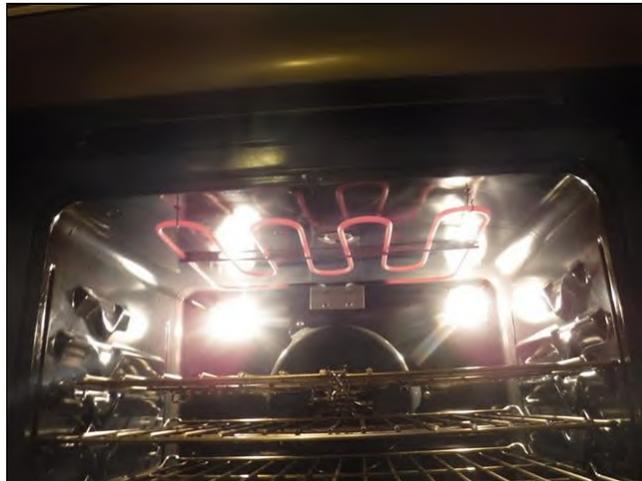
10.10 Item 1(Picture)

10.10 The oven and cooktop operated as intended at the time of inspection.

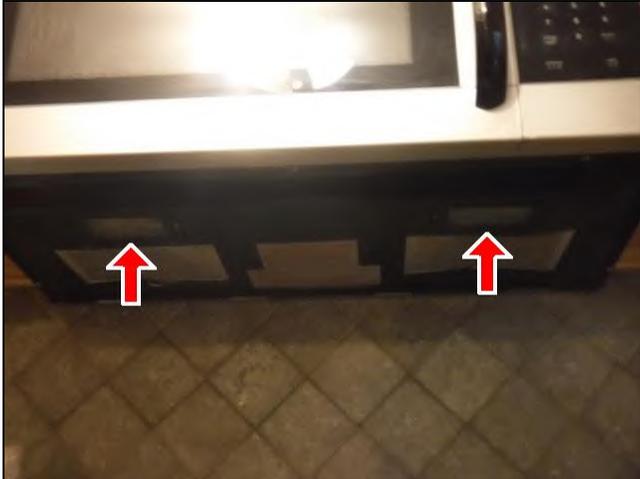
10.13 Item 1(Picture)

10.13 The microwave operated as intended at the time of inspection however the lightbulbs appeared to be burnt out. Replace bulbs.

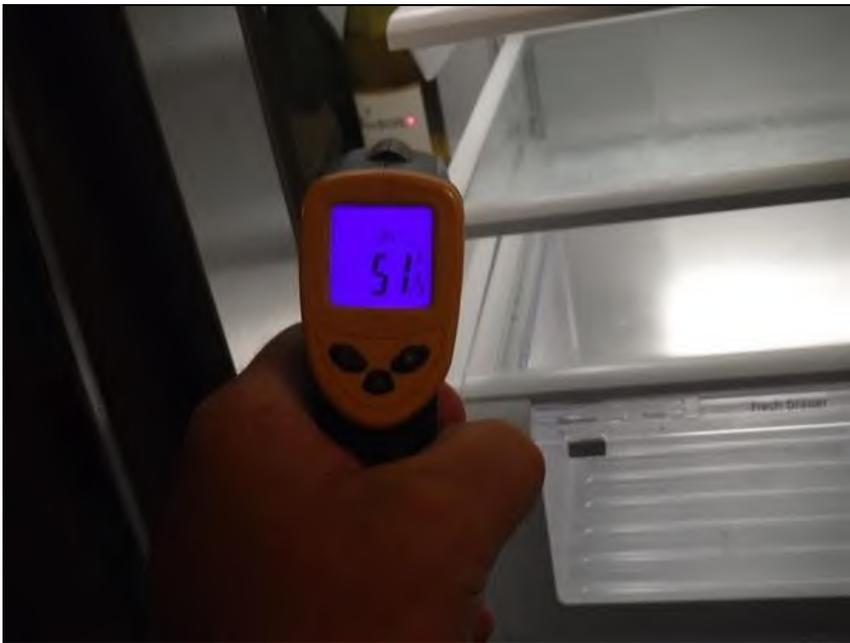
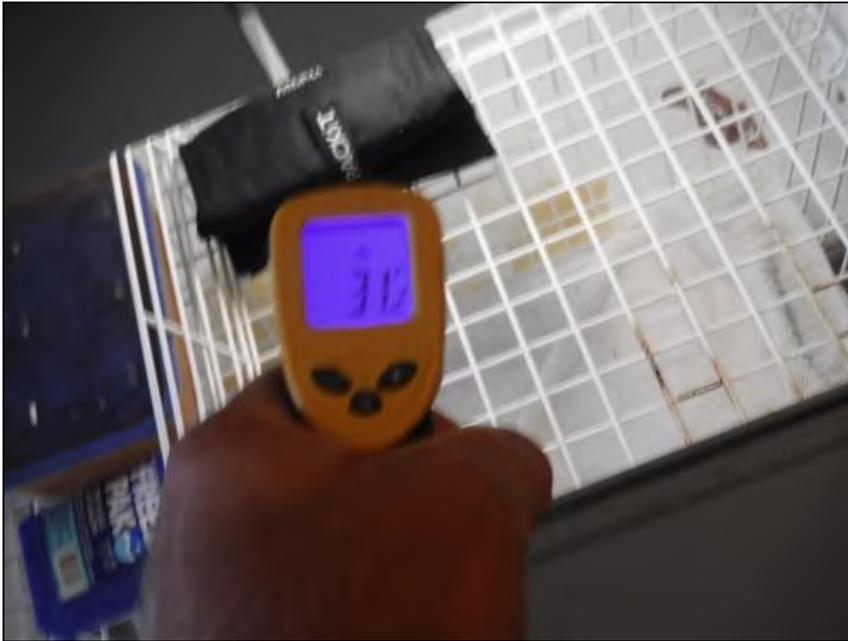
10.14 Item 1(Picture)

10.14 The refrigerator operated as intended at the time of inspection. The water line for the water dispenser and ice maker was not connected.

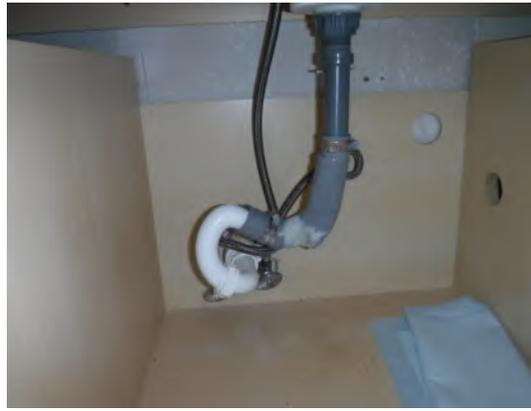
16 Bathroom Sink Drain

* Improper drain trap at master bathroom sink. * Temporary drain pipes installed where permanent rigid drain piping needed at both bathroom sinks. * Tub stoppers needed at both bathrooms. * Master bathroom tub faucet not functioning properly. * Toilet not operational at master bathroom. * Toilet loose at floor connection in hall bathroom.

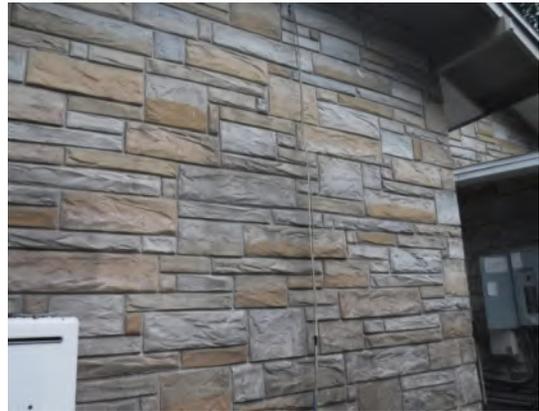
25 Exposed wiring at exterior

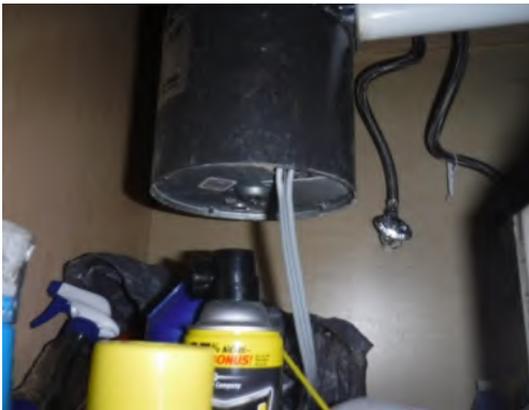
28 Exposed wires at kitchen

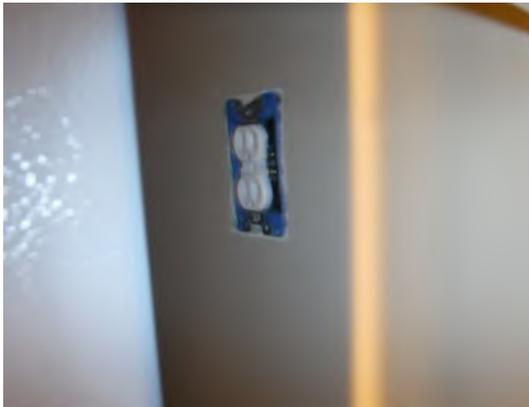
30 Outlet cover missing

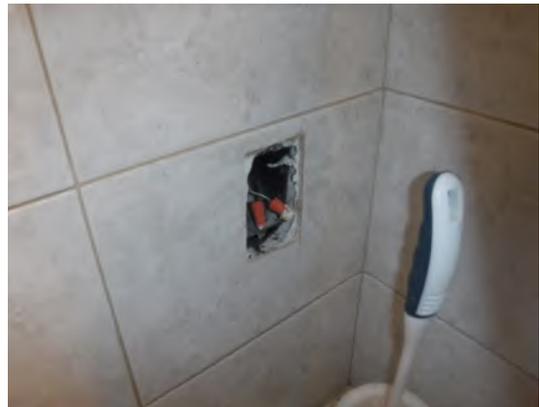
31 Outlet cover missing

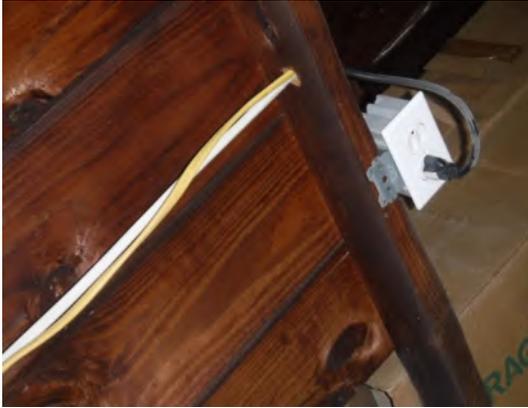
* HVAC condensation line in need of cleaning. * HVAC temperature split too low indicating service is needed. * Chimney roof flashing has gaps with possible water leaks and staining in attic and interior. * Large trees overhanging roof. * Membrane roof at end of service life. * Exposed/unsafe wiring at exterior, kitchen, and garage. * Exterior GFCI outlet not tripping. * Garbage disposal wiring missing wire clamp for safety. * Outlet covers missing at kitchen. * Live wires and missing junction box in hall bathroom. * Panel cover closing latch missing exposing panel. * Wire splices not in junction box at garage.

34 Exposed/Unsafe wiring at garage

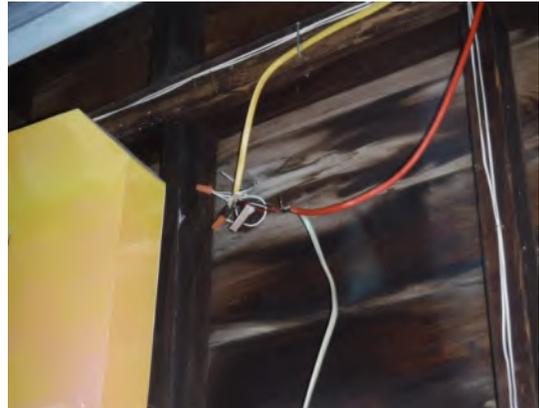
35 Exposed/Unsafe wiring at garage

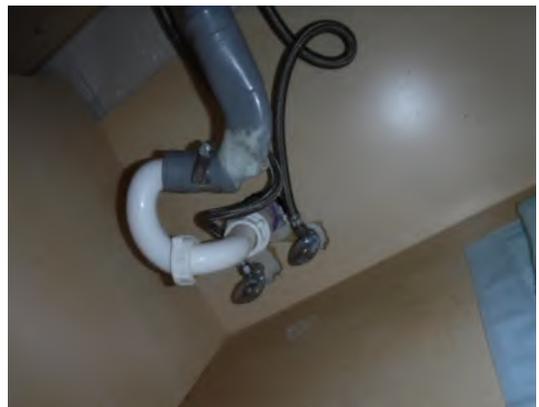
37 Improper trap at master bathroom

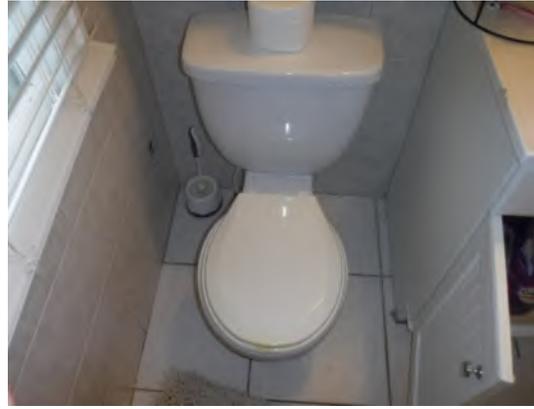
41 Master toilet not operational

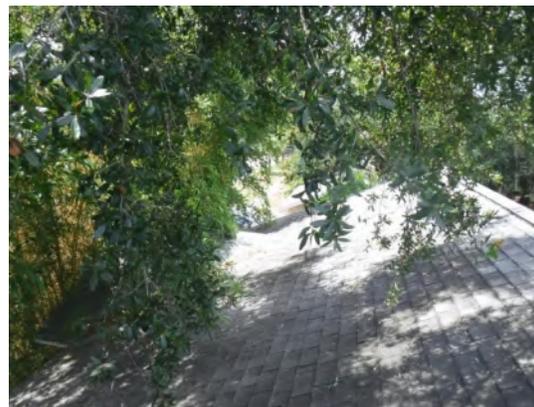
45 Trees overhang roof

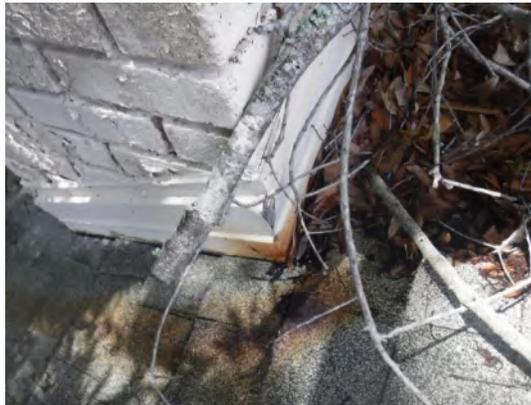
46 Trees overhang roof

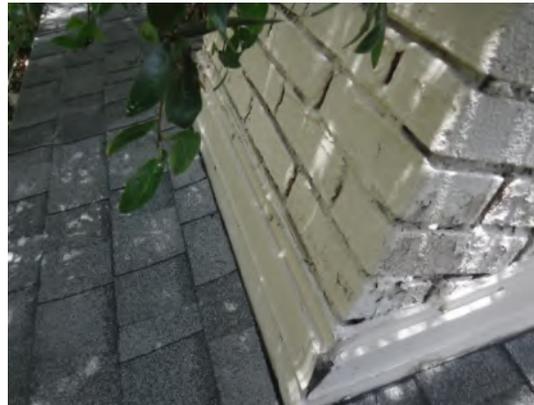
47 Chimney flashing
