CITY OF ST. PETERSBURG, FLORIDA
PLANNING AND DEVELOPMENT SERVICES DEPARTMENT
URBAN PLANNING AND HISTORIC PRESERVATION DIVISION

STAFF REPORT

Community Planning and Preservation Commission Certificate of Appropriateness Request

Approval of a Certificate of Appropriateness for alterations to a contributing resource to the Kenwood Section – Northwest Kenwood Local Historic District (18-90300008)

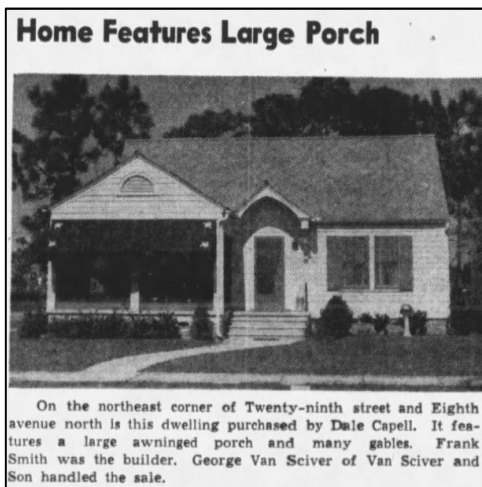
Figure 1: Subject property, as shown in *St. Petersburg Times* upon sale from builder Frank Smith to Dale Capell, November 24, 1940.

The subject property features a predominantly side-gabled form, with a gabled portico with barrel ceiling and bracket support highlighting the main entrance. A large, front-gabled front porch to the left of the entrance and engaging the street corner on which the building sits, is a noteworthy feature among Minimal Traditional homes. The subject property’s “large front porch” was emphasized in a 1940 *St. Petersburg Times* article which included a note of its sale.¹

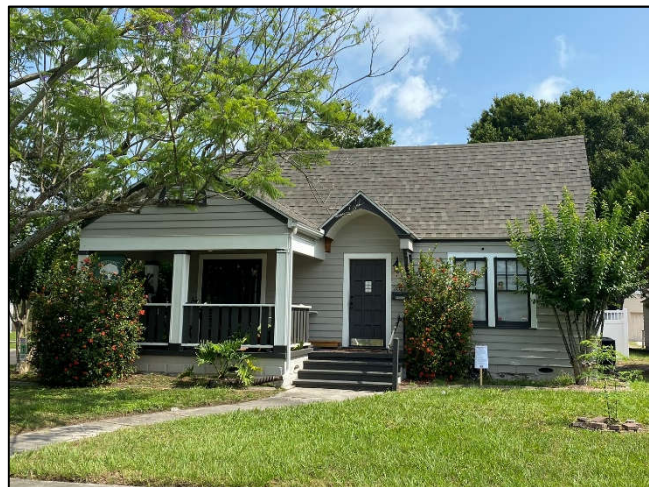
Figure 2: Current photograph of subject property.

The subject property has retained a high degree of integrity with regard to this historic design, as well as most of its historic materials, including original wooden double-hung sash windows with six-over-one configuration and wood siding with beveled corner joints. As such, it is listed as a contributing resource to the Kenwood Section – Northwest Kenwood Local Historic District, which was added to the St. Petersburg Register of Historic Places on April 18, 2019.

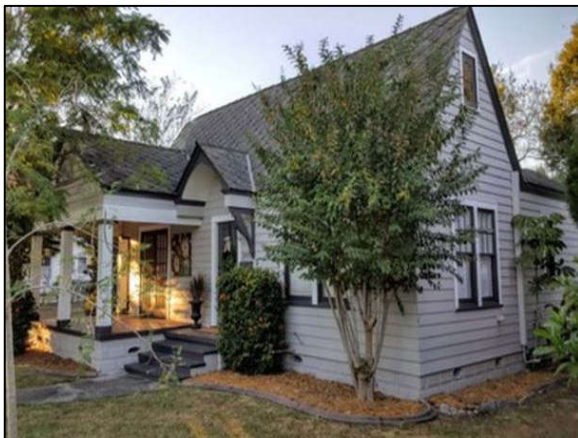
Figure 3: Photograph from circa 2016 real estate listing for property, via Zillow. Attic window shown appears to be historic to property.

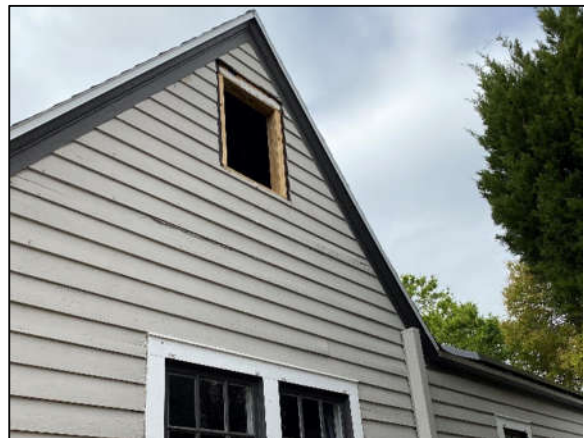
Figure 4: Missing unit on February 21, 2020.

Consistent The window previously installed in this location has been missing since February 2020, if not earlier. The installation of a permanent covering in this building opening is critical to the long-term preservation of the historic resource, particularly as Florida's wet season approaches.

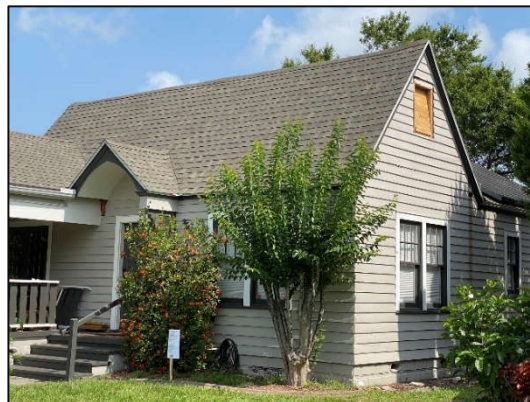
Figure 5: Present condition of attic window, replaced with board.

The proposed window is 22" wide by 33" high, one-over-one PGT 5500 series vinyl-frame impact window. Relevant details about the proposed windows are included in Appendix B.

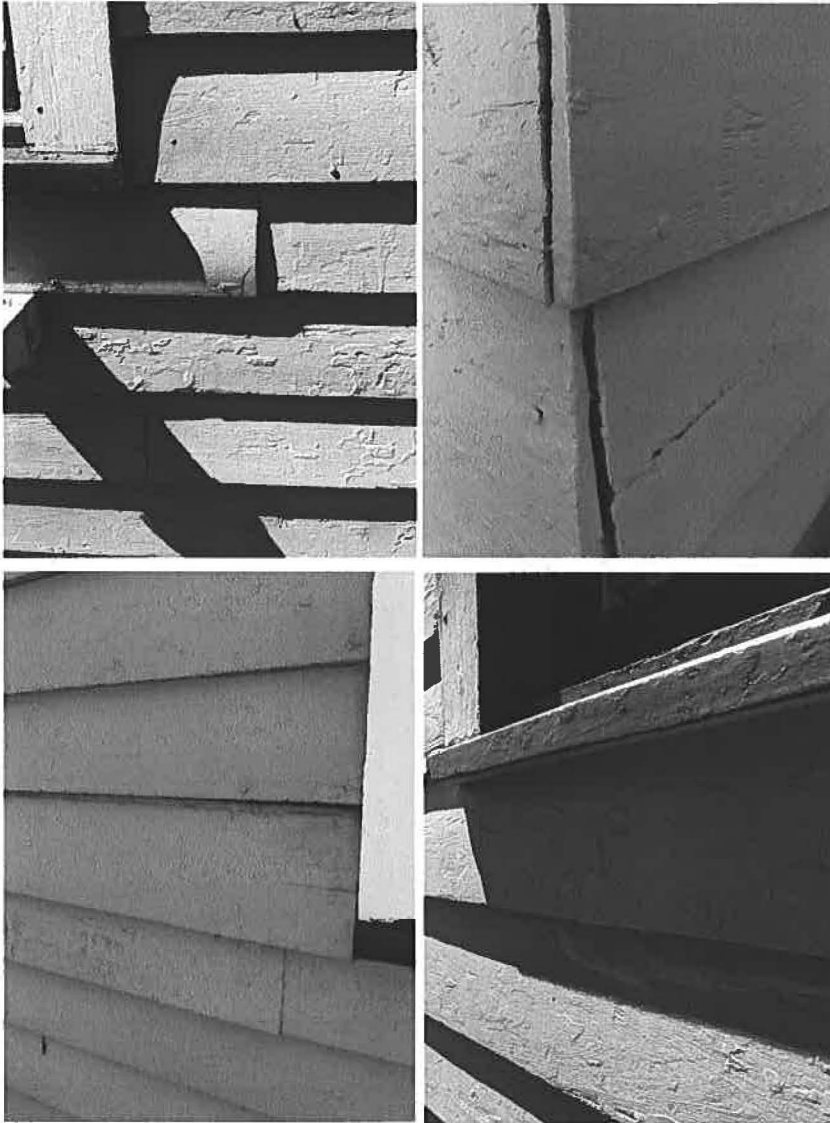
Examples of degradation

This is just an example of the problems. Prior homeowners tried replaced some boards in 2016. Those board are already cracking and degrading.

In order to restore rather than replace, all siding would need to be stripped, decalked, primed and repainted, and rotten boards replaced. See the cost of stripping below.

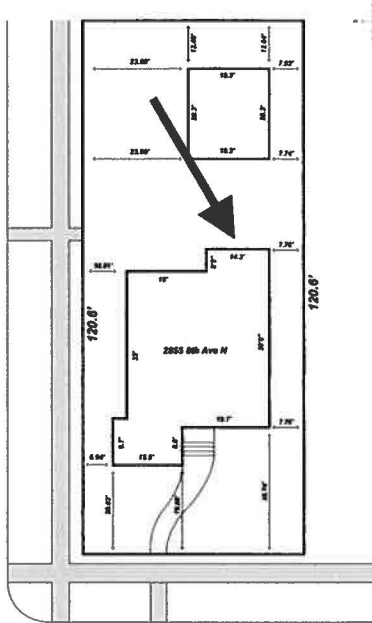
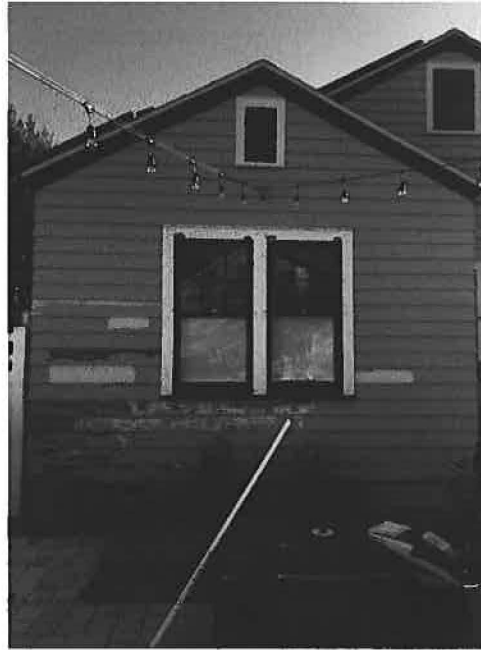
This estimate is for only the portion of the north facing wall shown here:

First Choice Painting Inc. quote: Portion of North facing wall (point 2 on survey) paint striping (no priming, painting, replacement boards or caulking are included): **~\$740**

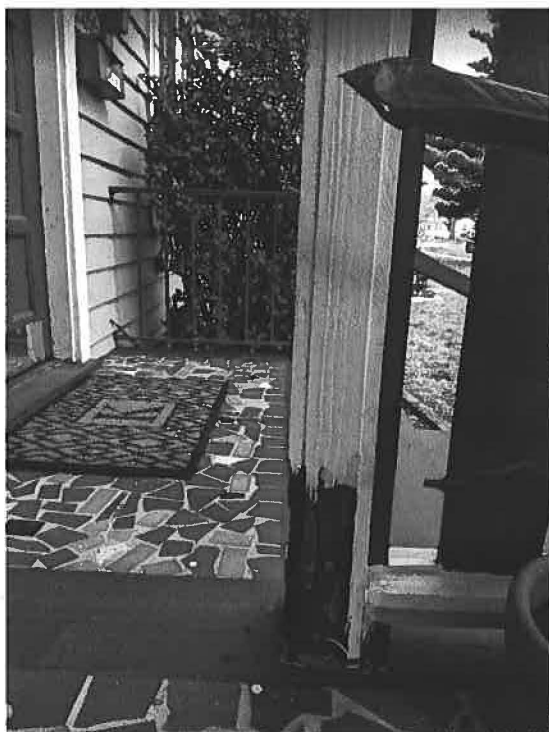
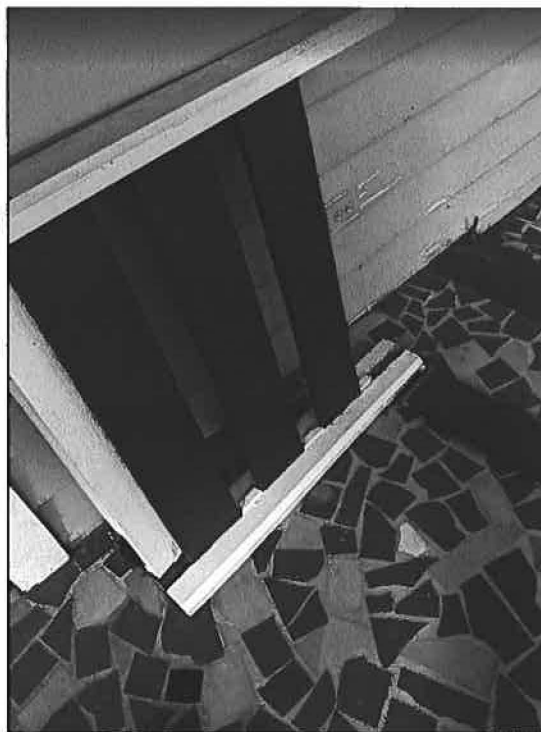
The cost of restoring the siding, or of replacing it with same material is un-affordable, and also not ideal as replaced wood is not holding up to the weather. As a further example of how new wood fares, please see the images below of our rotten porch railings. These railings were built with treated wood by Jeff Danner just three years ago. Last summer the gate rotted through and became unusable.

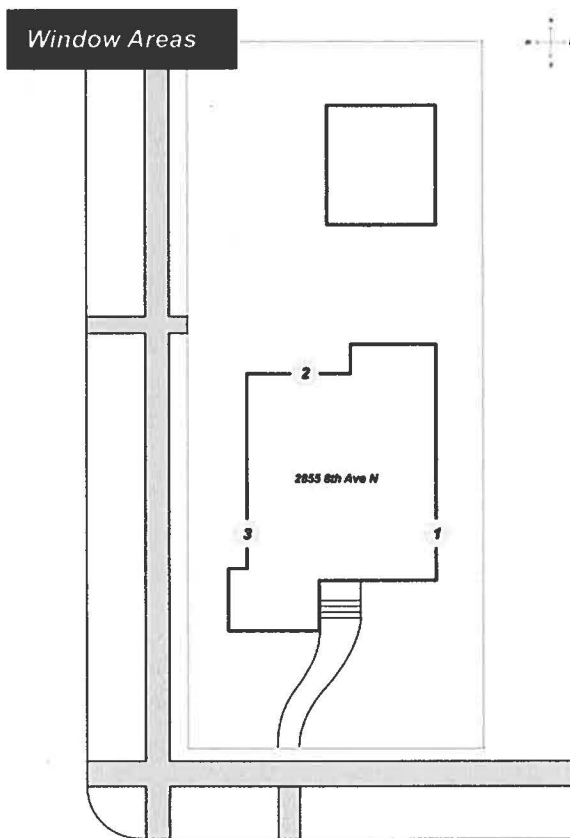
1. East-facing window attic location
2. North-facing window attic location
3. West-facing window attic location

We are planning renovations to our attic. As such we will need to add windows for appropriate light. New windows will be PGT - SH 5500/AR5540 Impact resistant Windows and follow same style/look as previous windows (if existing).

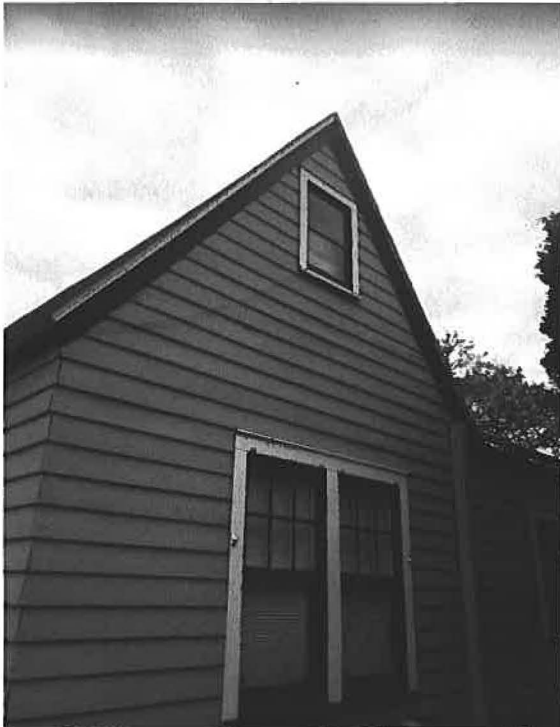
Original:

1. East-facing window

PGT 5500 Single-hung window, no grids - in keeping with what was there previously.
This window was not installed or maintained correctly by previous homeowners or builders.
It rotted, fell out and broke. Restoration is not an option.

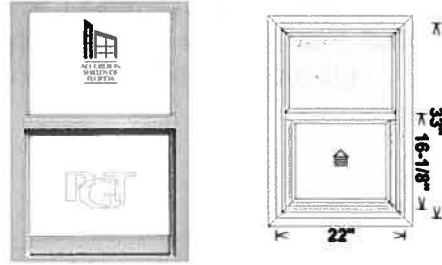
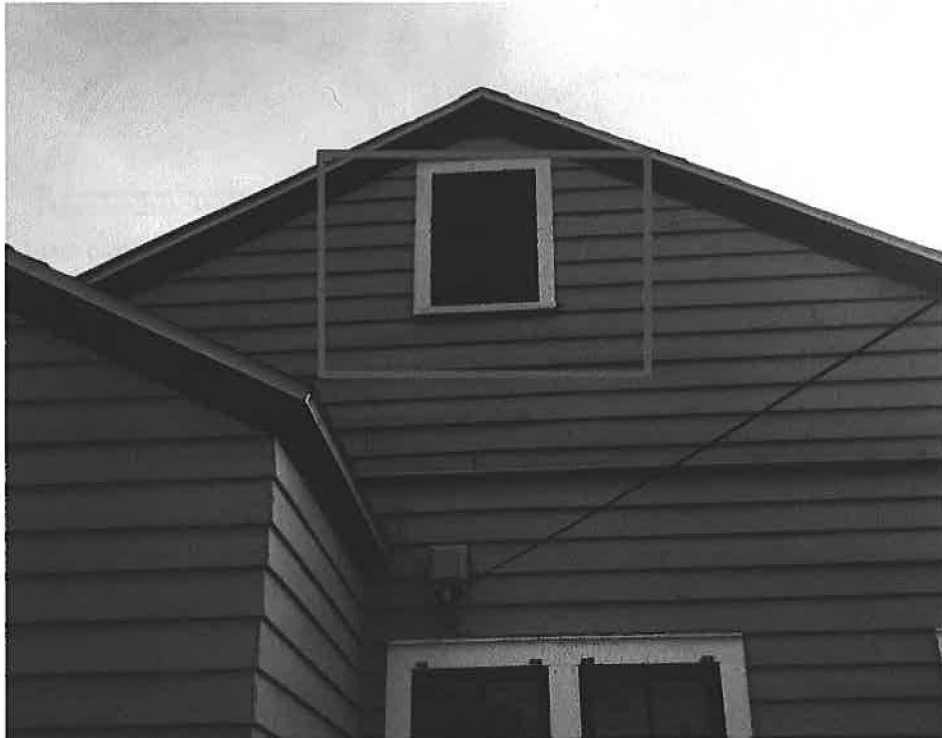
2. South-facing window

We will be adding two windows of the same size as #1, next to each other. Currently no window exists, and only a screen is there. New windows will match the appearance of the East-facing window - single hung, no grids.

Window Sizes: 22" x 33"

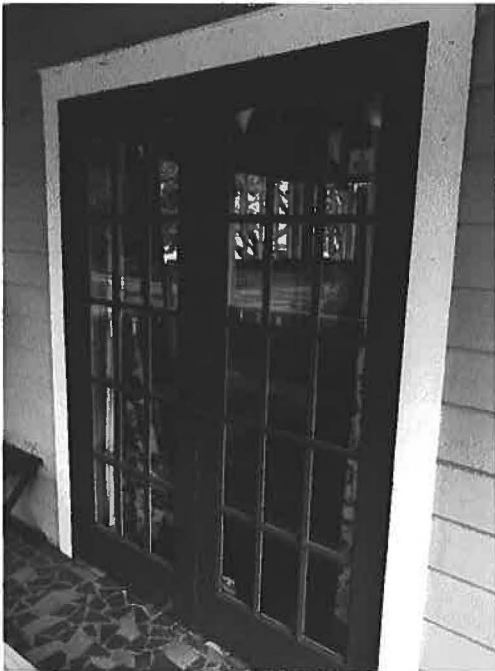
TRADITIONAL
SIMULATED
DIVIDED LITE
GRIDS

We have been told by previous homeowners that the French doors currently on our home are not original. They are deteriorating and need to be replaced. We would like to replace these with impact-resistant vinyl French doors that match the current appearance (i.e. 15 traditionally divided grids).

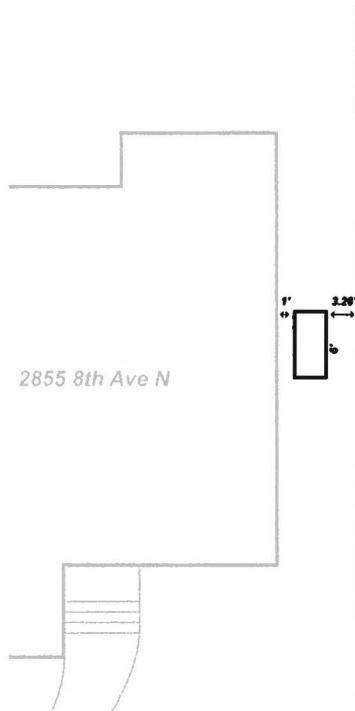
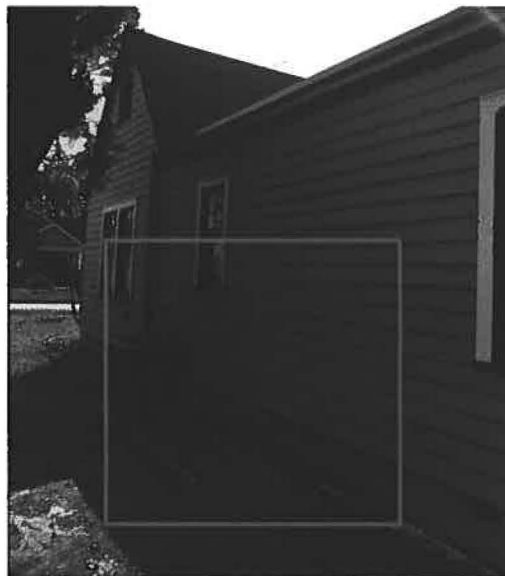
Water Heater Enclosure

We are moving our water heater out of our attic, to be housed in a new enclosure outside on the East-facing wall, next to the existing air conditioning unit.

We will be using the same HardiePlank described in the siding document, to side this enclosure.
