CITY OF ST. PETERSBURG MARINA REDEVELOPMENT

St. Petersburg Task Order # 21-01-MCL-MP(S) St. Petersburg Project # 21077-119 McLaren Project # 210154.01

ENGINEER'S ESTIMATE MEMO REVISION 1

MARCH 18, 2022

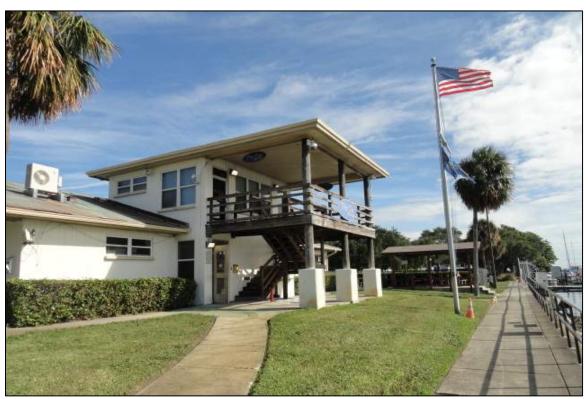
Photograph 9 – South Elevation of South Basin Comfort Center, View of Two-Story Timber Deck and Stairs.

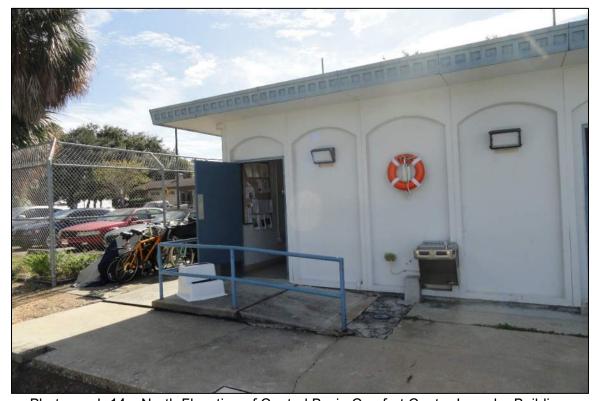
Photograph 14 – North Elevation of Central Basin Comfort Center Laundry Building.

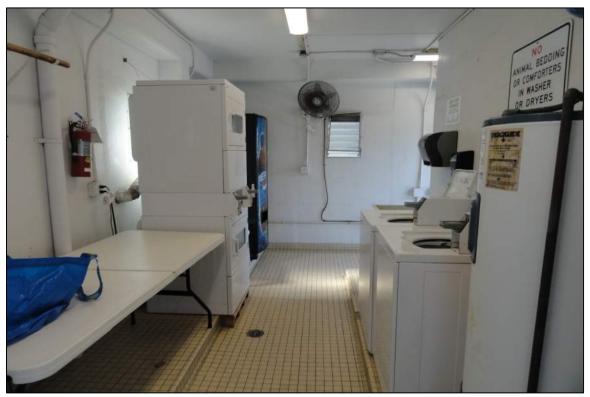
Photograph 15 - Central Basin Comfort Center Laundry Building, View of Existing Finishes and Equipment.

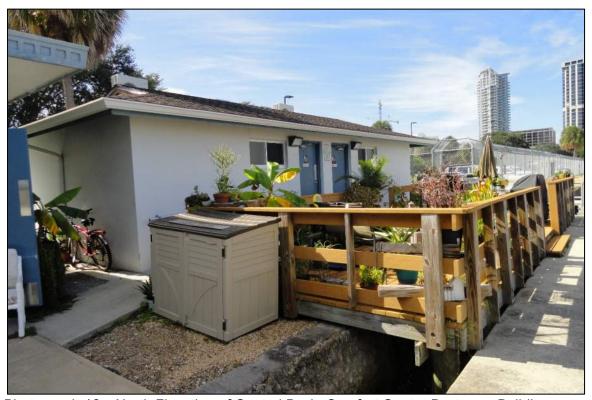
Photograph 16 – North Elevation of Central Basin Comfort Center Restroom Building.

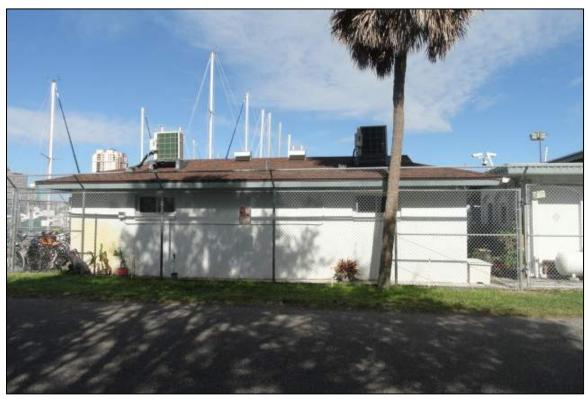
Photograph 17 – South Elevation of Central Basin Comfort Center Restroom Building.

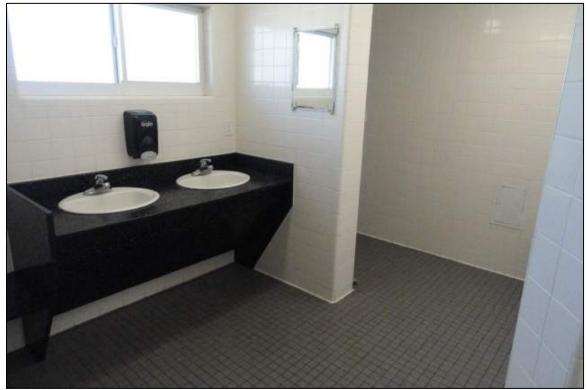
Photograph 18 – Central Basin Comfort Center Restroom Building, View of Existing Finishes and Countertops/Sinks.

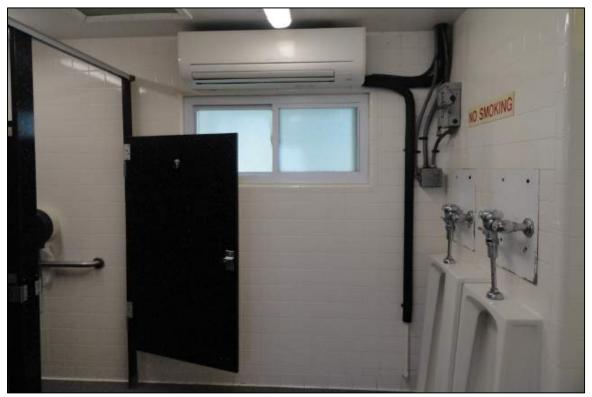
Photograph 19 – Central Basin Comfort Center Restroom Building, View of Existing Finishes, Fixtures, and HVAC Split Unit.

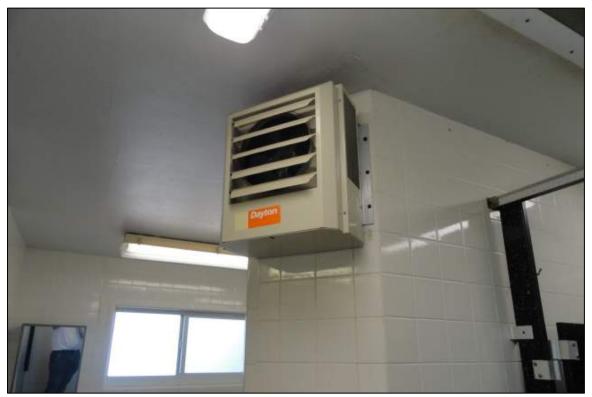
Photograph 20 – Central Basin Comfort Center Restroom Building, View of Existing Finishes and Wall-Mounted Space Heater.

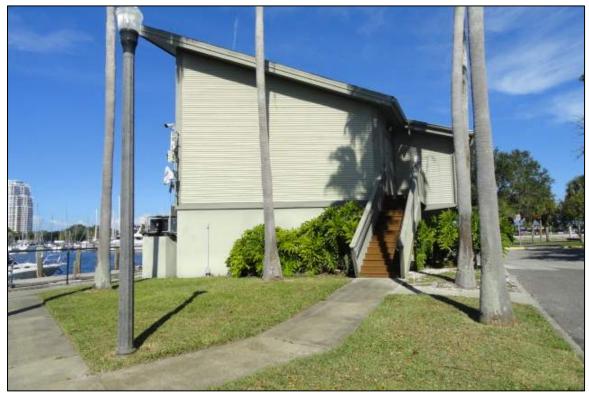
Photograph 21 – South Elevation of Marina Office and Ship Store.

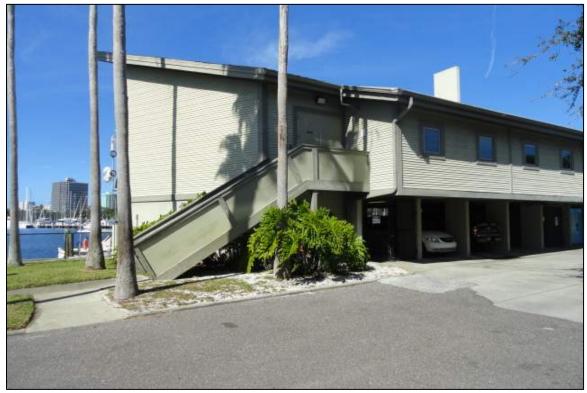
Photograph 22 – South and East Elevation of Marina Office and Ship Store.

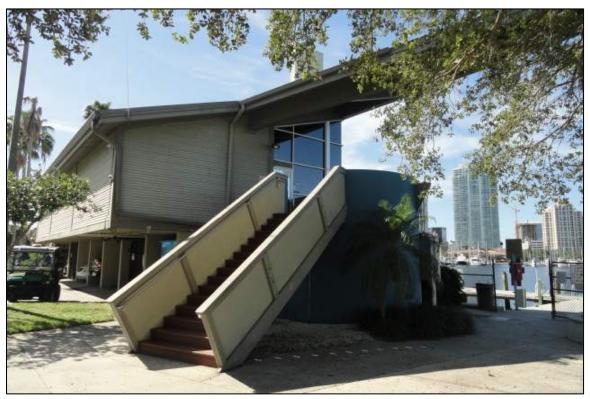
Photograph 23 – North Elevation of Marina Office and Ship Store.

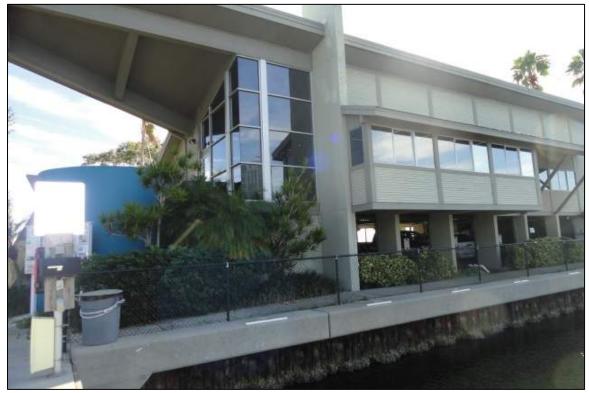
Photograph 24 – West Elevation of Marina Office and Ship Store.

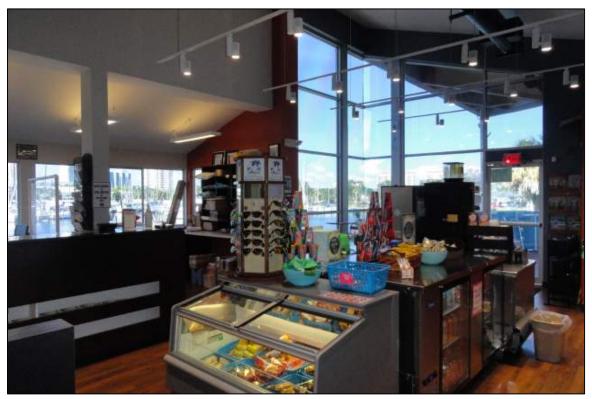
Photograph 27 – Marina Office and Ship Store, View of Ship Store Interior.
